LANDSLIDE IN LOESS ALONG THE BANK OF THE DANUBE

A. KEZDI, Prof. Dr. techn.
Technical University, Budapest.

SYNOPSIS Paper describes and analyses the sudden spreading of a loess plateau caused by the rise of the ground water table beneath a newly constructed industrial plant. After the outline of the geological conditions, physical characteristics of the soil and the results of stability analysis are given.

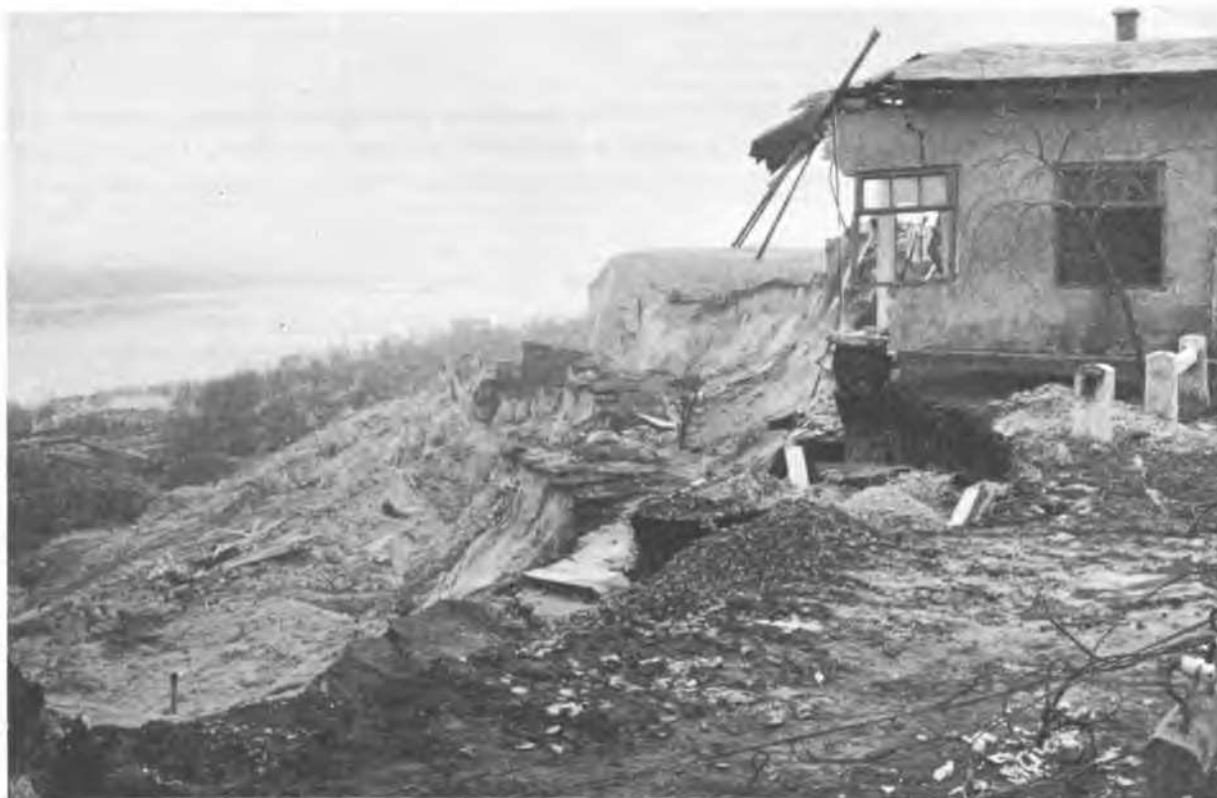
the main establishments, on February 29, 1964, a tremendous slide occurred, in a few hours, like a sudden spreading, on the section just above the first pumping station. An earth mass, with a length of approx. 1300 m, and a width of 15-20 m, came suddenly into a downward and outward motion; the bottom of the Danube was lifted, and the narrow, flat strip along the shore was horizontally displaced. The above mentioned pumping station also moved horizontally 35 m, and it was rotated around its vertical axis by 12°, without any change in its vertical position or any damage to the machinery. Fortunately, there were no casualties. The main part of the movement was over in a few hours; later, only secondary movements were observed.

Fig. 1 View of the slide from the West

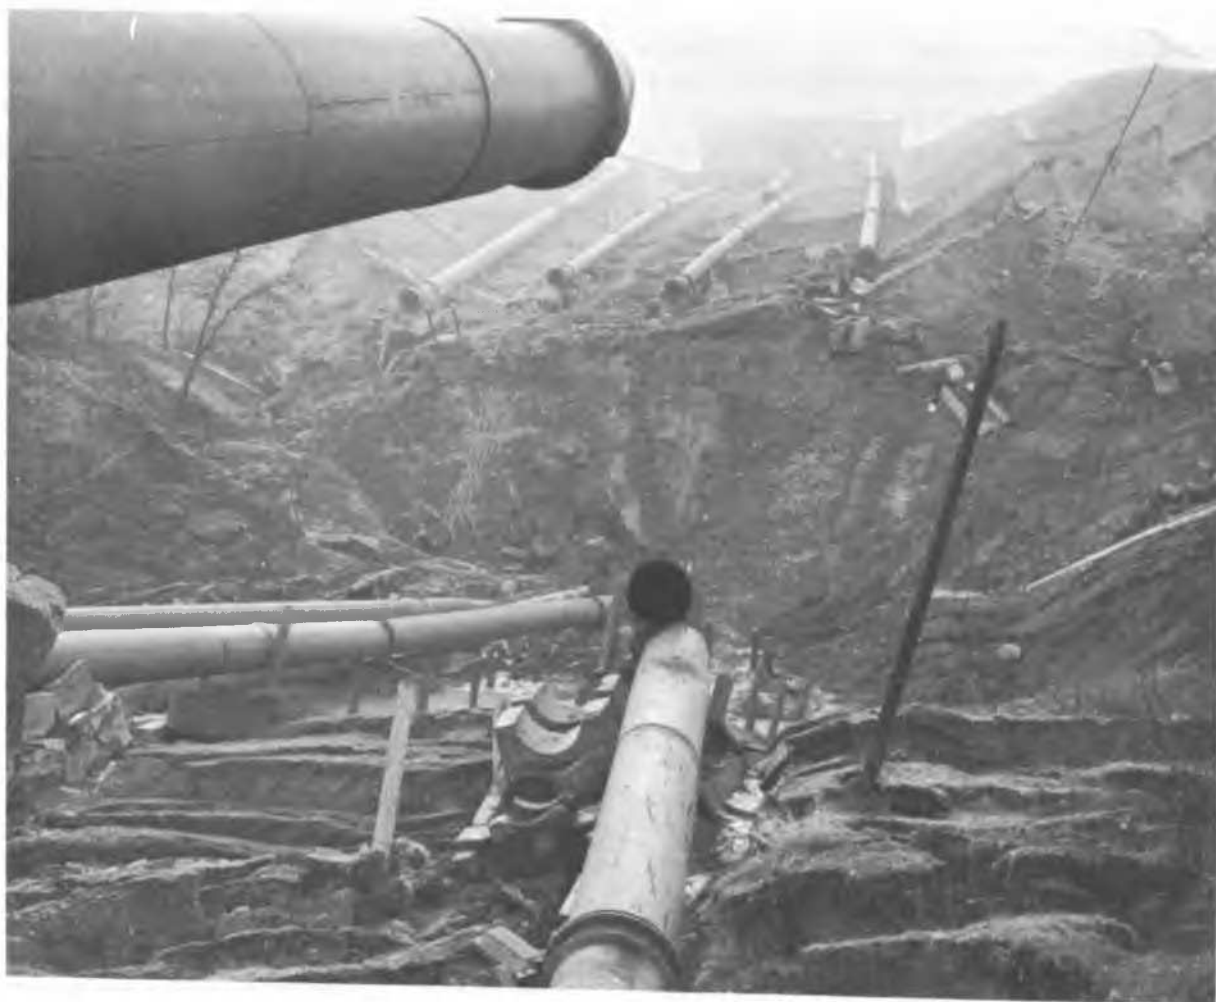
The view of the slide is given in Fig. 1. and 2.; the latter displays the wrecked water pipes coming from the pumping station.

Fig. 2 The broken pipes of the displaced pumping station

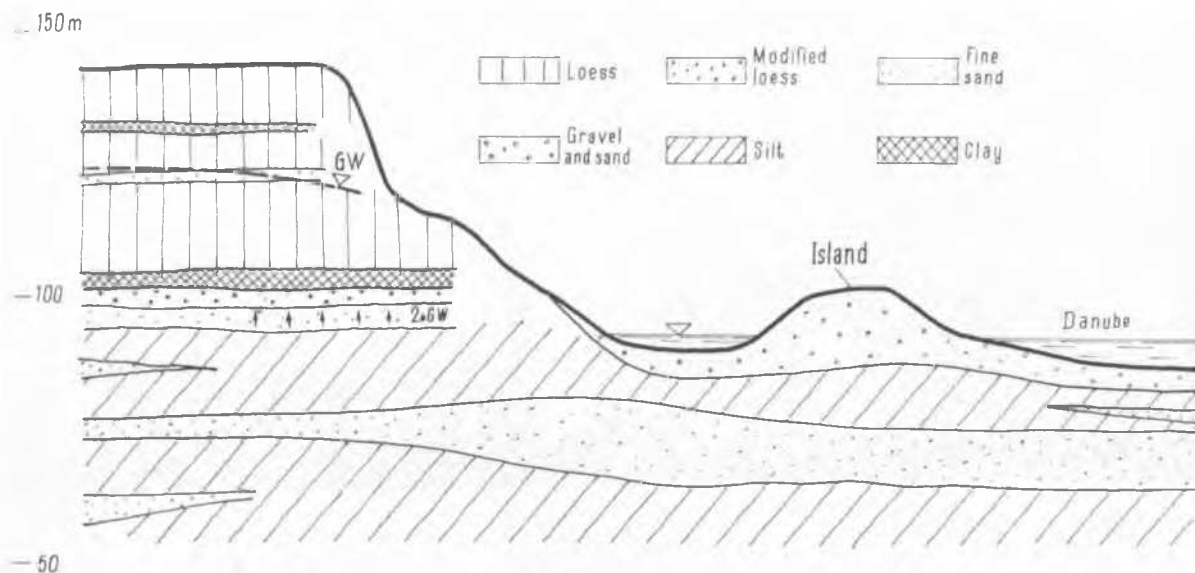
There are two water levels beneath the surface. The first, a free one in the loess layer, is fed by the precipitation on the area, while the second one, in the Pannonian layers, has a rather high piezometric level. (Fig. 4.)

Fig. 4 Geological section of the affected area

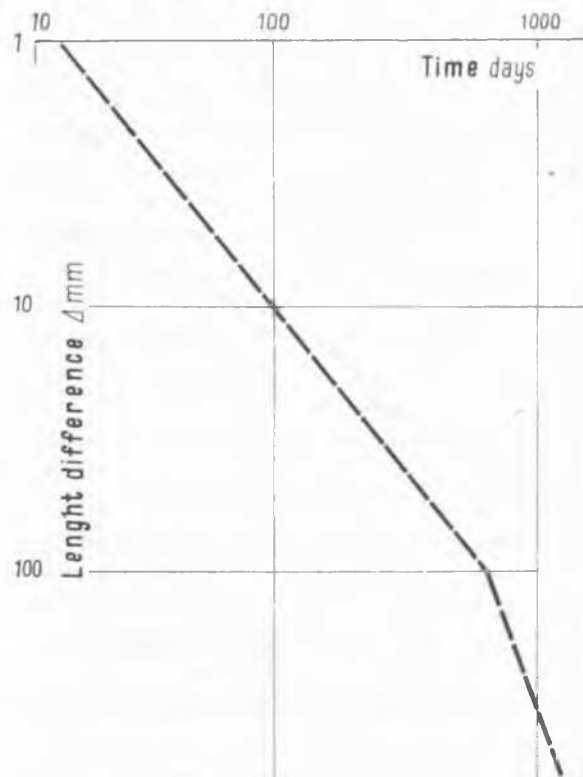
there was an old, abandoned house which showed cracks and fissures. So we decided to take measurements from time to time, and so, we could foretell the slide, because the reference points showed a movement of an increasing rate. However, the extent of the slide was many times greater than anticipated. The movement of an observed point up to the occurrence of the slide is given as an example on Fig. 6.

Fig. 6 Movement of a house on the rim of the loess plateau

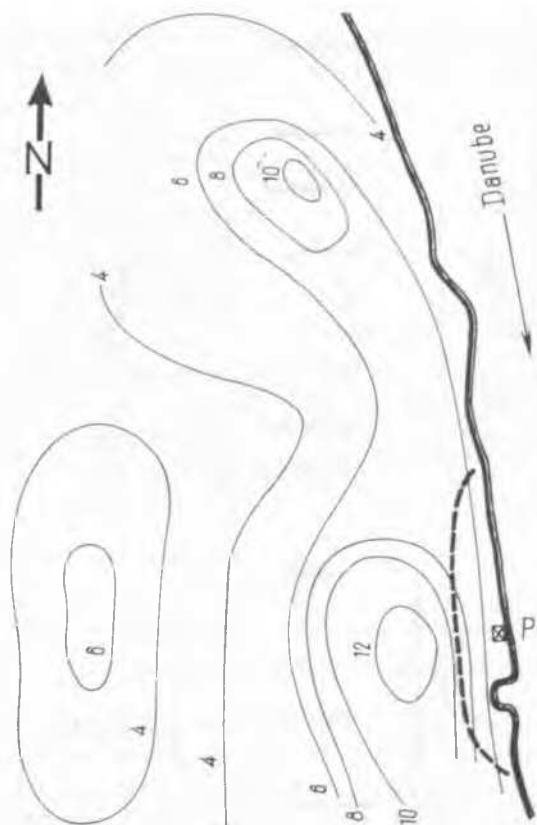
The situation outlined above has been rather drastically changed through the construction activity. A formerly agricultural land was transformed into an industrial and city territory; rainfall could enter into the soil in a concentrated manner, and what makes things worse, leaking water pipes and sewers supplied a great amount of water which caused a very significant rise of the ground water table. Fig. 5. gives an idea about

about the degree of this rise, presenting the contour-lines of equal rising heights, in meters. A very important factor in the development of these water-cupolas was the aelotropy of the loess: the coefficient of permeability being much greater in the vertical direction, due to the more or less vertical network of root holes. (Terzaghi-Peck, 1967.) The original water table had a slight slope toward the river, so the reservoir was drained through the foot of the steep loess-wall. After the rise of

Fig. 5 Rise of the upper water table; formation of water-cupolas
P - pumping station

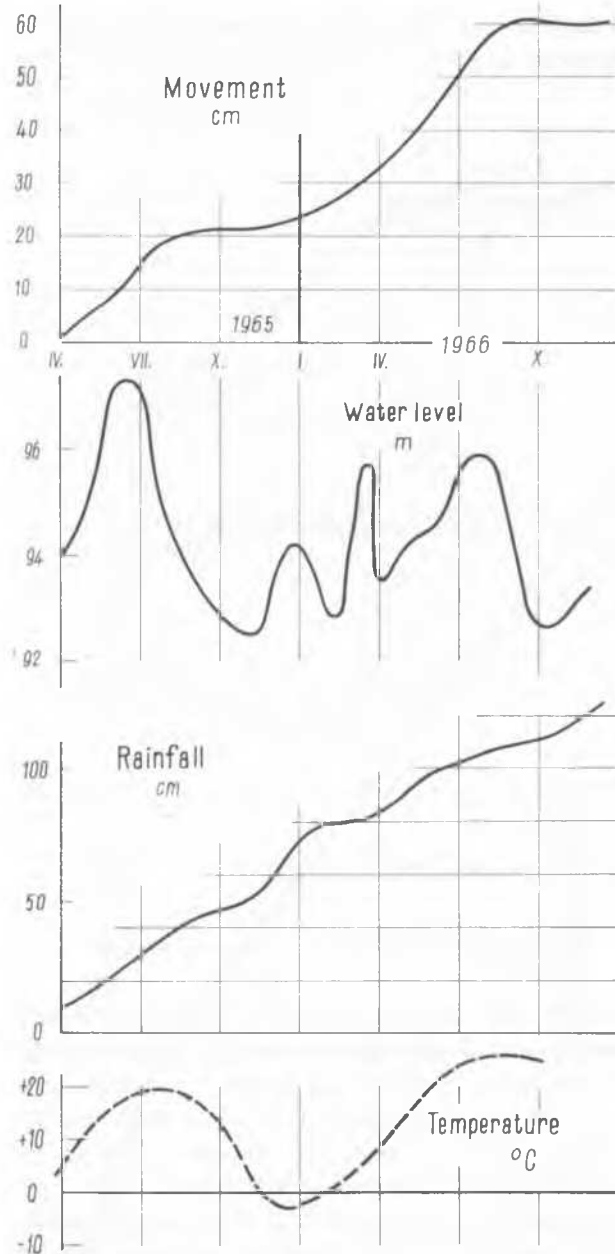
After the slide, in 1965, several further reference points were installed. The measured movements showed very interesting regularity and correlations. In Fig. 7., I plotted the change in the distance between two reference points installed at the top and at the foot of the plateau, further the velocity of the movement, the level of the Danube,

Fig. 7 Analysis of the measured movements of the loess wall

the summation of the rainfall and the variations of the temperature as well: it can be seen, that there is a marked correlation e.g. between the velocity and the water level. This fact gives right to the assumption that a rising water level reduces the shearing strength on a certain critical plane. However, this fact cannot be considered as the only agent which produced the slide.

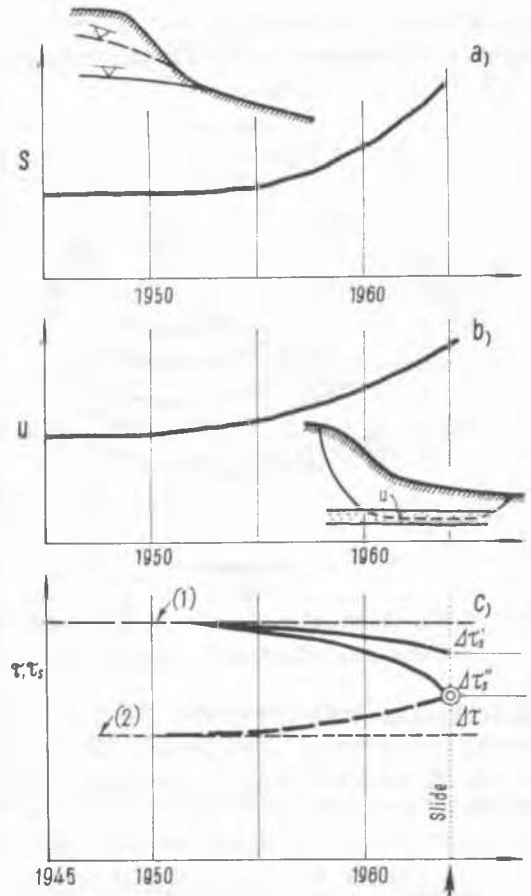
So, the progression of the slide can be traced, in the writer's opinion, as given in Fig. 13. Herein, the increase of the seepage force a, of the piezometric stress b and the variations of the shearing and resisting forces c are plotted. The factor of safety drops to unity, when the sum of the driving forces becomes equal to the resisting forces. The factor of safety is therefore given by (see Fig. 14)

Fig. 13 Mechanism of slide

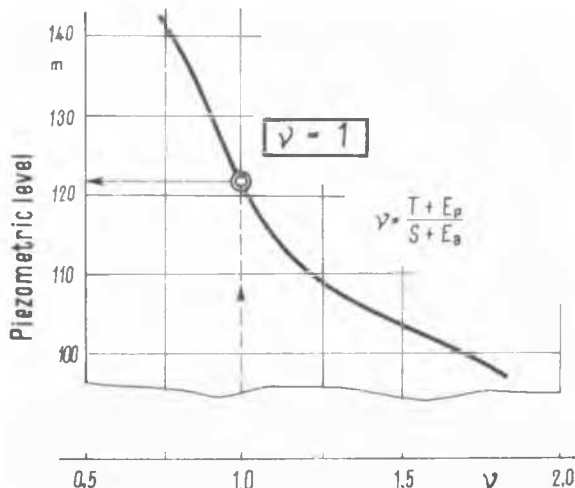
The height of the critical plane could be determined with a sufficient accuracy; also the extension and dimensions of the displaced block were known, so, the value of the piezometric stresses was the only uncertain quantity. Therefore, we calculated the safety factor assuming different values for the neutral stress acting in the critical plane; Fig. 15 presents the result of these calculations. We obtained $\nu = \text{unity}$ for a piezometric head 122 m above sea level. This value agrees very well with the observations before the slide, so it proved that the assumed mechanism of the slide cannot be far from reality. Since the original water levels - first and second ground water - were

Fig. 15 Factor of safety as a function of the piezometric head on the critical plane

It dropped to $\nu = 1$, due to the rise of the water level. After the movements stopped, its value was somewhat greater than 1, but the question arose, how to increase the stability of the plateau and to protect the constructions against further movements.

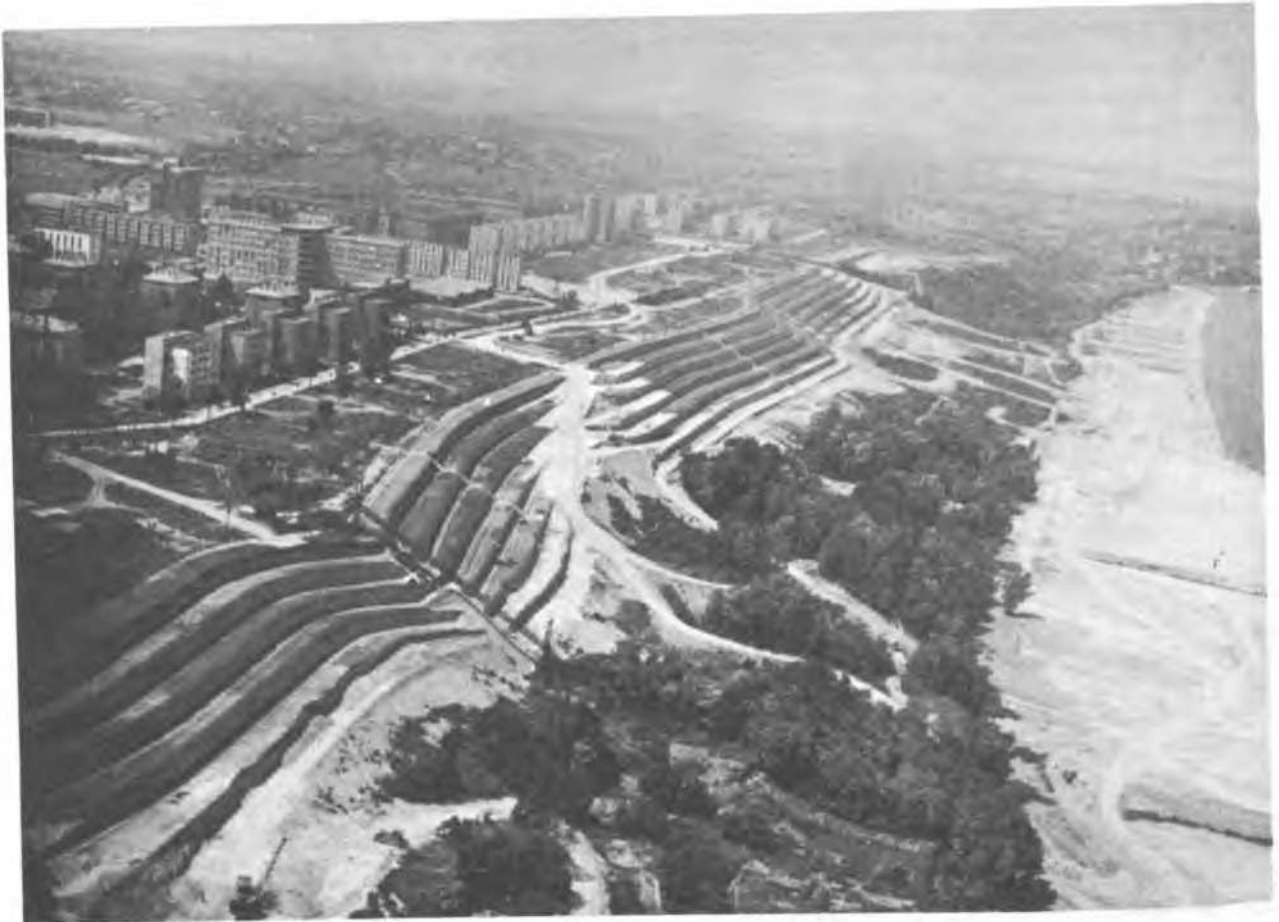
Fig. 16 Condition of the river bank after the remedial measures

In possession of the relevant features of the slide and having recognized the real causes, remedial measures could be proposed. Of course, any procedure employs one of the following methods: either we reduce the active forces, or we increase the resisting forces. Both methods were applied here. First, at the proposal of the writer, wells were installed at a certain distance back from the crest in order to lower the upper ground water table and, at the same time, to reverse the direction of seepage in the upper part, further, to reduce the piezometric level of the second water table. Then, shafts and galleries were built at the foot of the plateau, for drainage purposes and in order to increase the shearing strength of the afflicted masses. A fill in and by the Danube was made to protect the riverside from being washed away. As an additional measure, the shaping of the sides was provided, in order to take good care of the precipitation and to prevent gullying; also the appearance of the hillside particularly from a Danube ship should fulfill aesthetical requirements. It should go too far to discuss these constructions in detail; I give here only a table displaying the new factors of safety, due to these remedial measures. The new landscape is shown in Fig. 16. -
