# Behaviour of a Single-Line Grout Curtain

A. J. L. BOLOGNESI, *Consulting Engineer, Buenos Aires, Argentina*

LAS PIRQUITAS is the first major earth dam built in Argentina. Its characteristics have been described elsewhere (Grandi, *et al.*, 1961). It has a grout curtain built by a well-known firm, with the unusual feature, for an earth dam, of a concrete grouting gallery partially buried in the foundation rock below the impervious core. Piezometer holes placed in this gallery afforded the opportunity of checking the behaviour of the grout curtain. Theoretical analysis shows very clearly that rock grouting can generally be limited to the existing definite pervious zones of a dam site. Yet, indiscriminate grouting is still widely used and Las Pirquitas was no exception to this rule. Fig. 1g shows the cut-off grouting design adopted for this dam.

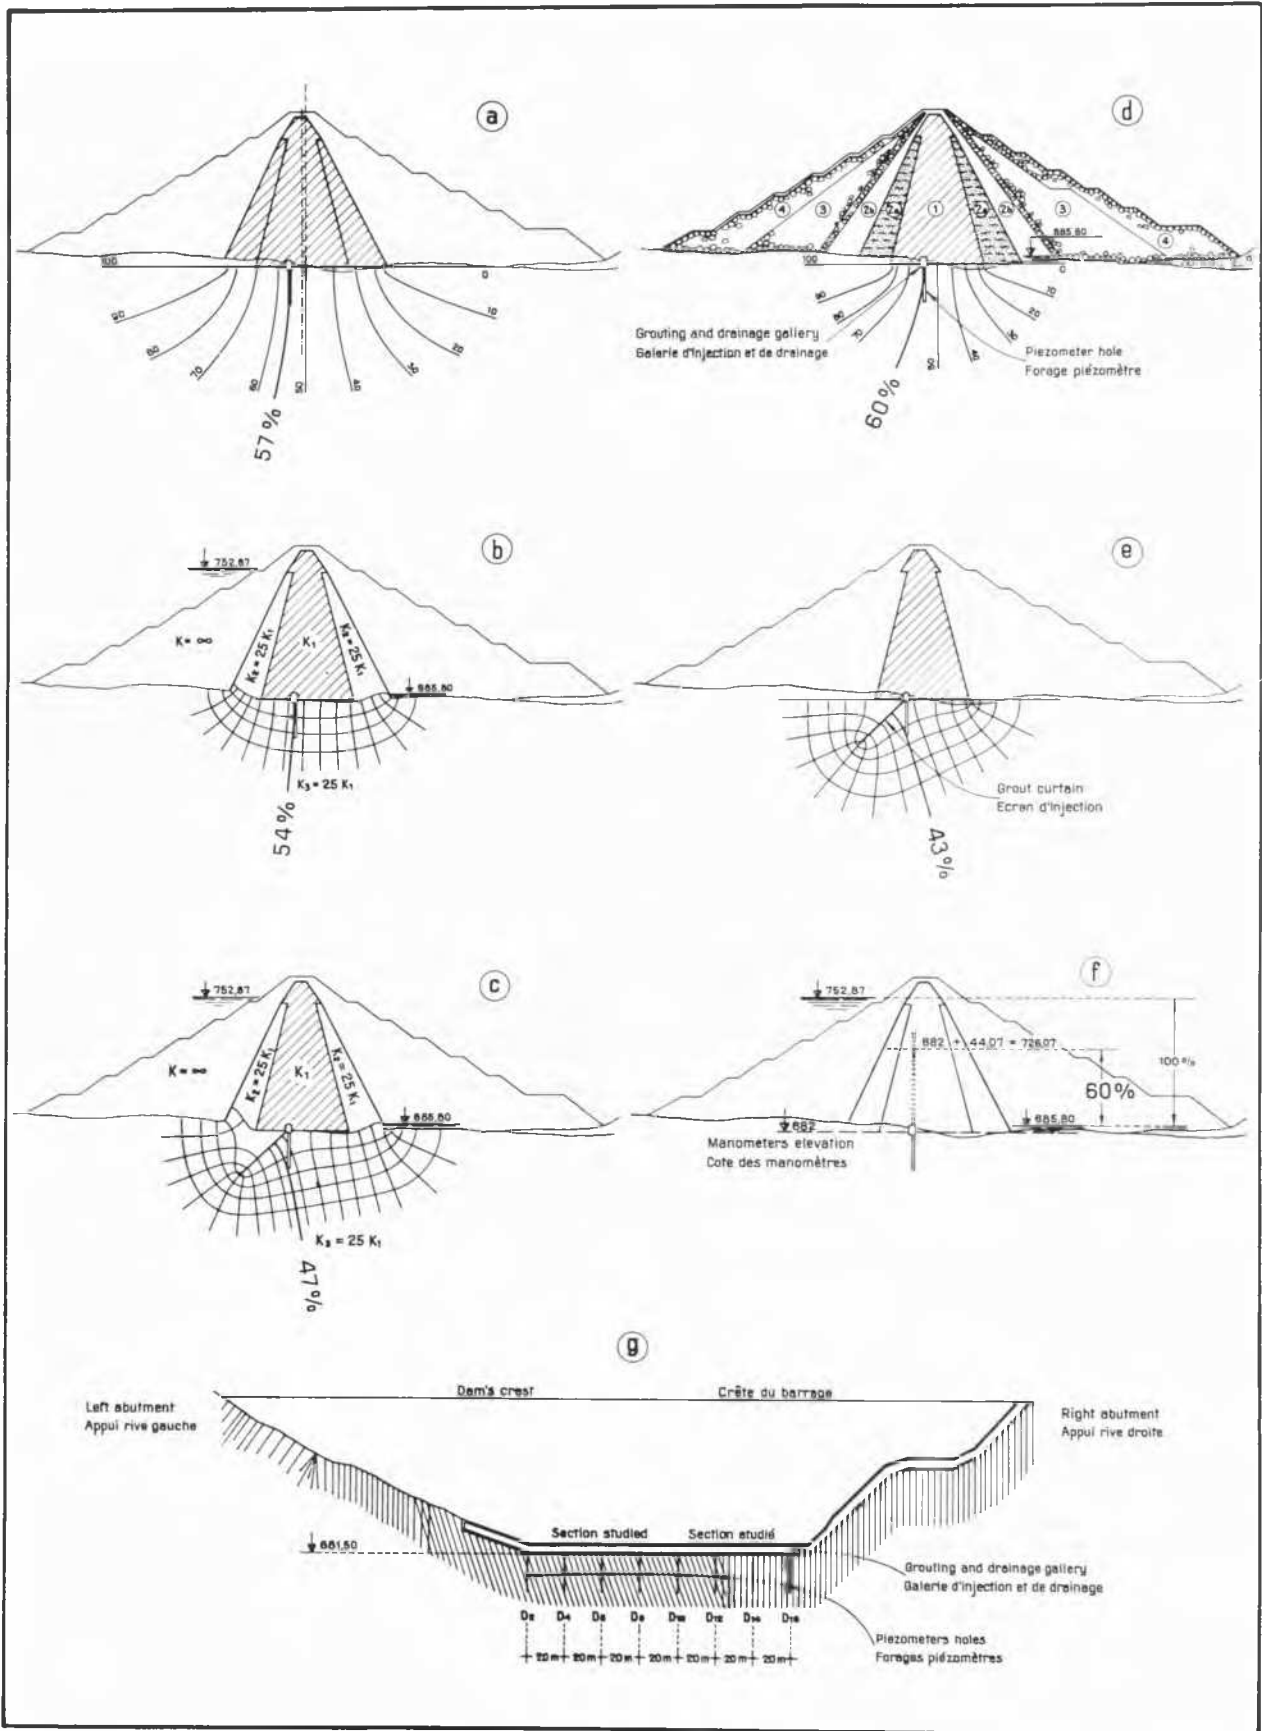
FIG. 1. Las Pirquitas Dam grout curtain; estimated and actual performance.

Fig. 1f shows graphically a summary of results. With an average reservoir elevation of 752.87 and a tailwater elevation of 685.80, an average uplift pressure of 4.407 kg/sq.cm. (44.07 m) is obtained, giving a water elevation of 726.07 at piezometer level. This indicates that at the piezometer location, 40 per cent of the hydraulic head had been dissipated. The piezometer holes must then be cut by the equipotential line representing 60 per cent of the hydraulic head.

By comparing the highest equipotential line cutting the piezometer holes with the actual drop in hydraulic head (Fig. 1f), it is clear that the grout cut-off has been ineffective, and that the dam has performed as if it had an impervious core (zone 1) with a zone 2b considerably more pervious than the foundation, as assumed in the hypothesis of Fig. 1d. It is to be remembered that the rock is neither semi-infinite in extent nor isotropic in permeability but, for the conditions shown in Fig. 1d, both the introduction of anisotropy and the limitation of the depth of the permeable foundation changes the distribution of the equipotentials below the foundation very little.

The pressure measurements presented here prove that the grout cut-off has been ineffective, and they add to the growing evidence pointing out the dubious efficiency of single-line grout cut-offs. From this study, one reaches the inevitable conclusion that even a perfect grout cut-off of the same design would have added practically nothing to the safety of the dam.

Grout cut-offs should only be used where a thoroughly competent and detailed analysis shows that they will be efficient for the purpose for which they are envisaged.
