Stabilization of a Quick Clay Slope by Vertical Sand Drains

by O. S. HOLM, M.N.I.F., Associate partner Norsk Teknisk Byggekonskontroll, Consulting Engineers, Oslo, Norway

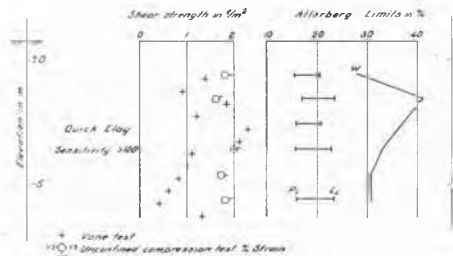
Fig. 2 Typical soil profile.
Profil des caractéristiques du sol.

The thickness of clay deposit is, on the average, about 10 m, with a maximum thickness of approximately 18 m. On Fig. 2 is shown a soil profile together with the results of the laboratory tests on undisturbed samples taken at the shore line, and the results of a nearby field vane test. The soil consists of very sensitive quick clay. The field vane test indicates an undrained shear strength as low as 1 ton per sq. m., whereas unconfined compression tests on undisturbed

samples show a shear strength of 1.7 to 2.0 tons per sq. m. This discrepancy is probably due to a considerable content of coarse material in the clay.

The natural moisture content varies between 30 and 40 per cent, which is 6 to 17 per cent above the liquid limit. The clay is therefore liquid in the remoulded state. The plasticity index is 5 to 9 per cent. These values are typical of Norwegian quick clays.

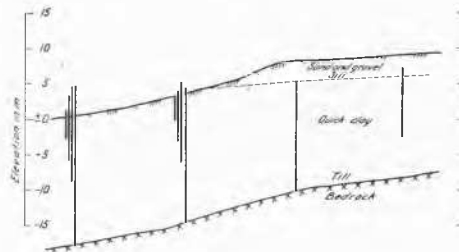
Fig. 3 Section. Pore pressure installations. Piezometric heads at measuring points prior to drainage installation. Coupe. Mesure de la pression interstitielle. Charges piézométriques avant drainage.

On Fig. 3 is shown a section through the slope and the corresponding piezometers. The piezometers are indicated by full lines drawn from their points to the original piezometric heads.

Behind the crest of the slope the free ground water level varied between ground surface in wet periods, and 1.5 m below ground surface in dry periods. On the shore line, and off-shore, an excess pressure of 5 m was measured at bedrock, gradually decreasing with decreasing depth. Water leaked steadily out of the ground in the lower half of the slope.

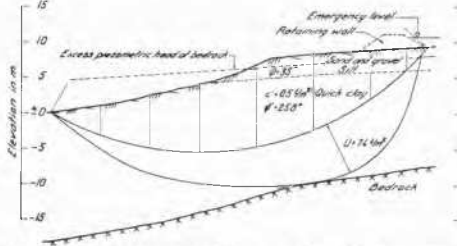
Stability calculations of the natural slope in terms of total stresses indicated a safety factor of 0.7. Stability calculations in terms of effective stresses, based upon the measured pore pressures in the ground, resulted in a safety factor of 1.6 (Fig. 4). Assuming the additional loads to be the retaining wall at the crest of the slope and the oil-filled basin behind the wall, and assuming that these loads result in 100 per cent pore pressures in the clay, the safety factor is reduced to 1.4, which is considered unsatisfactory.

Fig. 4 Natural slope. Stability analysis. Effective stresses. Talus naturel. Analyse de stabilité. Tensions efficaces.

It was therefore decided to take steps to reduce pore water pressure permanently, so that the safety factor would not be less than 1.6.

A stabilizing system of vertical sand drains was proposed which would act as relief wells of the bleeder type. The primary effect of the drains would be to reduce the pore pressures at bedrock, and in the sand layers in the clay deposit. This reduction would both occur rapidly, and increase stability. The secondary effect would be to consolidate the clay. The rate of consolidation would be accelerated by the drains.

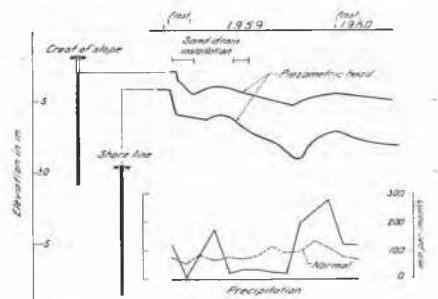
On Fig. 5 are indicated the results of the pore pressure measurements made by two piezometers, one at the shore line, and the other at the crest of the slope. The curves show that the pore pressures fell considerably during installation of the sand drains. Below the pore pressure diagram is shown the actual and normal monthly rainfall. The variation in the pore pressures and rainfall show an appropriate correspondence. In the long dry summer period of 1959 the pressures were low, but late in 1959 the rainfall was much higher than normal, with correspondingly higher pore pressures. Nevertheless, the pressures were still lower than the original excess pressures.

Fig. 5 Measured pore pressures and monthly rainfall. Pressions interstitielles mesurées, et précipitations mensuelles.

The curves indicate that there is a considerable variation in ground water flow.

The changes in the pore pressures during variable rainfall indicate that the spacing between the drains at the toe of the slope might have been smaller. The grain-size distribution of the filter material in the test drains might also have been used for the installed drains, as the test drains did not seem to be clogged.
