# Failure of Embankment in Kinkai Bay

by Y. ISHII, Dr. Eng., S. KURATA, Transportation Technical Research Institute, Ministry of Transportation, Tokyo, and  
S. HASEGAWA, Chief of Construction Office, Kinkai Salt Manufacturing Co., Okayama, Japan

The authors describe soil investigations and detailed analysis of the sliding action after the failure of the Kinkai reclamation embankment occurred in 1958 during construction.

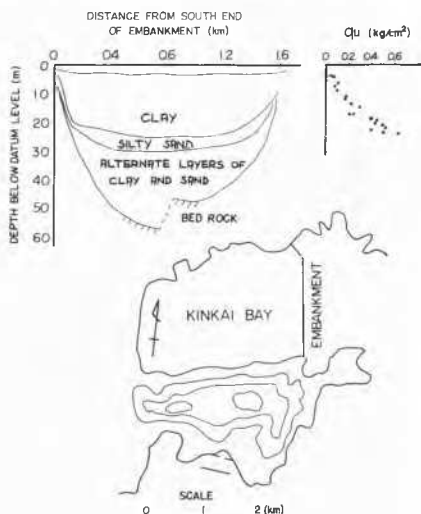
Fig. 1 Location of embankment and soil profile.  
Emplacement de la digue et coupe du terrain.

A reclamation embankment was constructed in January 1957 at the mouth of Kinkai Bay, Okayama Prefecture, Japan. A very soft alluvial clay layer with a thickness of about 22 m underlies the major part of the embankment. Profile of the underlying soil strata along the embankment is shown in Fig. 1. Mean void ratio of the clay soil is about 3.0, and unconfined compressive strength is 0.08 kg/sq. cm for the upper portion, and 0.5 kg/sq. cm for the lower stratum.

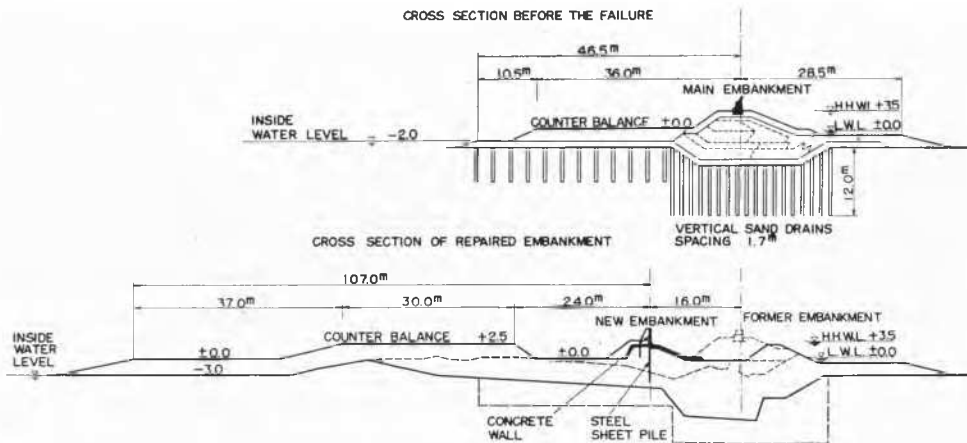
In Fig. 2 the typical schematic cross section of the embankment before failure is shown. Vertical sand drains were driven into the soft clay layer at the interval of 1.7 m and the soil was consolidated by the weight of embankment materials, which were transported over the embankment by dump trucks from a borrow pit near the site, and were placed in five layers every four months in order to ensure adequate consolidation.

Transverse and longitudinal cross sections of the embankment before and after failure are shown in Fig. 3. The maximum settlement of parapet concrete blocks was about 6 m, and the blocks were slightly inclined outwards the central portion of the embankment which failed having been completely submerged. The inside counterbalance and the inside sea bottom were heaved upward, and the maximum heaving

amounted to 3 m or more. Any movement in the outside of the embankment was not observed. According to these observations the failure seemed to be of the circular sliding type.

The cross section of the reconstructed embankment is shown in Fig. 2. The light weight embankment and reinforced concrete wall have been constructed on a line moved to a distance of 16 m from the crest line of the embankment which failed,

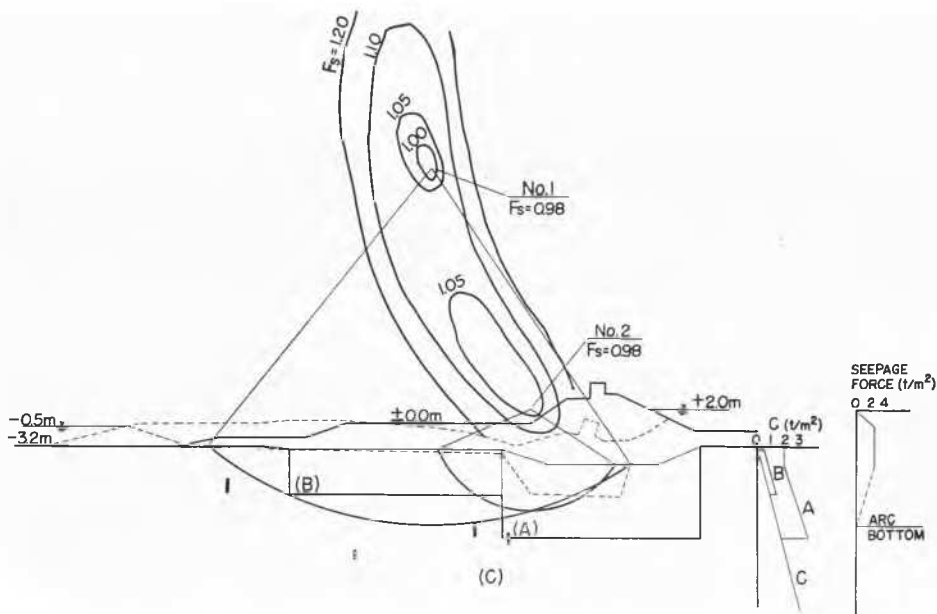
Fig. 5 Results of analysis by the circular arc method.  
Résultats des analyses par la méthode de rupture circulaire.

In Fig. 5, contour lines of the computed safety factors and also circular arcs of the lowest safety factor are shown. Two possible centres of circular sliding arc of the same minimum safety factor 0.98 were obtained. One of them, namely centre No. 1, is located in a higher position with a large circular arc, which coincided with the sliding surface found by soil investigations. Another centre, centre No. 2, is located in the lower position near the main embankment with a small circular arc. In these calculations seepage forces acting as sliding forces against soil masses within the circular arcs were

assumed to correspond to items (4) and (5) for simplicity of calculation, and therefore in cases of small circular arc sliding, seepage forces were considerably overestimated in the calculations. According to the stability computations about centre Nos. 1 and 2, considering seepage forces estimated by flow net, safety factors were 1.13 and 1.17 respectively. Therefore, it is conceivable that the sliding occurred along the large sliding surface.

By the above analysis it may be concluded that the failure is one of typical circular sliding caused by the lowering of the safety factor due to the increase of unit weight of the embankment materials by compaction from heavy traffic.
