A Study of a Breach in an Earthen Embankment Caused by Uplift Pressures

by Arthur MARSLAND, M.Sc. (Building Research Station, Watford, Herts. England)

Summary

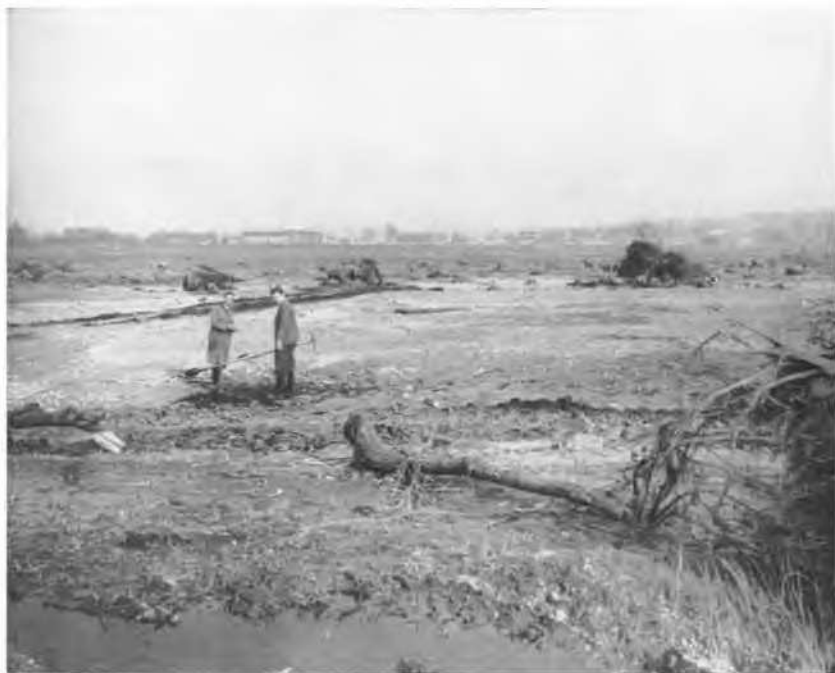
The first warning of danger was a report by the Keeper at Dartford Lock that water was coming over the bank at many points. Shortly after this the bank suddenly gave way and the marsh was rapidly flooded to a depth of 5-6 ft. By the next morning the breach was 90 ft. wide and 6-8 ft. below marsh level and the gravel was exposed at the sides and bottom of the breach. The most unusual feature of this particular failure was the fact that large lumps of clayey peat with a maximum size of 6 ft. cube were carried as far as a 1,000 ft. into the marsh (see Fig. 1). Away from the breach only superficial erosion of the weak top soil occurred, and the bank was completely undamaged at many of the lower spots.

Fig. 1 Photograph of outwash debris on marsh at rear of breach.
Photo des alluvions et de débris sur le marais, derrière la brèche.

(2) The large size of the outwash debris make it unlikely that failure occurred as a result of overtopping erosion especially since some of the larger lumps were composed of clayey peat from below marsh level. This was substantiated by the fact that even though shallow overtopping occurred over all the banks in the area the surface erosion was only slight because of the relatively firm condition of the clay in the bank.

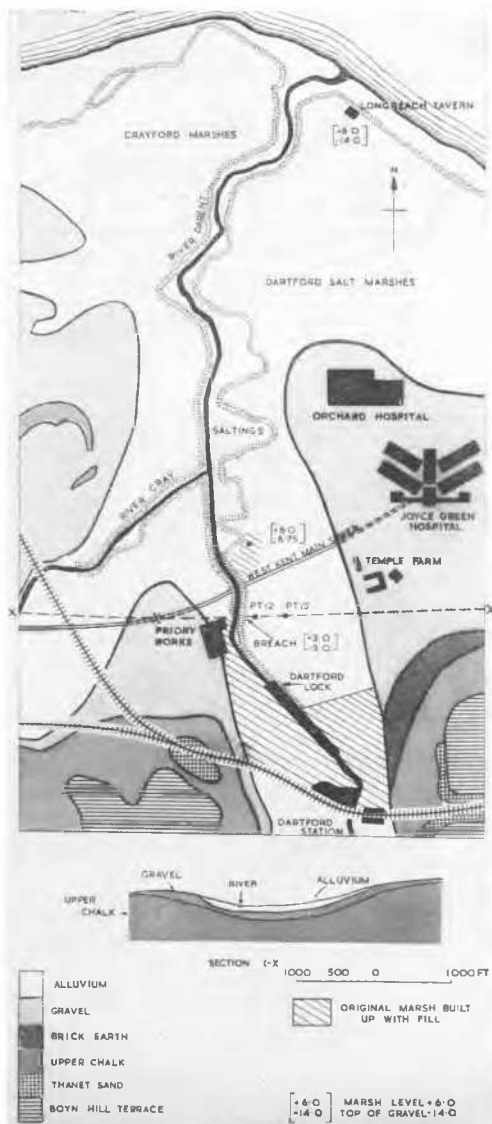
In the locality of the breach site the Darent Valley is covered with a thin layer of alluvium composed mainly of peat overlying a stratum of gravel about 10 ft. thick, which rests upon chalk. The gravel is exposed on low hills about 500 ft. to the West and 2,000 ft. to the East of the river as shown in Fig. 2. In the area of the breach the river channel is very close to

To ascertain the sequence of the soil stratum in more detail borings were made in the area of the breach and at intervals along the East bank of the Darent as far as the River Thames. The levels of the ground surface and the top of the sandy gravel are given against each bore hole in Figs. 2 and 3. It will be seen that the surface level of the marsh was lowest near the breach site (± 2.5 to ± 3.5 O.D.N.) and that the top surface of the gravel stratum falls from about -3.0 O.D.N. at the breach site to -20 O.D.N. at the mouth of the Darent. The thickness of peat and peaty clay above the gravel was thus only about 6 ft. at the breach site and gradually increased on both sides.

Fig. 2 Geological map and section across valley.
Carte géologique et section de la vallée.

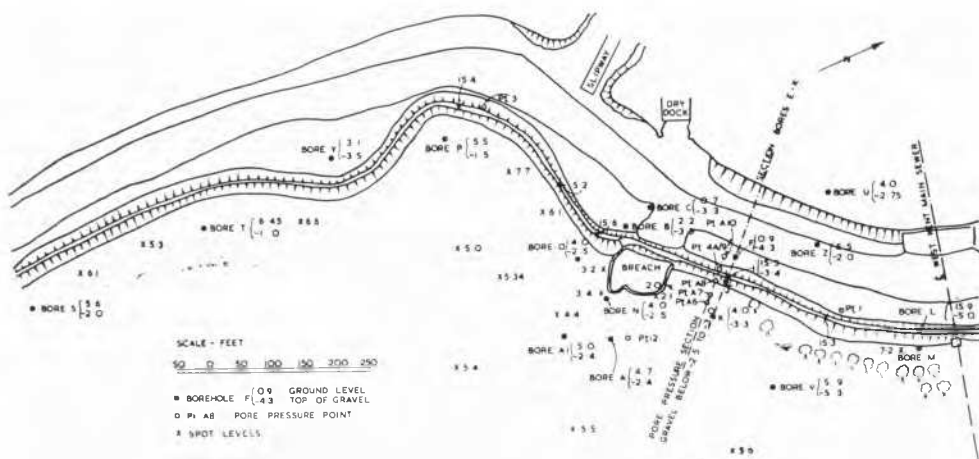
Fig. 3 Position of boreholes and pore pressure points.
Position des forages et des points de pression interstitielle.

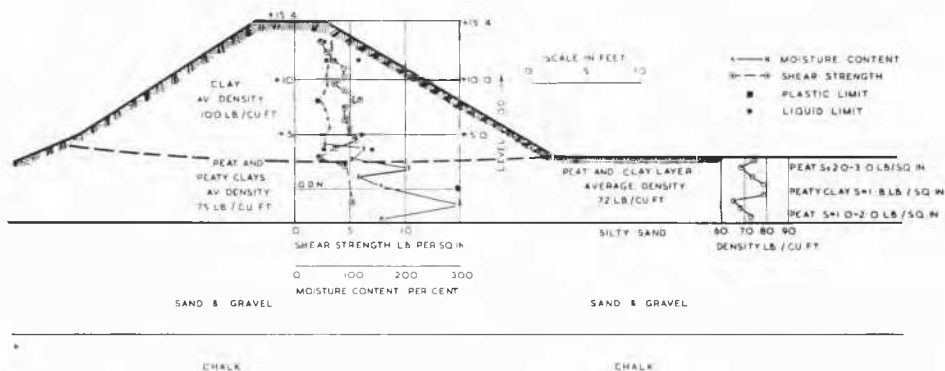
A section through the bank and marsh layers adjacent to the breach is shown in Fig. 4 together with values of density, moisture content and the results of unconfined compression tests made on undisturbed samples taken from the bank during normal tide conditions. Spot levels taken at intervals of 100 ft. along the top of the bank varied between 15.0 and 16.5 O.D.N. while at either side of the breach levels of 15.5 O.D.N. were recorded. The bank was composed of a firm clay and shrinkage cracking was limited to the top 12 in.

Fig. 4 Section through bank showing soil data.
Section du talus montrant les propriétés du sol.

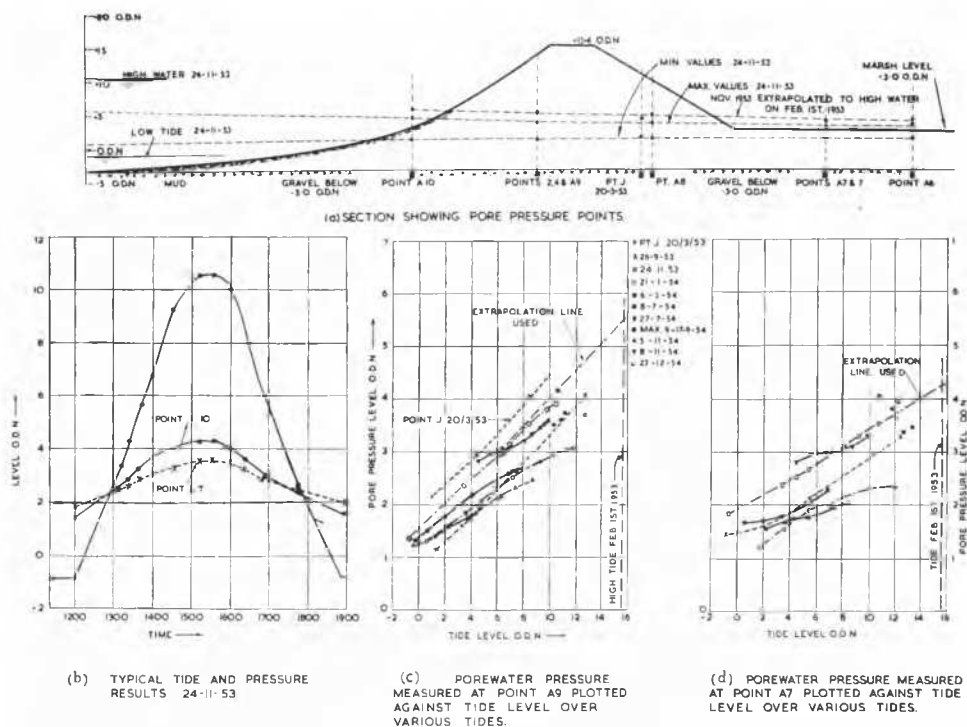
Detailed measurements were made of the water pressure changes which occurred during tides of various heights throughout the seasons during 1953, 1954 and 1955. The results of typical observations made during this period are plotted in Fig. 5. The changes in the water pressure in the gravel were only of the order of 2-3 ft. of water which represented about 25 per cent of the tidal range. Measurements taken at different distances from the bank (including points 12 and 13 Fig. 2) showed that at high water the pressure decreases with distance from the bank for some way and then starts to increase again as the general water table in the river basin (Fig. 2 (b)) becomes the predominating factor. At low water the flow of ground water is towards the river. In general the results showed that higher initial water pressures in the gravel at low water gave rise to greater water pressures at high tide. The decrease in slope of the plot of water pressure against tide level, as high tide was approached, was also less when the initial ground water pressure was high. There was some indication that the maximum water pressure depended to some extent on the length of time that the tide remained near its peak but this could not be definitely established.

This means that the passive resistance provided by the marsh at the toe of the bank is reduced to zero and in addition a small uplift force begins to act on the bank across the plane AB. This condition is attained by the pore pressure distribution extrapolated for a 15.5 O.D.N. tide from the results obtained in November 1953 in Fig. 5, and shown as line (b) in Fig. 6,

Fig. 5 Pore pressure measurements.
Mesures des pressions interstitielles.

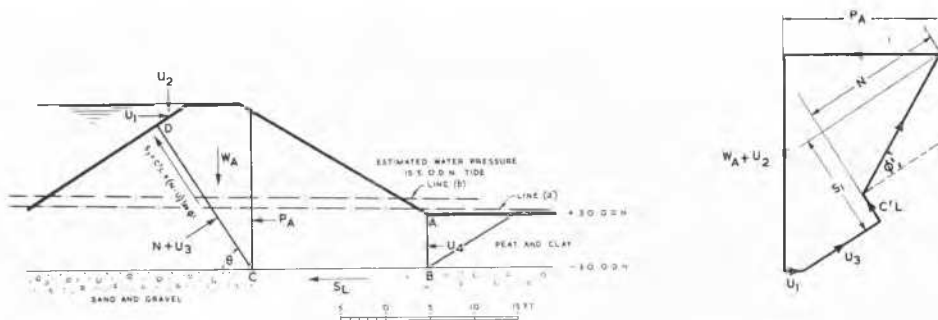
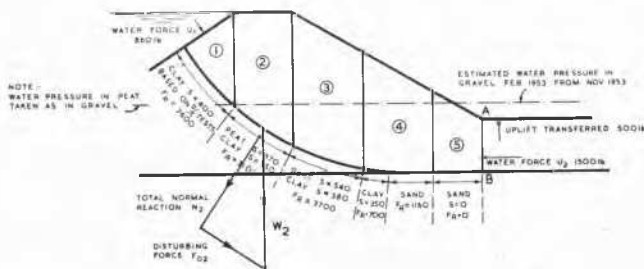
Fig. 6 Analyses.
Analyses.

Approximate stability analyses of the type shown in Fig. 6 have been made for the bank subjected to different tidal conditions. The shear strengths of the silty sand and peat were estimated from the slow drained shear box tests assuming the pore pressures to be the same as those extrapolated from the measurements made in the top of the sandy gravel. Because of the difficulty of estimating the actual pore pressure changes in the clay within the bank alternative values of strength based on unconfined compression tests or on fully drained shear tests using a steady seepage condition have been used in some of the analyses. It has also been assumed that the full shear strength of all the soils was mobilised simultaneously.

As the tide level rises further the water pressures in the gravel increase until a condition is reached when the marsh at the toe of the bank (to the right of AB in Fig. 6) begins to heave.

in the bank the effect of including a tension crack was small because of the low normal effective stress across the upper part of the shear plane. It will thus be seen that the factor of safety for overall stability under the extreme flood conditions prior to the formation of the breach was near unity.

(a) WEDGE ANALYSIS - FACTOR OF SAFETY (F) NEGLECTING PASSIVE RESISTANCE OF TOE = $\frac{S_1 \sec \theta + S_2}{(W_1 + U_2) \tan \theta + U_3 - U_4}$

(b) CIRCLE ANALYSIS. FACTOR OF SAFETY = $\frac{\sum F_{\theta}}{\sum F_{\theta} + U_1 - U_2} = 1.25$
