# Stability of Slopes in Earth Dams and Foundation Excavations

by Dr. K. L. RAO, M. Sc., Ph. D., M.I.C.E., M. I. Struct. E., M.I.E., Member (design and research) Central water and Power Commission, New Delhi

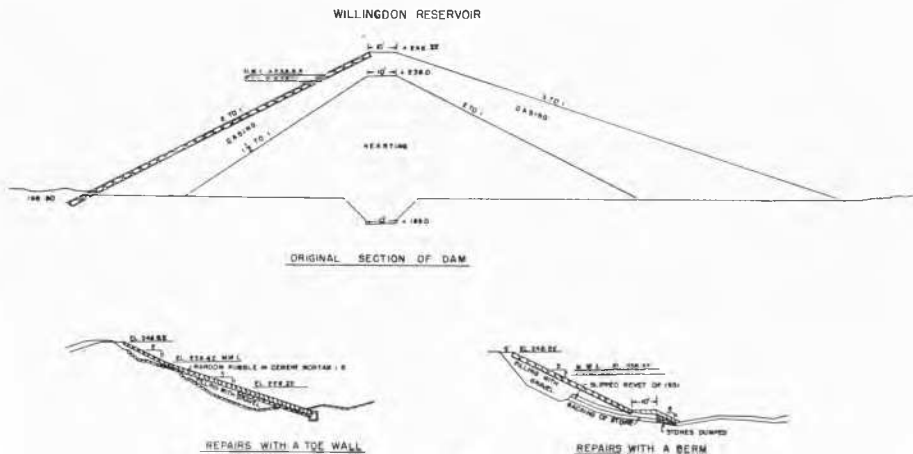
Fig. 4

giving trouble on account of slope failures. The section of the dam is shown in Fig. No. 4. The maximum height is 55 feet and the original upstream slope was 2 : 1 and rear slope 3 : 1, the reservoir capacity being 2 600 m cft.

The reservoir was filled eight feet below top reservoir level immediately after completion and when the water in the reservoir began to fall, a slip in a length of 460 feet occurred. The movement was gradual till water level in the reservoir dropped by six feet but quicker when the reservoir was drained further.

The embankment was repaired to the original cross section ; but this did not give satisfactory results. Later, piles were driven at the toe of the rebuilt revetment. Another slide occurred in 1935 in continuation of the earlier slip. The piles driven earlier were all pushed out.

Water was stored in November 1936 and when the water level was dropping, it was found that the length, where a masonry toe wall had been provided, showed slight movement and the revetment slabs cracked. However, the part where berms had been provided was quite satisfactory.

When the reservoir was refilled in November, 1937, and drained to 17 feet below the full tank level, further slips were observed. The gaps so caused were made up with stones.

A slip again occurred in 1939 when the water level was 28 feet below the full reservoir level. The same treatment i.e. provision of a berm 10 feet wide and 3 feet thick was given. The revetment was stopped at M.W.L. and portion above made up by filling with gravel in layers of 6 inches watered and rammed. This work was completed in July, 1939. The top of the revetment slipped in August, 1939. The revetment was repacked and the reservoir filled in October, 1939. After the reservoir had been drained, a movement 3 feet horizontal and 3 feet vertical at the worst affected portion was noticed

in June 1940. This was restored in July, 1940; but again the revetment subsided. This was restored but again slipped.

The apparent cause for frequent slips in this embankment is lack of proper distribution of materials in the construction of the embankment and poor compaction. It is noticeable that the slopes slipped whenever the reservoir was drained; thereby indicating that the soils used in the casing materials were of very poor quality liable to swelling and shrinkage and becoming unstable when water pressure was removed.

The clayey material in the foundations on saturation became very weak and offered no resistance to the movement of the slide into the bed.

In July, 1936, a length of about 110 feet was repaired by making the front slope 2:1 from top to M.W.L. and 3:1 from M.W.L. downward protected with rough stone masonry stone panels 10 feet. square with 1:6 cement mortar. Revetment was made to rest on a masonry toe wall 3 ft. square of rough stones in cement mortar in sections of 10 ft. length. The remaining length was repaired by providing a berm 10 feet wide and the revetment built to the original slope of 2:1 up to the top, all depressions being filled only with stones.

There was slight movement in the bank between 1940 and 1941. It was decided to provide cement concrete 4 inches thick revetment above M.W.L. in addition to 2 or 3 rows of wave breakers. No further accident was reported till 1942. A new slip, however, occurred in August 1942 above the cement slabs. The slabs sank about 6 inches. The only remedial measure taken was further to strengthen the rear slope of the bund at 3:1 with gravel. No further serious accident has been reported since.

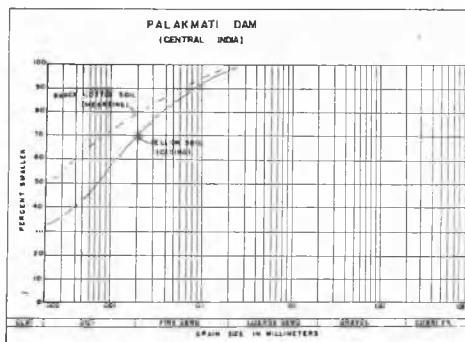
Fig. 5

Another example of failure of a earth dam is afforded by that of the Palakmati Dam in Central India. This dam has a maximum height of 46 feet and was constructed in 1938. The upstream and downstream slopes vary from 2:1 to 3:1. The upstream slope was pitched with stones 1ft. thick. The section was built of a core of black cotton soil with heavy clay content and a casing of yellow soil with clay content up to 33 per cent. The grain size curves of the core and the casing material are given in Fig. 5.

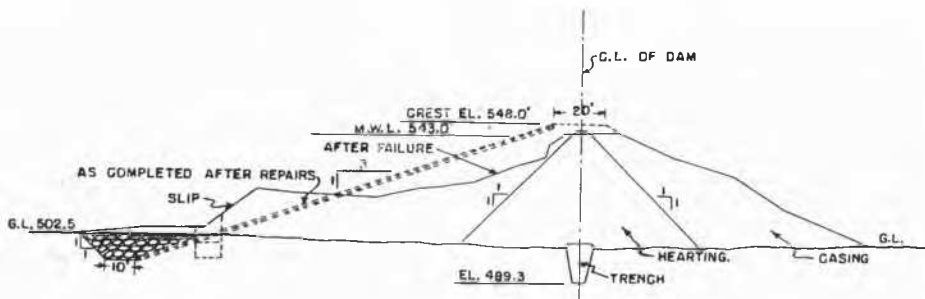
Fig. 6

On 26th June, 1953, a slide occurred for a length of 400 feet. Immediate repairs carried out consisted of filling up the gap with earth but this resulted in further movement of slide.

The slide occurred when the water level was falling from top reservoir level to about 16 feet below the top.

The slide was apparently due to the clayey nature of the soil used in the casing and the predominantly clayey nature of the foundation.

The remedial measures adopted consisted of replacing the yellow clayey casing material by hill wash material and rock fill, flattening the upstream slope to 3:1 (Fig. 6).

A heavy rock toe taken to a depth of 10 feet was provided upstream to stabilise the slope. These repairs were completed in 1956 and no further slide has been reported after this date.
