Buckling Tests of Slender Steel Piles in Soft, Quick Clay

by A. BRANDTZAEG, Norges Tekniske Høyskole, Trondheim, Norway,
and
E. HARBOE, Elvegaten, Trondheim, Norway

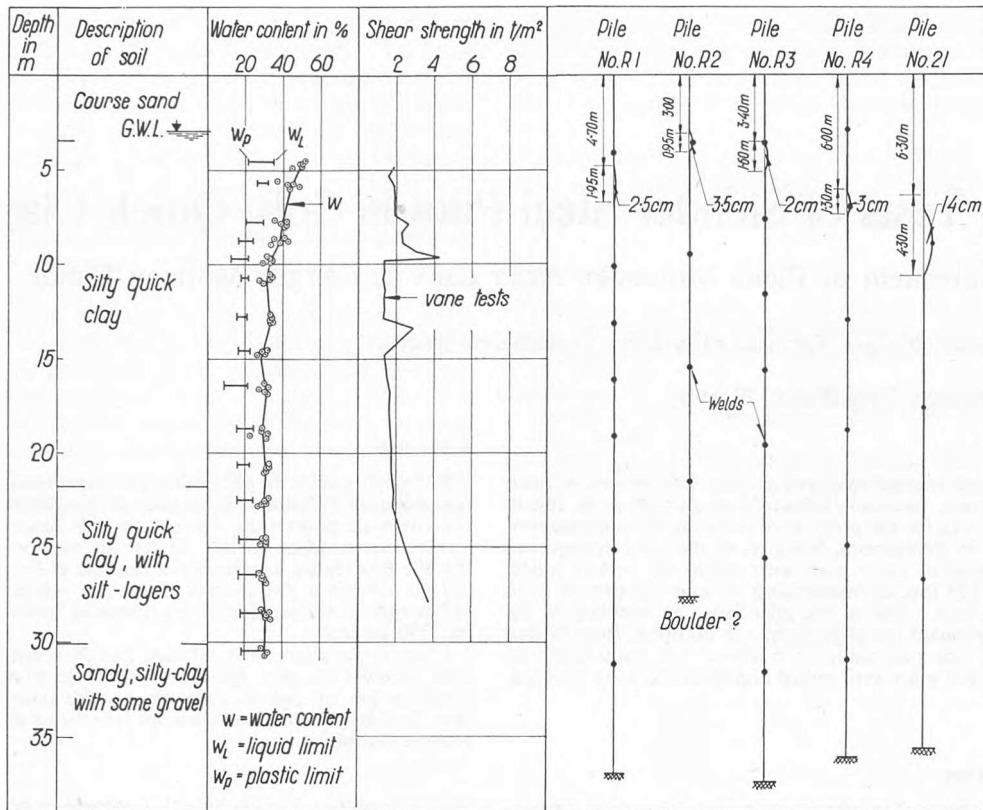
Fig. 2 Soil profiles and details of buckled piles
Coupe du sol et détail des pieux après flambement

was practically the same for three of the piles, but R2 stopped abruptly about 10 m short of the others. The location and extent of the buckling is indicated, as well as the location of welds. It is seen that all four piles failed within the upper 4 m of the quick clay deposit, immediately underneath the top layer of sand. Except for the buckling of the piles after pulling were, as far as could be seen, straight. In two cases the welds were entirely outside the region of buckling, in one case a weld was inside, but somewhat off the middle of this region. Buckling seems to have started at the weld in the case of the pile carrying the extraordinary high load of 16 ton, against 9 and 11 ton for the others.

Fig. 2 shows the deformation. The pile had buckled in the direction of least moment of inertia between about 2.5 m and 7 m below the top of the soft clay deposit. Fig. 6 is a photograph of the buckled part of the pile as it appeared above ground. As far as could be ascertained, without special measurements, the pile outside the buckled part was perfectly straight. There was a welded joint in the bend a little below the point of maximum deflection and a crack was found on the tension side. The photograph shows that the rail has been stressed in bending beyond its yield point close to the weld and as such stresses could not have been transmitted through a cracked weld, the crack was clearly the result, and not the cause, of the buckling.

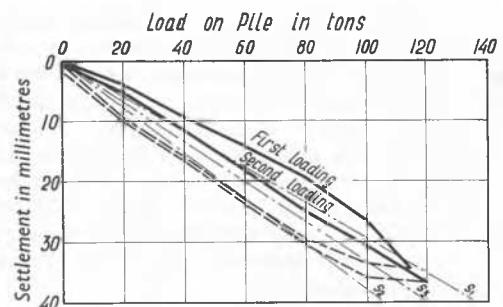
Fig. 3 Load-settlement curves for pile 27
Diagramme des tassements en fonction des charges du pieu 27

A typical load-settlement curve observed for one of the piles tested is shown in Fig. 3. The permanent settlement in this case was small but, due to defects in the loading arrangement, the full test load was not reached the first time and a second loading was made. It is seen that at medium loads, the settlements are larger the second time, and the difference is not caused by permanent set of the pile point. Three straight lines (S_1 , S_2 and S_3) have been drawn indicating what should have been the purely elastic settlement of the pile top if the full load were carried by the pile to a point, (1) on top of the hard bottom layer, (2) on top of the rock, or (3) half way between (1) and (2), and were entirely absorbed by the ground at the point mentioned. None of these assumptions is fully plausible but the third one seems the more probable approximation as regards the main part of the load. However, it is clearly seen

(a) that some part of the load was transmitted to the soft soil above, and (b) that this part was considerably smaller at the second loading than at the first, showing that the adhesion between soil and pile had been loosened by the loading of the pile. At 100 ton load, the difference between the actual settlement and that corresponding to the line S_3 is about 7 mm at the first and 3 mm at the second loading, which roughly would

correspond to an adhesion of 2.6 and 1.1 ton/m² respectively if the adhesion is assumed to be constant from the top of the hard layer upwards. Similar differences were observed in all tests, although the figures vary slightly. The fact that some adhesion was active has a bearing on the evaluation of the buckling tests.

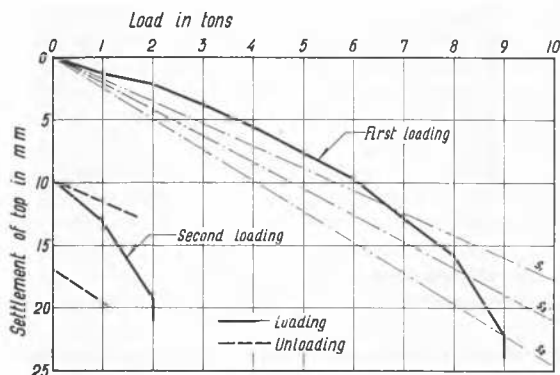
Fig. 4 Load-settlement curves for pile R1
Diagramme des tassements en fonction des charges du pieu R1

Fig. 4 shows the load-settlement curves obtained for pile R1, which failed at 9 ton with a permanent top settlement of 10 mm. On reloading only a load of 2 ton was reached. Lines S_1 , S_2 and S_3 , as explained previously, are shown. For loads between 2 and 6 ton, the curve of the actual settlements runs

nearly parallel to the line S_3 . The difference at 6 ton load is about 2.7 mm, corresponding to a hypothetically uniform adhesion above the hard ground of about 0.9 ton/m².

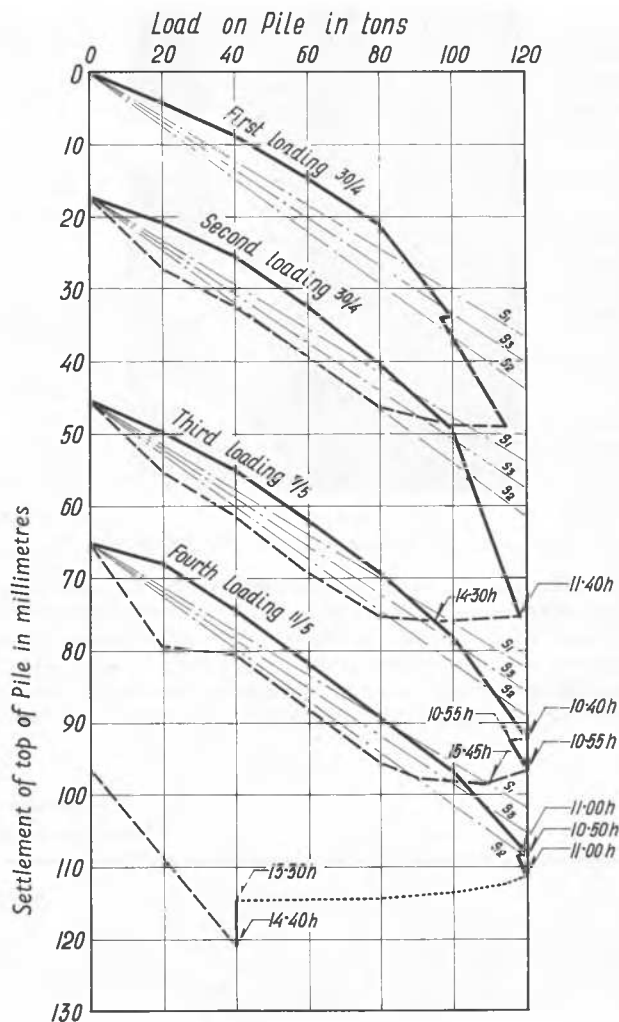
Fig. 5 Load-settlement curves for pile 21
Diagramme des tassements en fonction des charges du pieu 21

This pile was intended to be part of the permanent structure. The loading test indicated some settlement of the pile point, as explained earlier. Therefore, the pile was loaded four times in the course of 12 days. Fig. 5 shows the load-settlement curves for all loadings, with the time noted for some important observations. On the fourth loading, the load reached 120 ton, intended to be the maximum. In 5 minutes it fell off to 115 ton,* was brought up again to 120 ton and then seemed to stay constant; the test was considered to be complete. However, after 2½ hours, when the loading apparatus was to be dismantled, the load had fallen to 40 ton and could not be increased. The pile was pulled and inspected.

Fig. 5 again shows the lines S_1 , S_2 and S_3 (described previously). Calculated as before, the average adhesion between pile and clay at 80 ton load would be about 2.0, 1.3, 1.0 and 0.9 ton/m² at the first, second, third and fourth loading respectively.

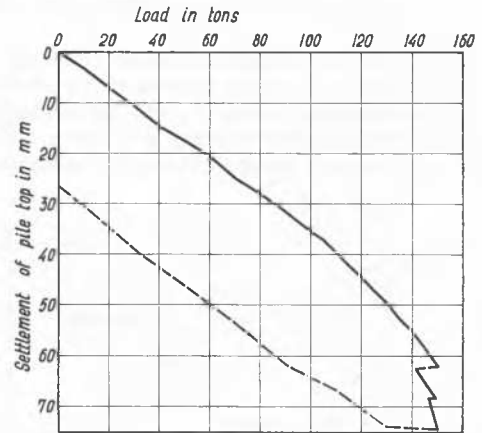
Fig. 7 Load-settlement curve for test pile A
Diagramme des tassements en fonction des charges du pieu A

As mentioned before, a tramway rail pile was included among the piles initially tested. The load-settlement curve for this pile, designated 'pile A', is shown in Fig. 7. An attempt to pull this pile after the test was not successful; therefore, the type

of failure is not definitely known. However, Fig. 7 indicates that the pile had buckled and the data for this pile have been included in the summary of test results (see table).
