# Unusual Necking of Cast-in-situ Concrete Piles

by N. B. HOBBS, M.A. (Cantab), A.M.I.C.E., Lecturer in Civil Engineering at the University of Natal, Durban, South Africa

### Summary

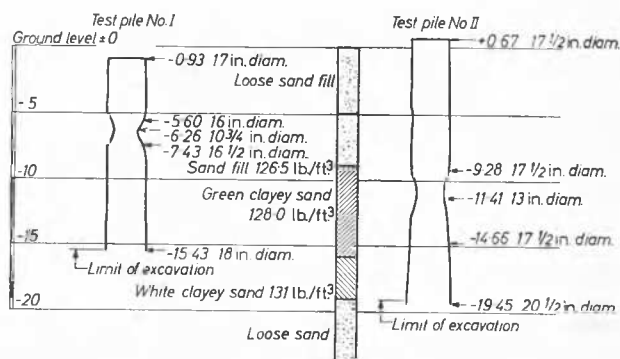
Fig. 1 Typical profiles  
Coupes perpendiculaires types

degrees of severity. This necking started just below the top of the pile as shown in Figs. 1 and 2, the diameter being reduced to 7 to 10 in.—in many instances the reinforcing steel being exposed. The loss of concrete varied from  $\frac{1}{4}$  to 3 cu. ft., the appearance of the neck being smooth in some cases and rough with exposed aggregate in others, particularly where the loss of concrete was large. The residue of laitance observed was 10 to 15 in. which is about 3 times as much as is normally found on the top of this type of pile.

Both test piles were found to be necked, Figs. 1 and 2, but whereas No. 1 was typical in that the necking occurred near the top of the pile in the pervious fill, in No. 2 the necking was much lower down in the green sand and was followed by a thickening of the shaft which continued to the bottom of the excavation. A ring of fine light brown sand was observed to surround this pile in the region of the neck, and it appeared that as the tube was withdrawn this sand was forced up the void between the green clayey sand and the concrete by the upward flow of water. It is not unlikely that altered soil conditions were responsible for this change of behaviour since no washed-in material was found around the first test pile.

An attempt was made to remove the two test piles in order to see what had happened in the loose sand layer, but unfortunately only the top halves of the piles were recovered. The usual remedy in cases where the pile shaft has to intersect layers of loose sand below the water table lies in forming the pile inside a light metal casing which remains part of the finished pile—whether this should be full length or need only overlap the dangerous zone depends upon such local conditions as the thickness of the zone, the properties of the adjacent soil, the water pressure and its source. A metal casing with its top 2 or 3 ft. above the top of the loose sand layer would undoubtedly have prevented the necking in the case under discussion. The percolation of water up the perimeter of the shaft above the casing would have continued, however, but with no effect other than a possible weakening of the concrete leading to low early strength. If this is undesirable the casing should be carried up the full length of the pile shaft.

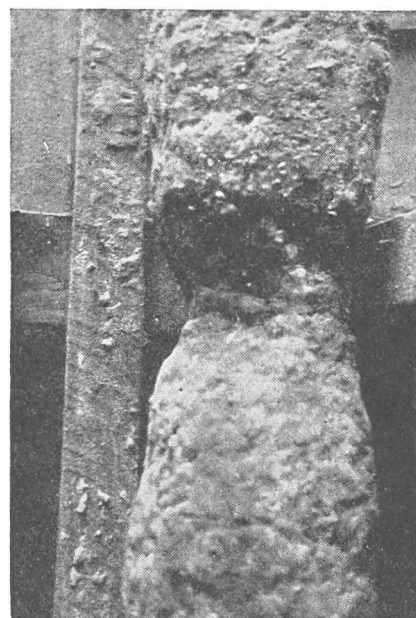
Fig. 2 Necking of concrete pile  
Etranglement du pieu en béton

(d) The walls of the hole lubricated by the flow of water allowed the liquid unset concrete to settle bodily downward as displacement into the layer of loose sand occurred, at the same time drawing a neck just below the partially set concrete in the upper part of the shaft. This appeared to be a slow process, as in the case of test pile No. 1, where the concrete in the neck had a comparatively smooth surface. Alternatively, a faster run, of perimeter concrete only, occurred over a much longer length leaving the concrete retained by the steel reinforcement cage with a very rough outward appearance. The weak sand fill completed the process by collapsing into the void so formed.
