# Present Soil Properties and Performance of the Arvo Dam During Twenty-five Years of Operation

by G. BARONCINI, Dr. Ing., Direttore delle Costruzioni della Società Meridionale di Elettricità, Naples, Italy  
and

A. CROCE, Prof. Ing., Incaricato presso l'Università di Napoli, Direttore del Centro Geotecnico della Fondazione Politecnica del Mezzogiorno, Naples, Italy

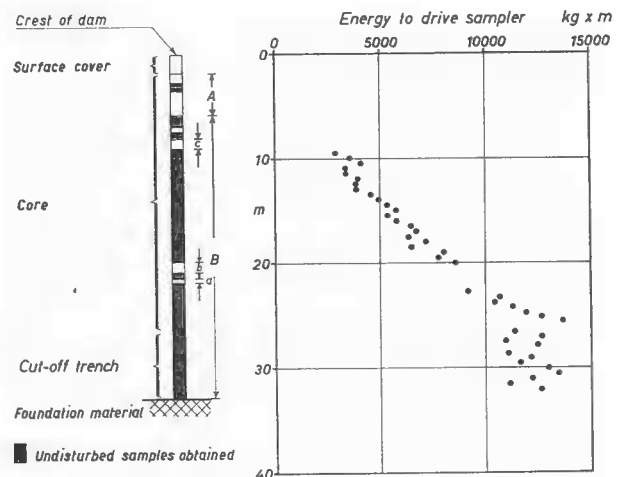
Fig. 6 Boring made in 1955  
Sondage exécuté en 1955

In December 1955 a boring was made in the dam from the crest to the foundation and undisturbed samples obtained. The energy necessary to drive the sampler was measured and Fig. 6 shows these data.

The material 'A' (Fig. 6) consisting of decomposed granite was encountered first. The fraction 0.02 to 2.0 mm predominated with the fraction < 0.02 mm always present. Plasticity was medium-to-low and the material was not at all homogeneous. Often particles with diameters of 2.0 to 10.0 mm were encountered.

Subsequently a brown material designated 'B' was encountered. It was of the same origin as material 'A', but the grain sizes were smaller, the plasticity medium and the material on the whole more homogeneous.

During the sampling operations it was found that in the strata *a*, *b* and *c* the soils were soft and had very high water contents. In fact they were so soft that it was not possible to obtain intact samples of these strata.

The strata *a* and *b* were in that part of the embankment constructed at the end of the construction season in 1929 and the stratum *c* was in the part of the embankment constructed at the end of the next season. Since the placement area was sloped downward towards the core (Fig. 2), during the two periods of inactivity water from rain and melting snows increased considerably the moisture contents of the surface stratum. When work was resumed in the spring, these wet

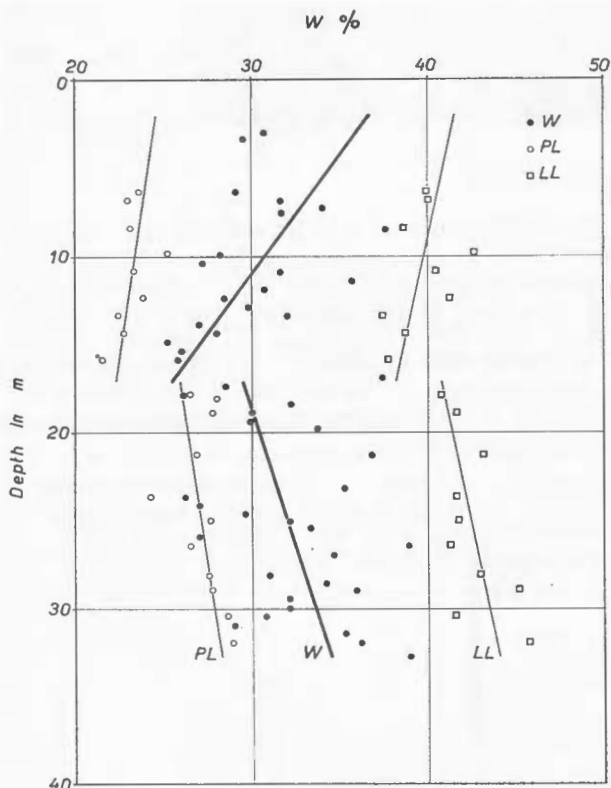
Fig. 7 Atterberg limits and water content in 1955 in the core of dam  
Limites d'Atterberg et teneur en eau en 1955 dans le noyau du barrage

In Fig. 7 the values of  $PL$  and  $LL$  are plotted at the depths where the samples were obtained. Straight lines are the result of a statistical examination of the test data. At a depth of 17 to 18 m there is a definite discontinuity, although the magnitude is small. This shows that the material 'B' is not homogeneous as one would believe on the basis of its appearance. This experimental result is perfectly explainable, because just when the embankment had reached this elevation in July 1930 it was found necessary to change the borrow area.

Fig. 7 shows also the moisture content  $W$  of the samples taken in 1955. Here also are noted the same slight trends observed in the Atterberg limits.

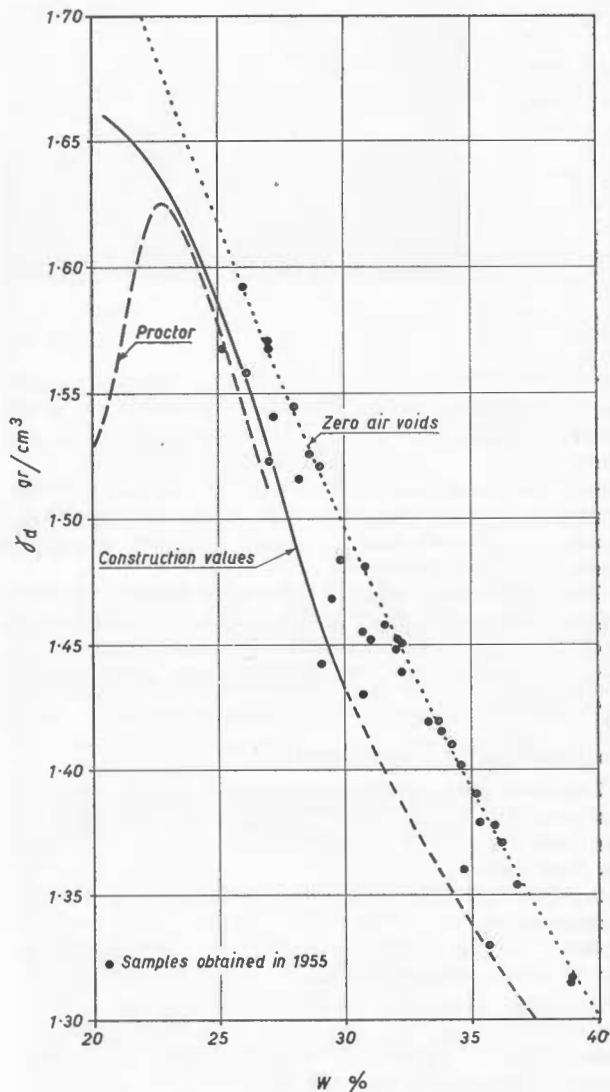
Fig. 8 Dry unit weight—water content  
Poids unitaire à sec. Teneur en eau

Unfortunately very little data are available on the water content and the dry unit weight of the materials immediately after rolling. These few values correspond to the continuous curve in Fig. 8. From an examination of this figure and with a knowledge of the construction methods we find a basis for believing that the original moisture content was in excess of the optimum.

Also in Fig. 8 are shown the values of  $W$  and dry unit weight of the same materials in 1955: there is definite indication that a condition of complete or almost complete saturation exists now.

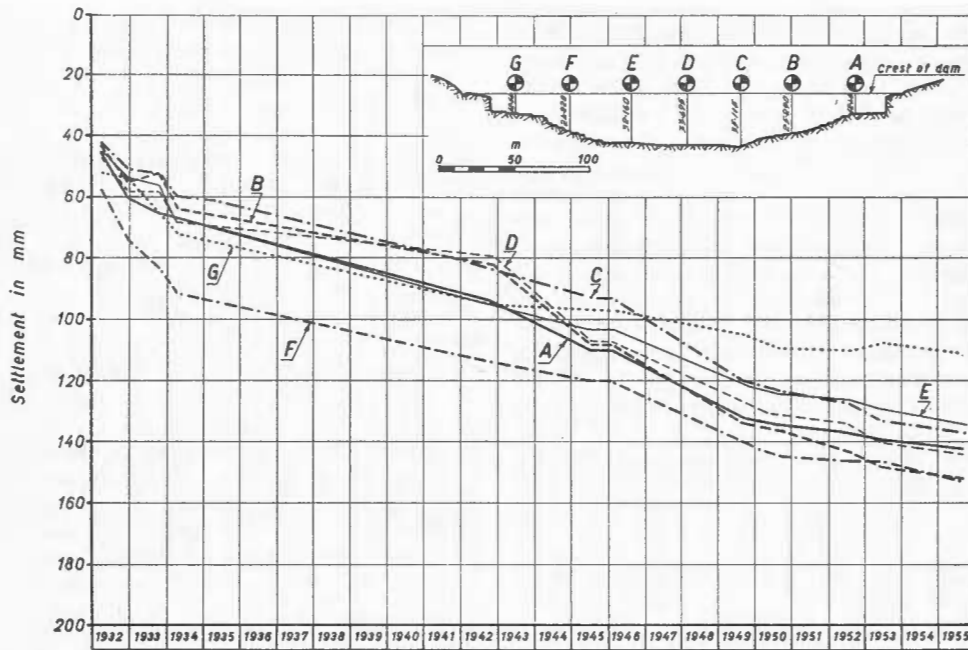
Fig. 9 Settlement data  
Tassements mesurés

It seems evident (Fig. 9) that there is no relation between the amount of settlement and the height of the embankment where the reference point is located.

The progress of the settlement has been gradual and with the exception of one reference point, which has not changed elevation appreciably since 1950, the structure continues to settle. There seems to be justification for believing that the settlements of the crest over the 25-year period since the dam was finished were independent of the height of the embankment.

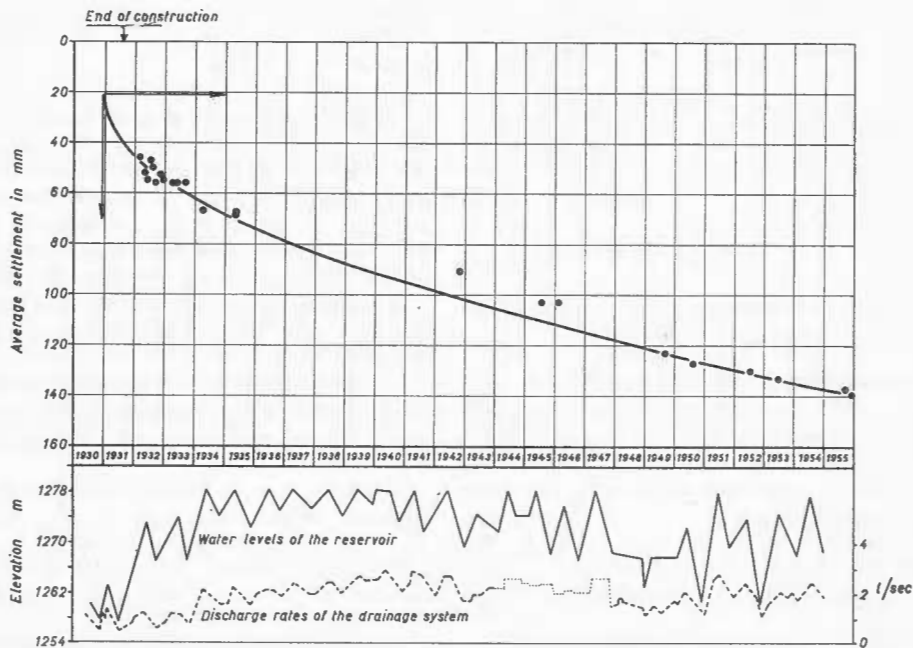
Fig. 10 Settlement-time curve for dam  
Courbe de tassement du barrage en fonction du temps

The average settlements are shown in Fig. 10, the value reached in 1955 is about 14 cm. This amount of settlement would result in an average decrease of 0.025 in the voids ratio.

The trend of the time-settlement curve (Fig. 10) is also significant. The settlements measured until 1935 and those subsequent to 1948 fall along a parabola with axis horizontal and its vertex on the abscissa at a point which corresponds to the beginning of the year 1931, a few months before the dam was completed. Therefore the experimental time-settlement curve is very similar to that indicated by the theory of consolidation for one-dimensional compression.

From the record of the levels of the reservoir (Fig. 10) it is seen that until 1935 the level was in general rising with an

average value of 1270 m above sea level. From 1935 to 1942 there was a period in which the reservoir was almost always full; as a consequence the neutral pressures in the core due to the water levels of the reservoir were greater than before and the rate of settlement was less. After 1942 the levels of the water in the reservoir averaged somewhat less than in the previous period and finally from 1947 the average level was about the same as in the initial period of filling of the reservoir. Correspondingly, the settlement rates were increased and then returned to normal values.

During the time the dam has been in service the amount of water collected and discharged by the foundation drainage system has been observed and measured (Fig. 10).

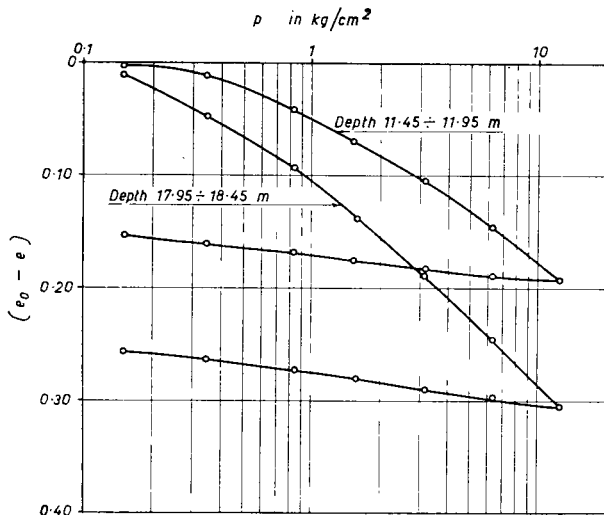
Fig. 11  $e$ - $\log p$  curves for samples  
Courbes,  $e$ - $\log p$  pour les échantillons

Consolidation tests were made on 12 of the undisturbed samples obtained in 1955. Examination of the results shows that they can be grouped in two categories. The first category includes the samples obtained from 0 to 15 m depth from the crest and the second group the remaining ones. Fig. 11 presents a curve that is typical of each of the groups.

The study of these curves supports the idea that in the lower zone of the core effective pressures are still negligible. They make it possible, also, to evaluate the effective pressures in the upper zone; from these values and on the basis of the voids-ratio-pressure curves it is possible to calculate a settlement of the crest of the dam very close to the value of 14 cm which has occurred.
