Earth Movement Investigations in a Landslide Area on the Bosphorus

by H. PEYNIRCIOĞLU, Ord. Prof. Dr. Ing., Technical University of Istanbul, Turkey

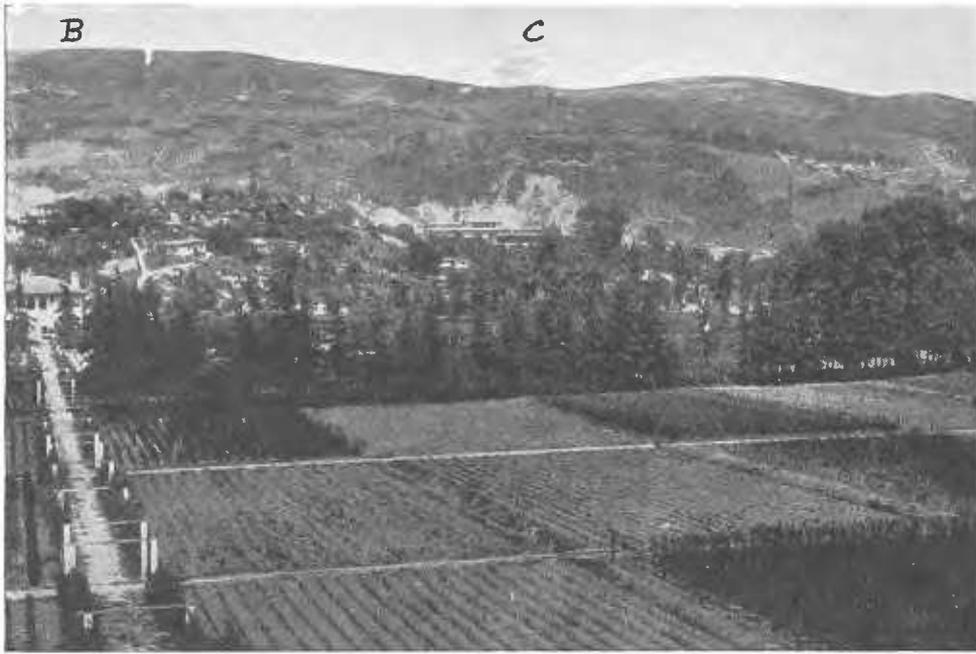
A great number of landslides occur in the area shown in Figs. 1 and 2. This area has been mined for clay for more than 50 years. In Fig. 2 a new system of landslide caused by recent excavations at the foot of the hill is marked by *B*. The site of the new brick and tile factory buildings is marked by *C*. This area had been excavated before as shown in an older map of the area, Fig. 3. The average depth of this first excavation at the site was about 20 m (Figs. 4 and 5).

Fig. 2 Landslide area seen from the place marked by *A* in Fig. 1
 Zone de glissement vue du point *A* de la Fig. 1

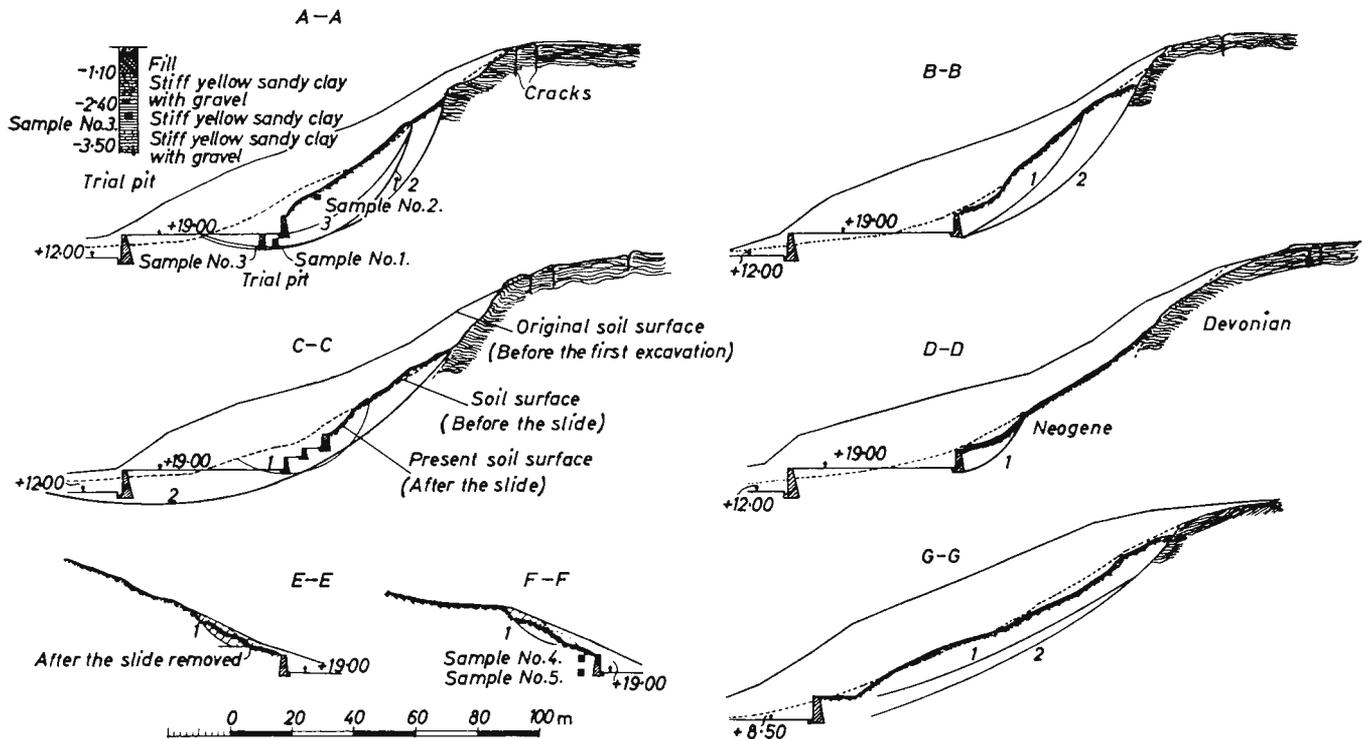
Fig. 5 Cross-sections along the lines marked in Figs. 3 and 4
Coupes transversales de la colline suivant les lignes indiquées dans les Figs. 3 et 4

The ground water table lay below the assumed slip circles (Fig. 5), but at the site there were temporary springs which dried out after the rainy season. Permanent springs or water veins met during the excavations are marked in Fig. 4. In the moving earth masses there was no continuous ground water table. A short distance from a water vein the clayey soil was partially saturated, its degree of saturation lying (approximately) between 0.95 and 0.85. The trial pit excavated to recover undisturbed samples was dry down to the 16 m contour.

The slip circles marked in Fig. 5 were chosen on the basis of the factors described previously, and are believed to represent the critical slide surfaces. These slip circles, as well as the shear properties of the soil, were subjected to further investigations and checking. Nevertheless, the factors of safety determined on the basis of these data were considered to be good approximations to the actual *F* values. Above the assumed critical slip circles, even after the rainy periods, there was no continuous ground water table. The degree of saturation of the clay lies between 0.95 and 0.85. Considering these facts calculations were made with total stresses.

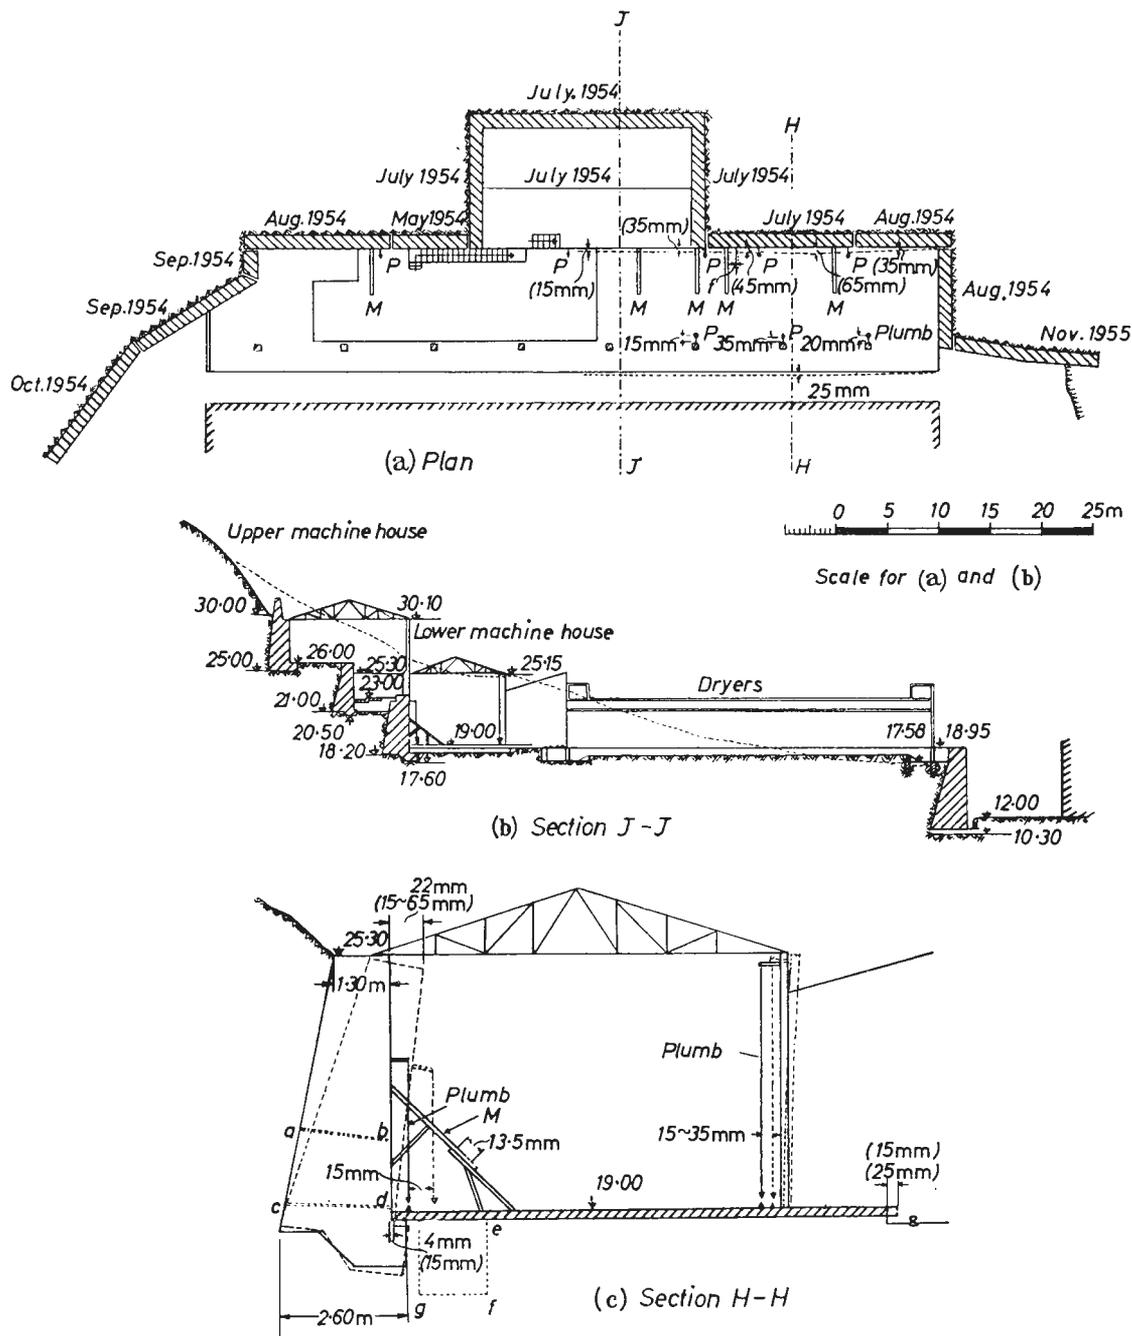
In the summer of 1954 a terrace was excavated for the new machine house at the foot of the steep slope. The former excavations, made about 40 to 50 years ago, were responsible for the steepness of the slope in this place. The general plan and sections of the terrace and the retaining walls are given in Fig. 6; the dates referring to the construction of the retaining walls.

first noticed, and cracks on the slope between the contours 60 and 70 running parallel to the walls were observed. Towards the end of 1955 cracks widened and multiplied. The forward movement of the walls amounted by that time to 15 to 65 mm. Dangerous cracks in the masonry and excessive distortions in the steel frames and columns forced the owners to dismantle most of the machinery, so that the plant became inoperative.

Reference points and arrangements (such as plumb lines and reference frames) shown in Fig. 6 were installed to observe and measure further movement. As the rates of movement were not decreasing it was decided, as a safety measure, to strengthen the retaining walls by buttresses. According to the measurements made since 1 January 1956 the rate of the wall movement was about 1 mm/day. At that time the slope was covered with snow, and the soil surface south of the upper slide boundary had subsided in some places more than 2 m.

The movements of the masonry were measured until March 1956: at that time the construction of buttresses was nearing completion. The wall movements decreased and became too small to measure with the arrangements installed. Measurements made until March 1956 on retaining walls and concrete floor are summarized in Fig. 6, section *H-H*.

Fig. 6 Movements in masonry and the general layout of the arrangements to measure the displacements
Mouvements de la maçonnerie et dispositif servant à les mesurer

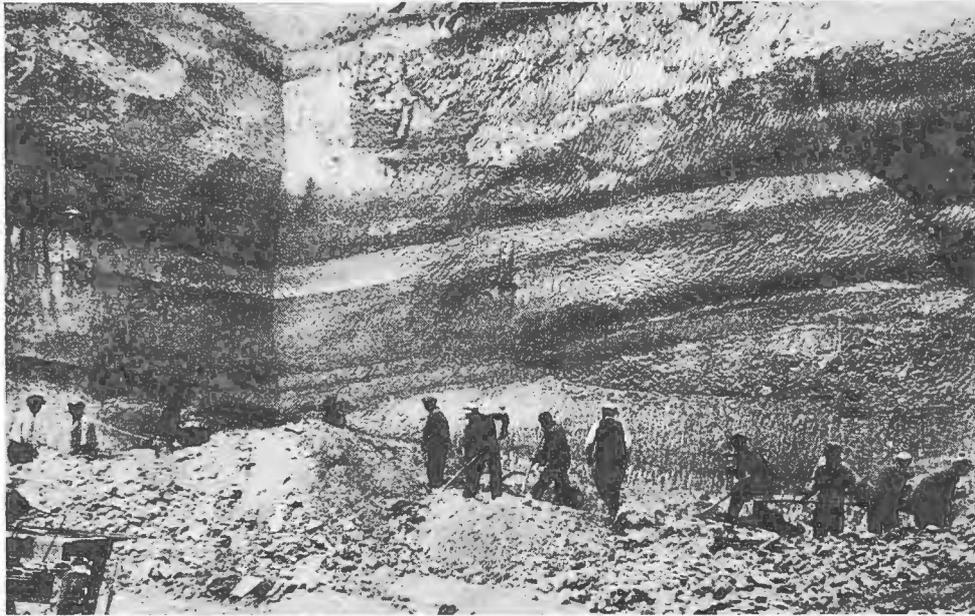
Fig. 7 New excavation made in the place marked *D* in Fig. 9
Nouvelle excavation, au point marqué par *D*, Fig. 9

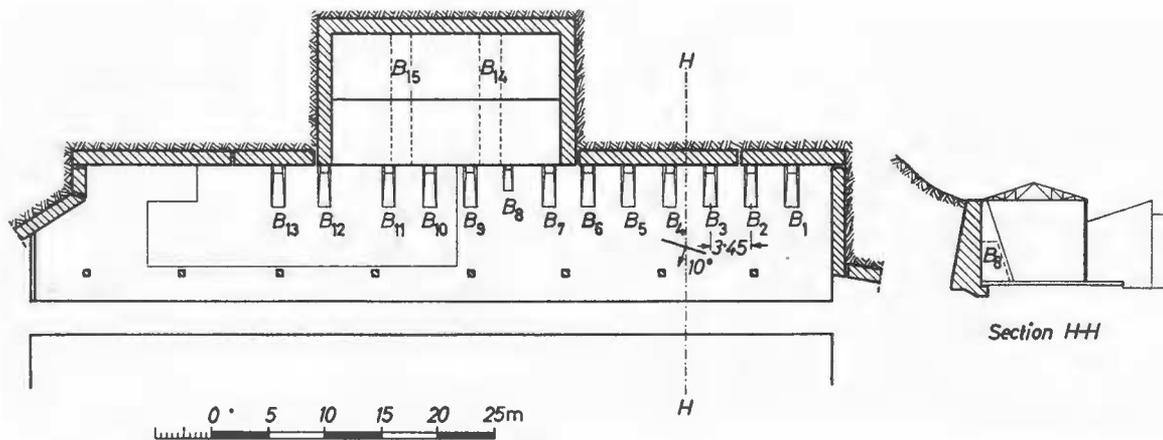
Fig. 8 Plan of the buttresses to strengthen the retaining walls
Plan des contreforts

By May 1956 the slope was dry, the temporary springs had disappeared, and 15 buttresses (*B1* to *B15*) indicated in Fig. 8 were completed: still some micro-movements in the masonry were perceptible, and the glass plates installed on some joints cracked. Movements of the earth on the slopes were observed by means of poles marked in Fig. 4. The upper part of the slip surface was seen to be decomposed and strongly fractured schisty graywackes and clayey schists. Soil masses in the slope marked *G-G* in Figs. 4 and 5 show all the characteristic features of a slide: depression, tension cracks and steps on the upper part; bulging and bulging cracks on the lower part. The way to the machine house along the foot of this sliding mass had to be cleared of the advancing earth masses several times during the rainy periods.

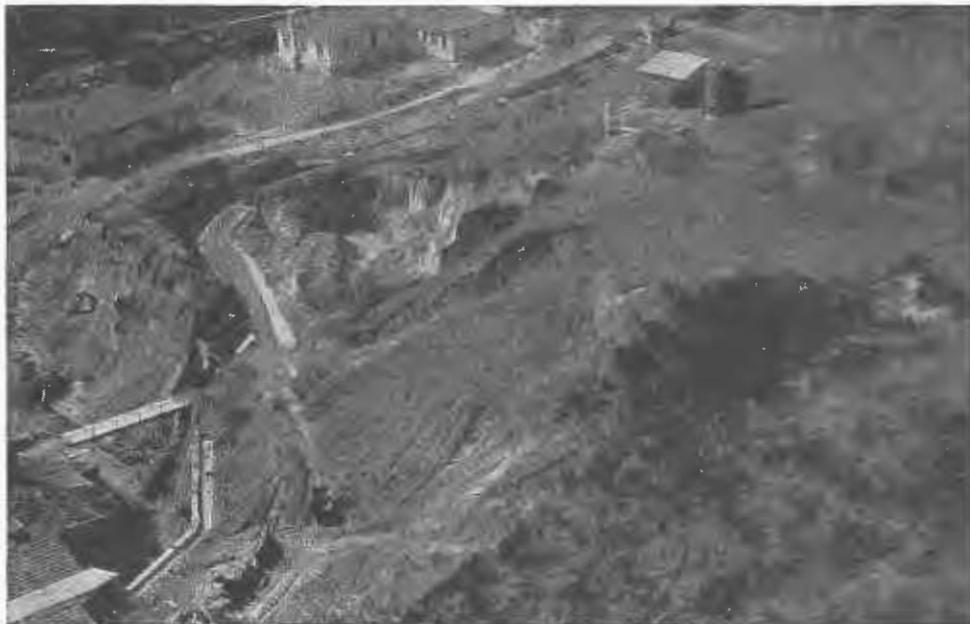
The downward movement of the earth masses above the machine house was resisted by the retaining walls of the buildings; but the pressure exerted caused dangerous movements and cracks. Along the sections *E-E* and *F-F* two slides with well-defined boundaries took place as shown in Fig. 9. On

Fig. 9 Slides along E-E and F-F marked in Figs. 4 and 5
Glissements suivant E-E et F-F, Figs. 4 et 5

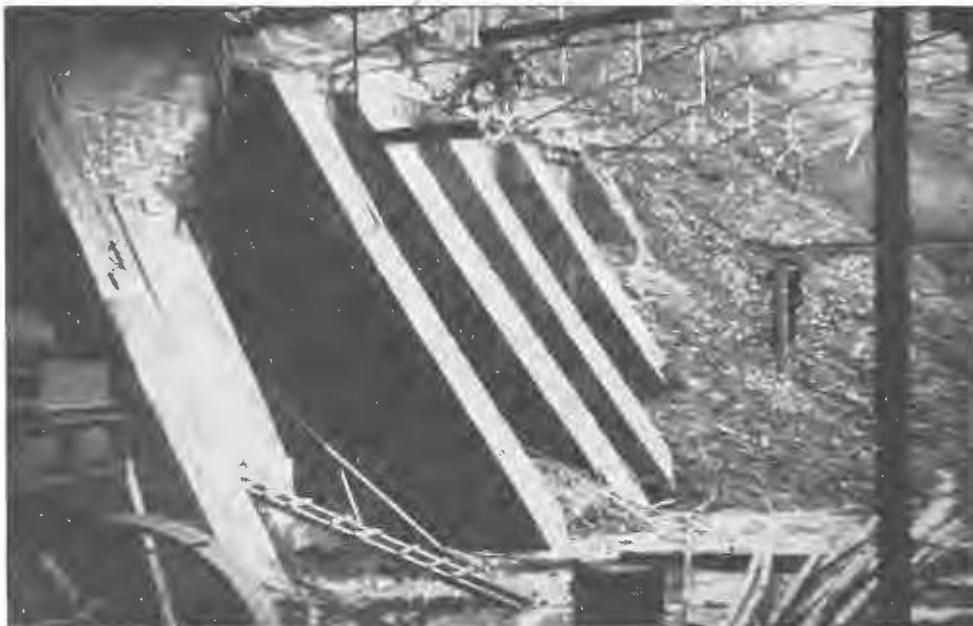
2 March 1956 a detritus slide damaged the roof of the machine house, and débris filled the lower machine house.

Fig. 10 Inside view of the lower machine house after detritus slide
 Vue interieur de salle des machines après l'éboulement de debris
