Behaviour of Recent Earth Dams and Levees in India

by K. L. RAO, Dr, M.Sc., Ph.D., M.I.C.E. (London), M.I.Struct.E., M.I.E. (India), Member, Central Water and Power Commission, New Delhi, India

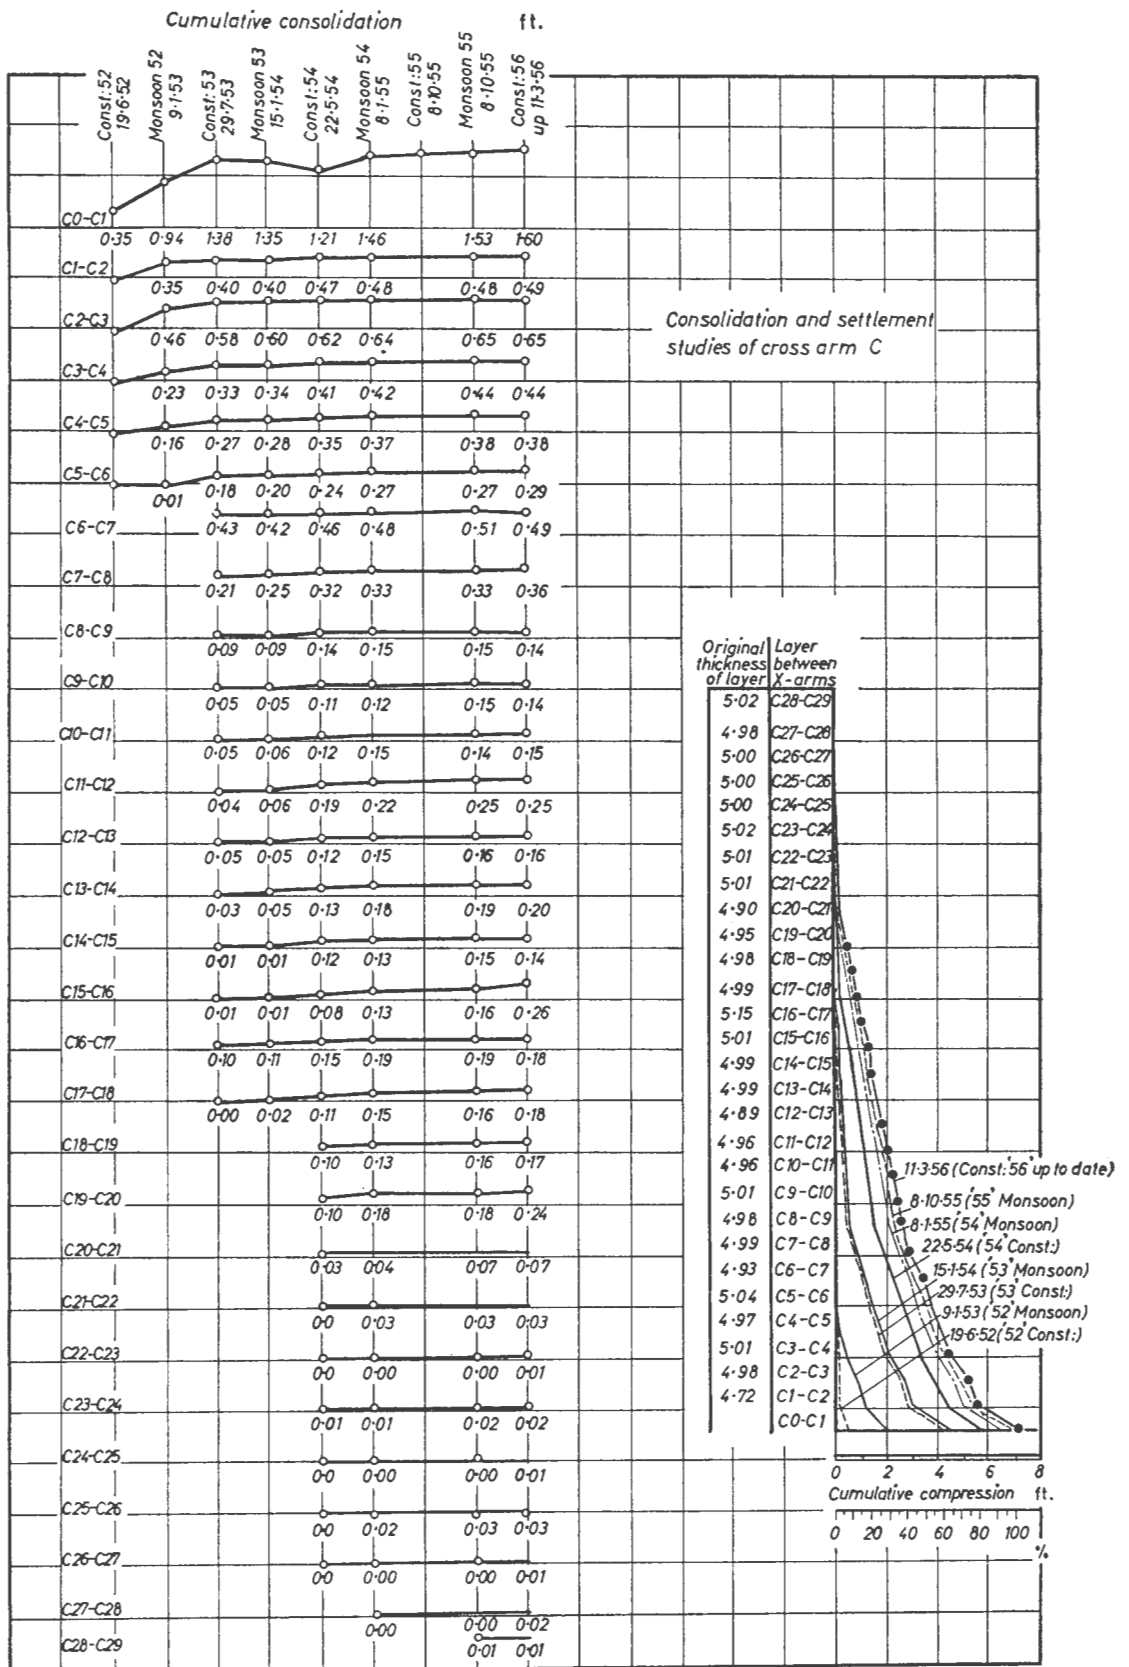
Fig. 5 Settlements of cross arm installation C—Hirakud Earth Dam
Tassements d'appareil C—barrage en terre à Hirakud

of cross arm installation *C* are plotted in Fig. 5. The individual consolidation between layers is also shown. The following observations are made from the drawings: (1) the consolidation movement of both the installations is similar; (2) a large percentage of the settlement is in the bottom layers; (3) large settlements have occurred during construction and the monsoon of 1952 when water was standing on a portion of the earth dam; (4) the settlement during construction periods is considerable; (5) the initial void ratio of the fill material in the bottom layers is large and is now reduced after placement of the top layers.

Some of the cores taken from the bore holes showed existence of soft soil patches at different elevations in the bottom 70 ft. of bank. The moisture contents of some of the samples were high, being 25 to 30 per cent, while the optimum moisture content of the soil was 15 to 20 per cent. The reason for this excessive moisture is not apparent. The sampling procedure, where samples were taken 5 to 10 ft. ahead of the casing, may perhaps result in the presence of extra moisture. It may be due to saturation of soils placed relatively dry and with low densities or it may be that these soft patches are due to excessive placement water content of the soil.

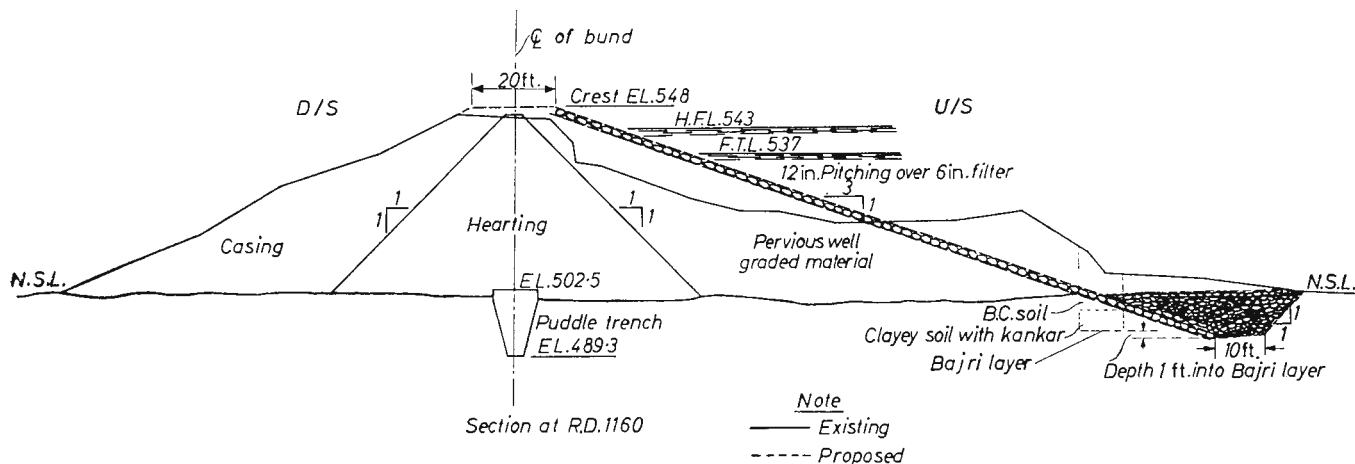
Fig. 6 Section of Palakmati Earth Dam showing slide and remedial measure suggested
 Profil du barrage de Palakmati, montrant le glissement et les dispositions suggerées pour y remédier

Palakmati Dam (Bhopal) provides an example of how an earth dam of even 40 ft. to 50 ft. height can give trouble if proper precautions are not taken in its construction. The dam is 3300 ft. long and was built on black cotton soil overlying clayey soil mixed with pebbles. The last two soils are known to possess very little shear strength under saturated conditions. The dam was built with an upstream slope of 2:1 and downstream slope of 3:1. The upstream slope was pitched with stones 1 ft. thick overlying 6 in. filter material. Fifteen years after construction, during a year of heavy rainfall, a slide occurred on the upstream slope in June 1953. Dumping of earth resulted in a further slide. Fig. 6 shows the section of the dam, the slide and suggested remedial measures, which consisted mainly in flattening the upstream slope to 3:1 and providing an upstream rock toe.
