# Study of Several Low Earth Dam Failures

by R. PETERSON and N. L. IVERSON, Soil Mechanics Engineers, Prairie Farm Rehabilitation Administration, 505 Canada Bldg., Saskatoon, Saskatchewan, Canada

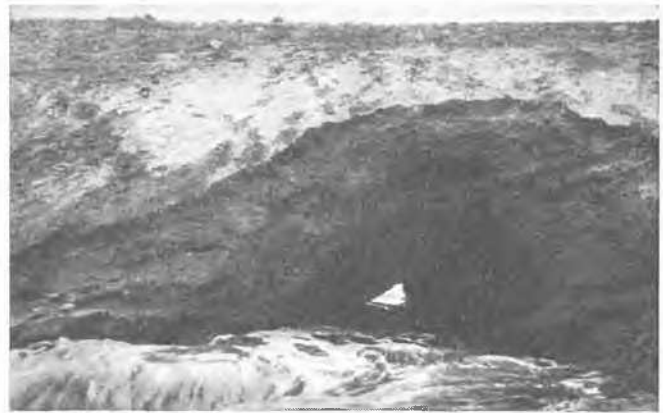
The dam failed during the first filling of the reservoir during the period of spring run-off. At the time of failure the water was only 3 or 4 ft. below the top of the dam. According to reliable eye-witnesses, water was first noted gushing from the downstream slope 15 to 20 ft. below the top of the dam. The flow rapidly increased and in two hours time a large tunnel existed through the fill, as shown in Fig. 1. A few hours later the roof collapsed, at which time, practically all the water had drained from the reservoir. The breach through the dam had almost vertical sides and was approximately 50 ft. in width.

Fig. 1 View of Failure of Dam, Case B  
Vue de la rupture de la digue B

An investigation of the fill after failure revealed that the silty clay had a liquid limit of 33 and a plastic limit of 18. The average water content of the unsaturated portion was 8.2%, varying between 5% and 11%. Proctor compaction tests indicated that the optimum moisture content was 15% at a dry density of 116 lbs./cu.ft. The average placement water content was therefore about 7% less than Proctor optimum and 10% below the plastic limit. Unfortunately, density tests of the material in place were insufficient to formulate conclusions as to average density. This dam has since been successfully reconstructed with proper moisture and compaction control.

(5) In three cases in which inspection was made shortly after failure the fill was found to form an arch over the failed area similar to that shown in the photograph of Case B. This arched material collapsed a few hours after the failure.
