# Recent Research into the Coastal Landslides at Folkestone Warren, Kent, England

by A. H. TOMS, B.Sc., A.M.I.C.E., Research Assistant to Civil Engineer, British Railways, Southern Region, Waterloo Station, London, S.E. 1, England

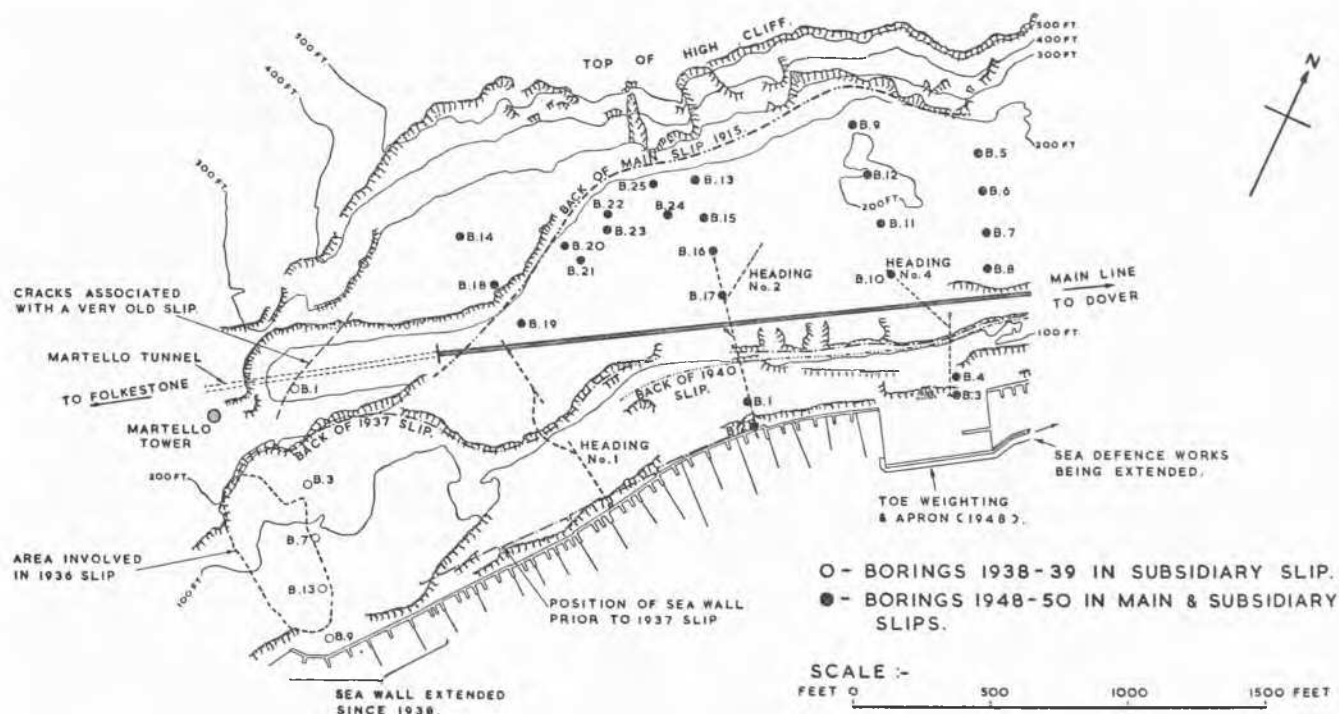
Fig. 1 Plan of the Western Half of Folkestone Warren Showing the Areas Investigated by Borings in 1938-39 and 1948-50  
Plan de la partie ouest de Folkestone Warren indiquant l'emplacement des recherches et sondages entrepris en 1938-39 et 1948-50

Fig. 1 is a plan of the western half of the Warren (the two mile long slip area between the high cliffs and the sea) showing the 1938–39 borings for investigation of the subsidiary slips, and those sunk in 1948–50 into the main slips also.

Boreholes Nos. 1 to 4 (see Fig. 1) were therefore sunk close to these headings to locate the slip and to help in determining the most suitable stabilising measures. These headings are some distance east of the western end of the Warren, the base of the Gault there being well below shore level. The slips were found to pass down close to the base of the Gault, but the mechanism of the toe upheaval appeared to differ from that of a normal "Circular" slip in homogeneous material. Photographs of the 1915 and 1937 slips and the appearance of the denuded Gault in 1948 suggested that the backs of many old slips exist in the shore, and that thrust causes upheaval by wedge action under them, except towards the west end of the Warren where the Gault cover to the Greensand is thin. There the Gault crushes up at random. The seaward limits of disturbance of the foreshore were estimated by levelling at different times on rail stumps driven deep into it.

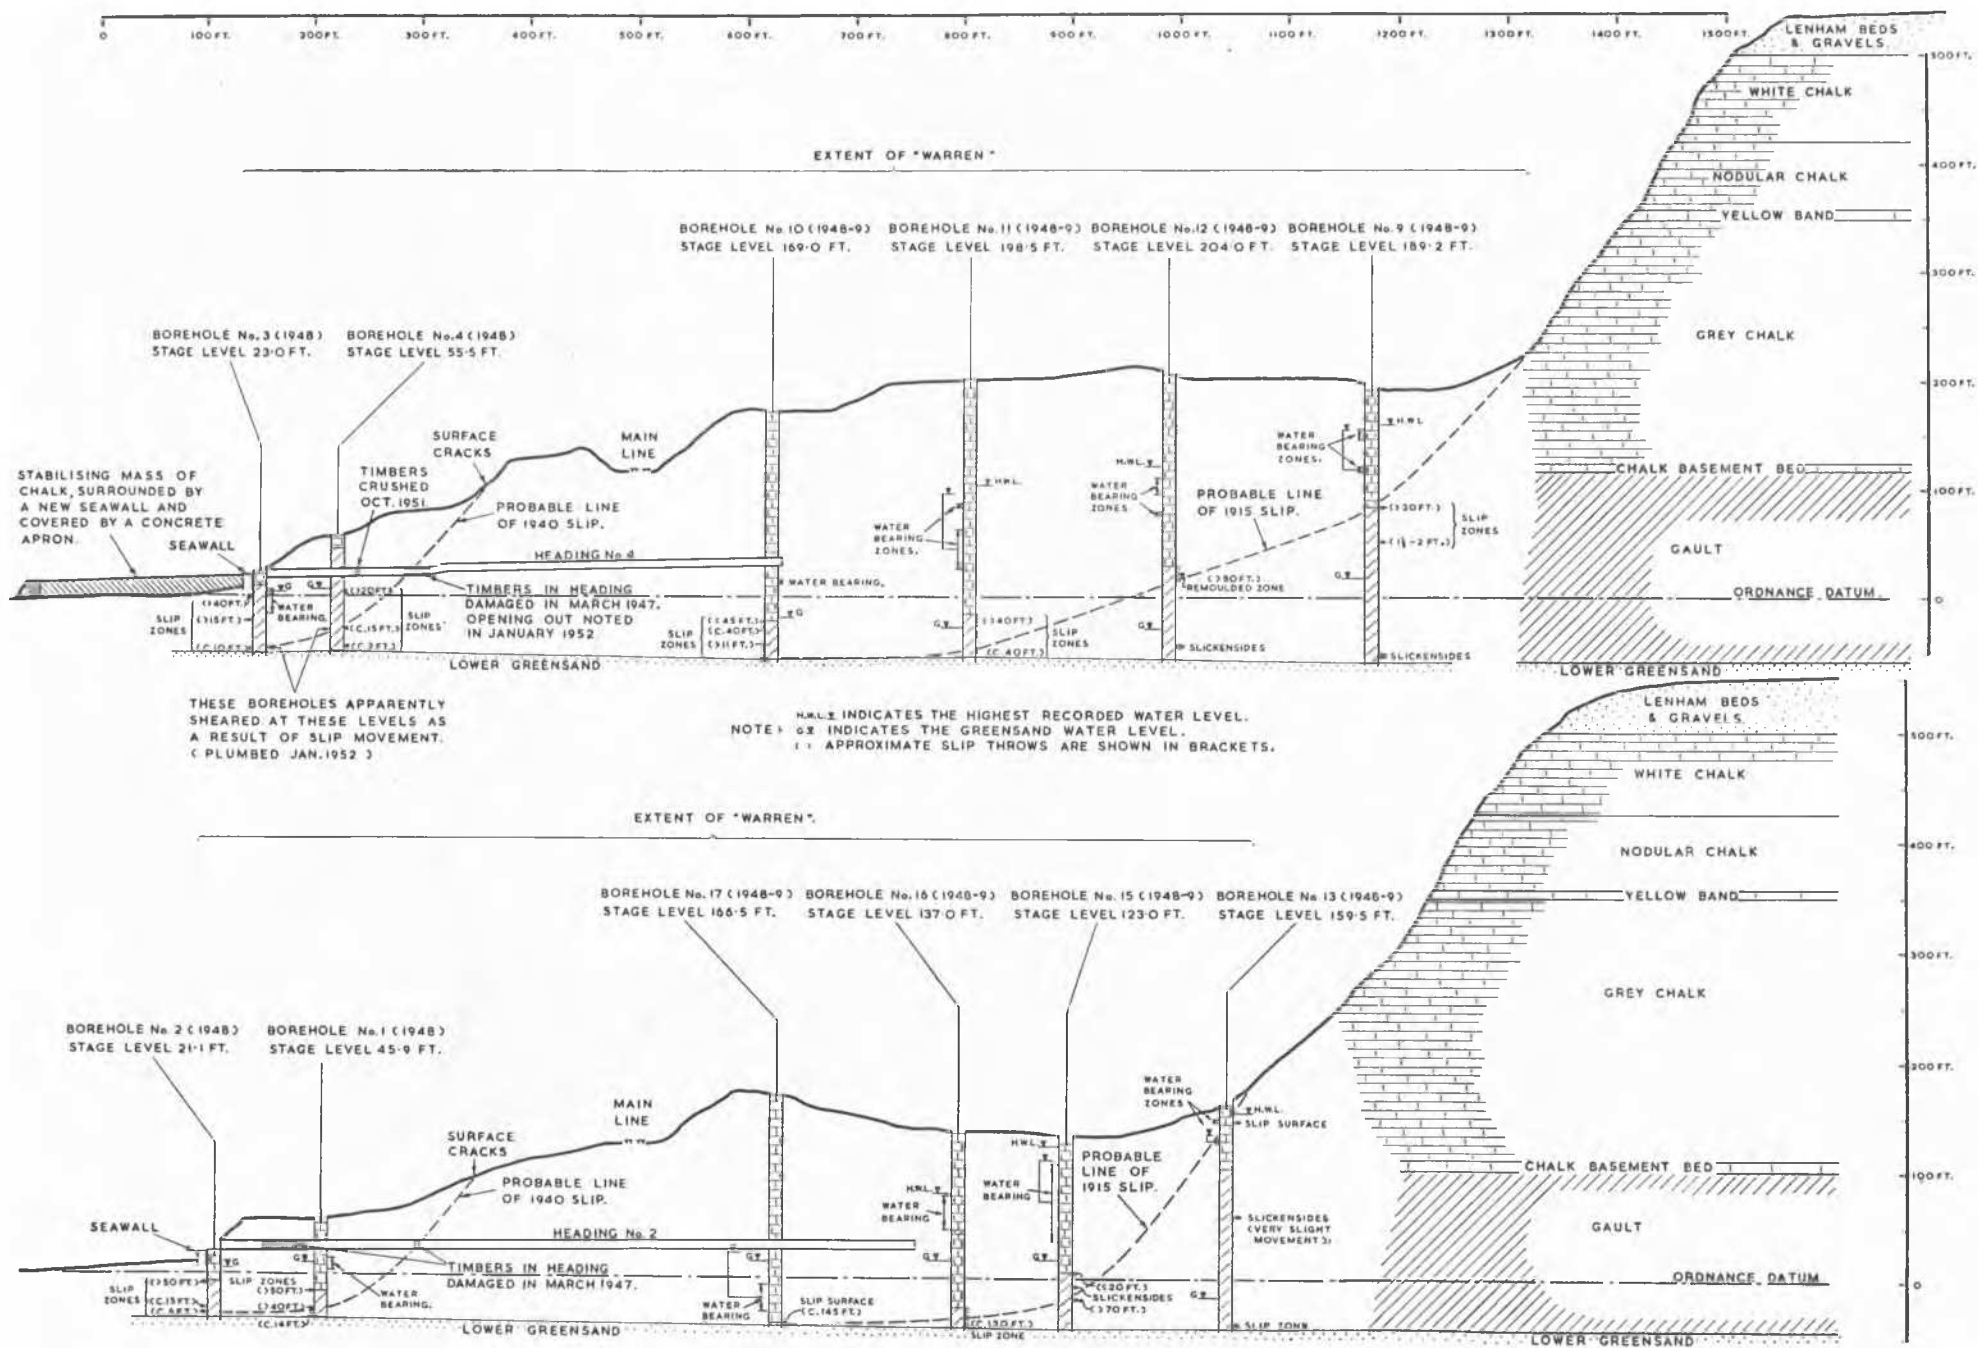
Fig. 2 Typical Cross-Sections Showing Boreholes and Headings  
 Profils montrant les sondages et galeries

Fig. 2 shows typical cross-sections through the Warren. The unslipped strata of the high cliff comprise the middle and lower chalk resting on the Gault clay, overlying the Lower Greensand. The Coast runs north of east and the Gault increases in thickness in this direction by 14 ft. per mile.

Fig. 2 shows the positions and shapes of the slip surfaces as determined from:—

- Features and known changes in the ground surface.
- The positions of shearing of headings Nos. 2 and 4.
- Weak zones and other significant discontinuities in the borings.
- Disturbances and discontinuities of the foreshore.
- The levels at which shearing has already occurred in boreholes Nos. 2 to 4 in which earthenware standpipes were installed specially for the detection of such movements.

Fig. 2 shows how the slips have resulted from shear failure of the Gault principally along its basement bed, involving large displacements of the earth masses and correspondingly large reductions in thickness of the Gault in the "Warren" compared with its "unslipped" thickness.

The 1948–50 boreholes proved, for the first time, that the major slips are due to shear failure of the Gault on slip surfaces which pass down deeply into it: in fact right down to its basement bed in the western half of the Warren at least. They also revealed very high ground water levels in the back of the Warren, indicating the existence of large hydrostatic pressures tending to drive it into the sea.

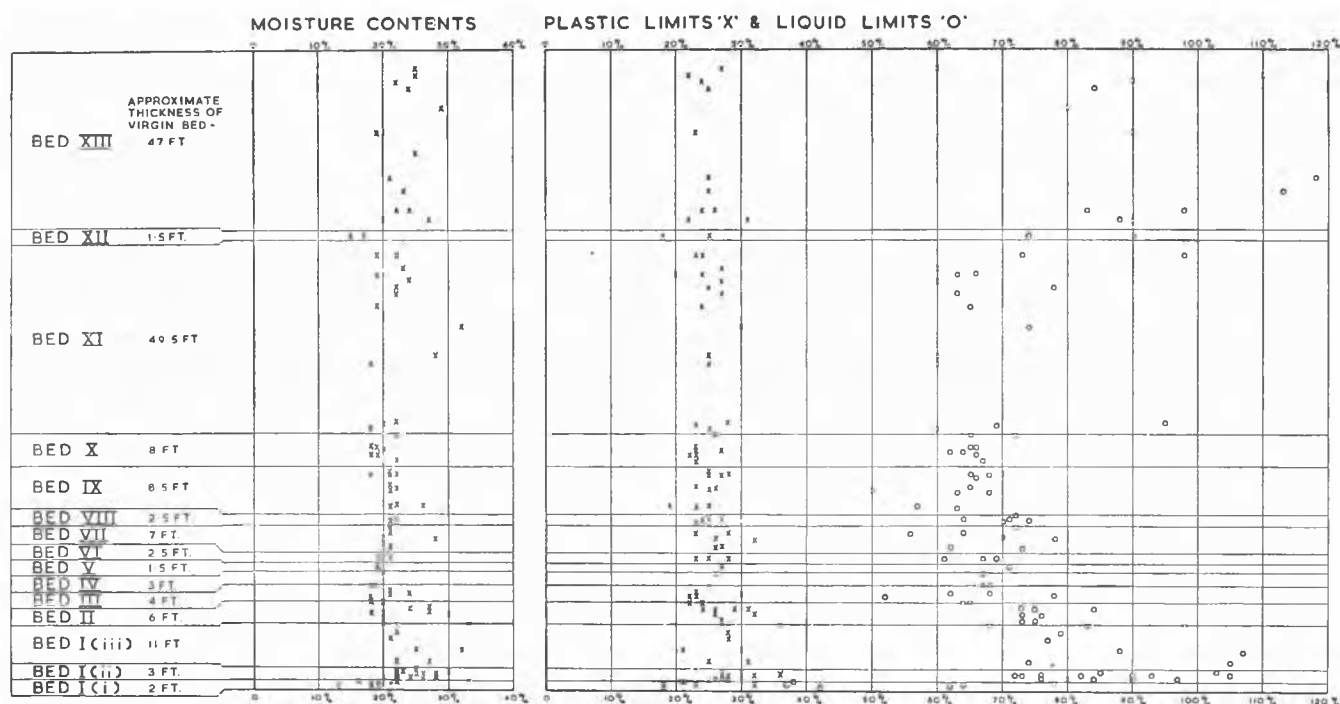
Fig. 3 Atterberg Limits and Moisture Contents of the Gault Beds  
Limites d'Atterberg et teneur en eau des différentes couches du Gault

Fig. 3 is a typical section through the undisturbed Gault showing the subdivision into thirteen beds identified by zonal Ammonite type fossils. It was prepared by the author's assistant Mr. A. M. M. Wood, M.A., A.M.I.C.E., from the 1948–50 borings and other sources, for the purpose of establishing the vertical displacements of the slipped soil masses. Alongside are shown the classification indices of samples not involved in

shear zones. The author hoped originally that these indices might be of assistance in the assessment of vertical displacements, but it will be seen that slight variations only over large depths rendered zoning by them impossible.

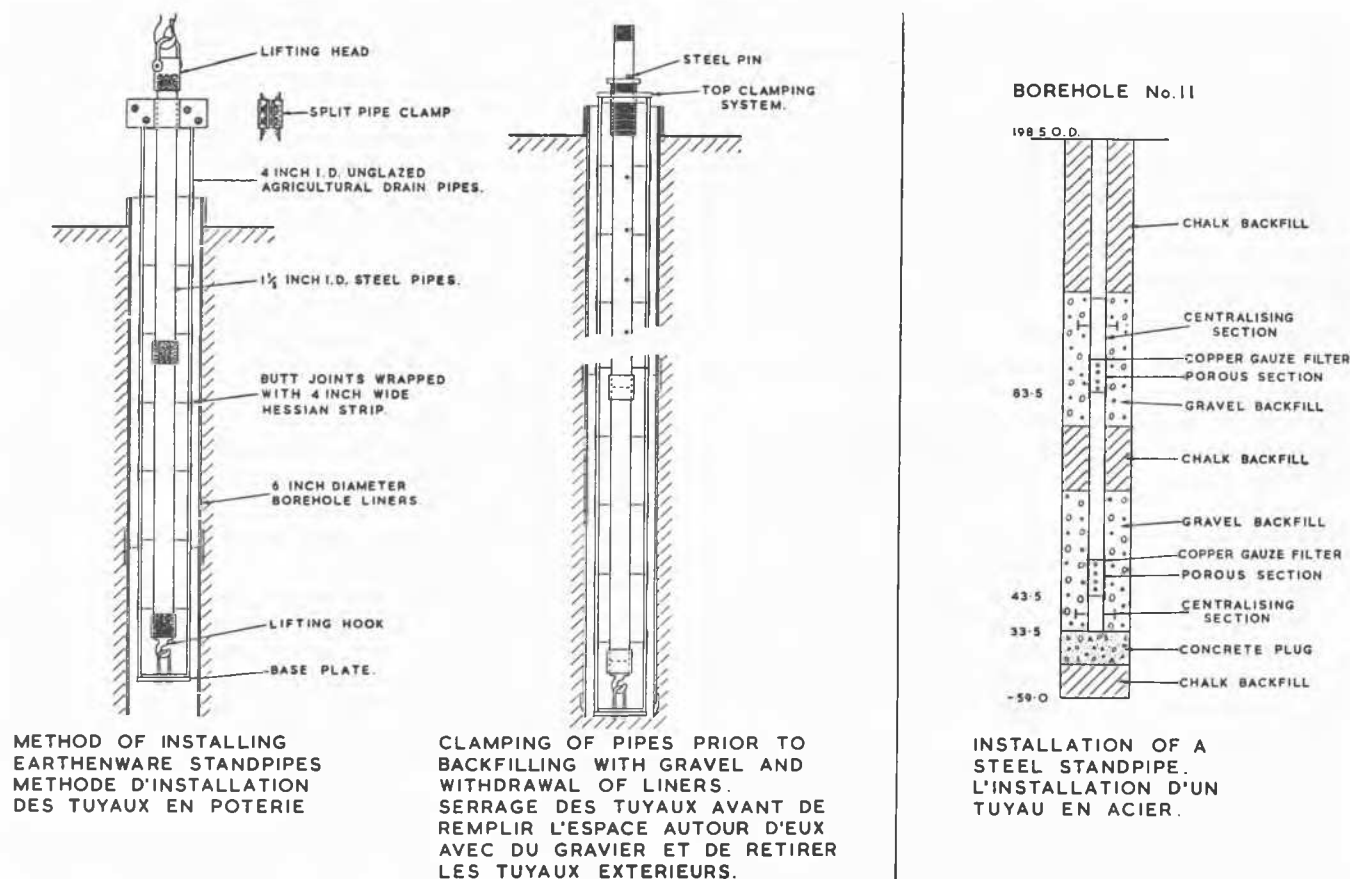
Fig. 4 Installation of Standpipes for Measuring Water Levels  
Installation des piezomètres indiquant les niveaux de l'eau dans le sol

head of water in this stratum to be recorded. Finally each boring was sealed above the Lower Greensand and earthenware pipes, or steel standpipes with bronze gauze and gravel filters at the water-bearing zones were inserted for the subsequent recording of the levels of the water over the Gault. These standpipes are shown in Fig. 4.
