CONSTRUCTION OF MUIRHEAD RESERVOIR, SCOTLAND

JAMES A. BANKS, O.B.E., M.I.C.E.

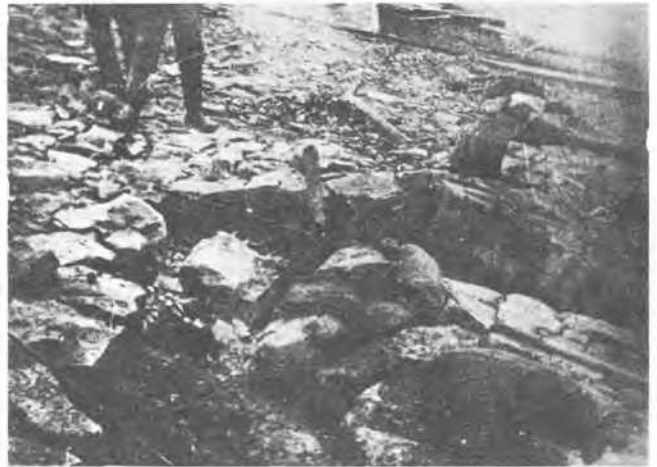
FIG.6

Muirhead reservoir. Arched deformation of stone pitching

Superficially, the embankment had every appearance of a substantial, thoroughly compacted job, but on 16th September a limited displacement of the stone pitching was observed on the lower part of the upstream face and three days later the pitching at one or two places had risen in the form of an arch (Figure 6). The placing of material on the central portion of the embankment was suspended pending a survey to determine the nature and degree of deformations. On 22nd September two cracks were observed on top of the bank, one on each side of the puddled core parallel to and about 20 feet distant from the centre line of the iam (Drawing 4).

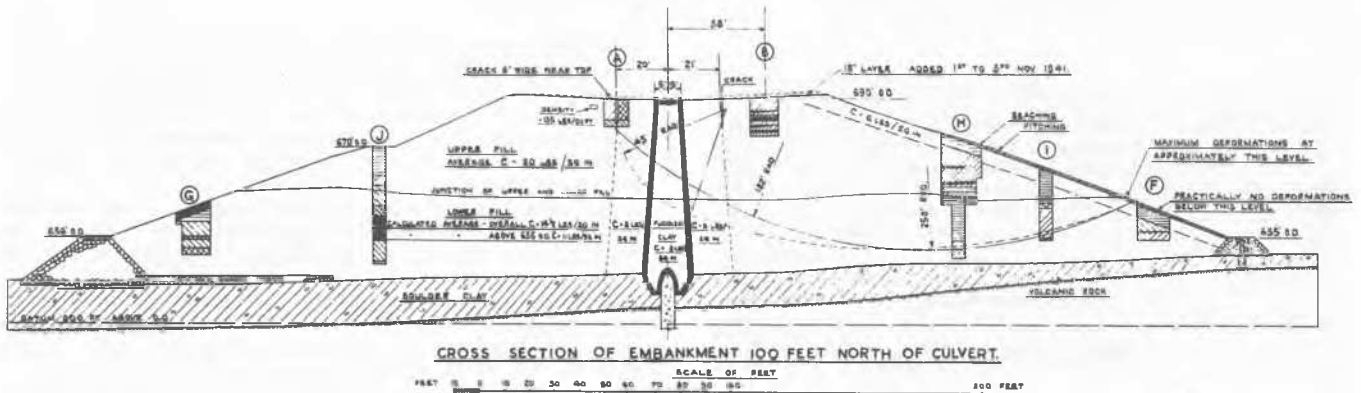
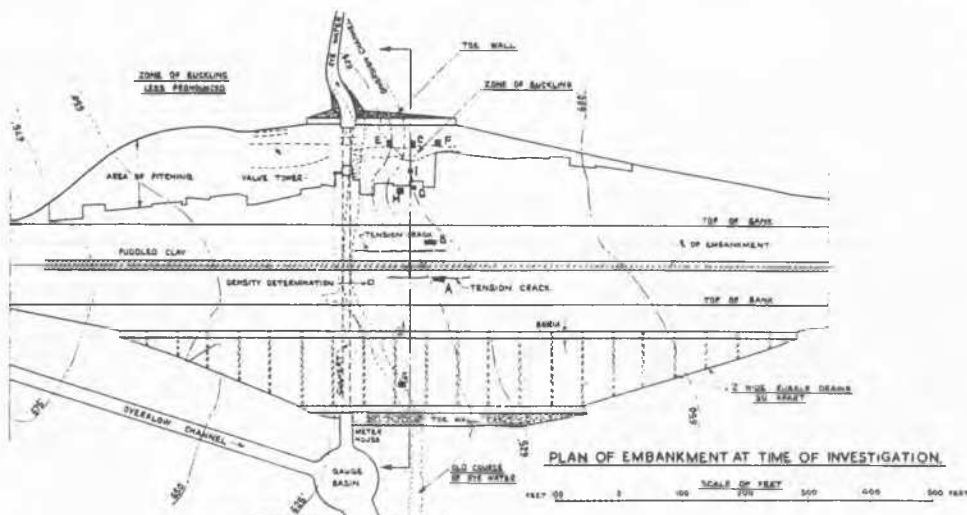
DRAWING 4

MUIRHEAD RESERVOIR.
 STABILITY ANALYSIS
 OF EMBANKMENT.

The strength of the material in various zones of the embankment, as deduced from the tests, is shown in Drawing 4. The compression strength of the core was 3 lbs. per square inch which was governed by the water content necessary to produce well-puddled clay. The strength of the embankment was low near the surface of the slopes and adjacent to the puddled core, which is explained by the difficulty of getting good compaction in these zones. The strength in the upper fill (i.e. material placed by the second contractor) was reasonably consistent, but the strength in the lower fill was variable and the value adopted for the latter in designing the modifications was arrived at from the assumption that the embankment had a factor of safety of unity. The foundation clay and also the clay at the base of the embankment was firm and the surface level of the latter defined the probable lower limit of the curve of shear.

The conditions of stability were examined on the basis of (a) a single-circle slip, (b) a two-circle slip, and (c) pressure from the puddled core for both upstream and downstream sides of the embankment on the lines indicated in Drawing IV. There was little evidence to prove that puddle pressure actually contributed to movement but the possibility of this was taken into account in the final design.

each method of failure analysed. The height of the embankment was restricted to the level established at the second stage of movement. The upstream slope was stabilised by constructing a rubble berm at the toe. The same means could not be adopted on the downstream side because costly modifications to outlet works already completed were involved and stability was procured by excavating material from the top of the embankment. The different methods adopted to stabilise the upstream and downstream sides of the dam led to an asymmetrical cross section and occasioned the unorthodox construction of the top section of the puddle wall. The completed dam is shown in photographs, Figures 11 and 12.

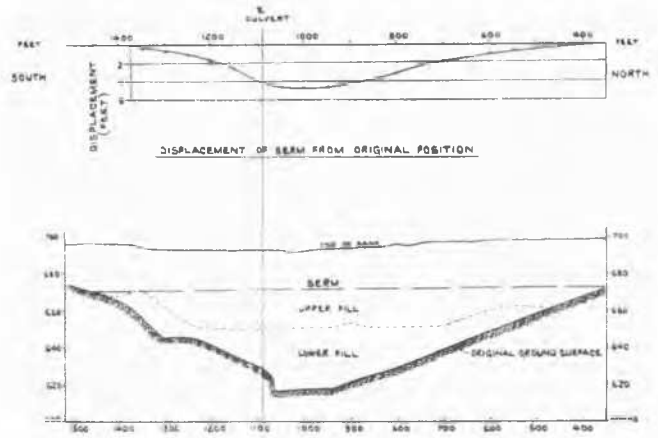
FIG.8

A survey across three sections of the embankment revealed that displacement of the earthwork had occurred practically in a horizontal direction, the extent varying almost directly with the height of the embankment (Figure 8). The toe walls remained stationary.

Longitudinal section along a line 110 feet down stream from centre line (IE vertically through berm)

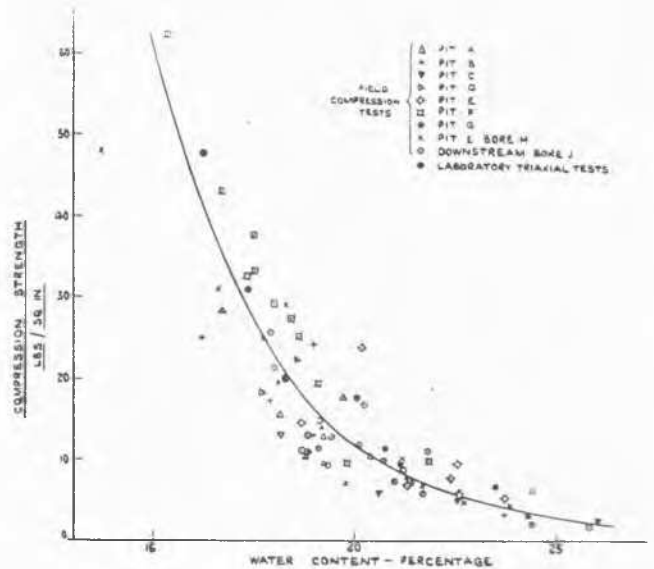
FIG.9

Relation between compression strength and water content

The drop in strength with increasing water content was very marked. At 18.5 per cent. the strength was 20 lbs. per square inch and at 20.5 and 22.5 the strengths were 10 lbs. and 5 lbs. per square inch respectively. The relation between compression strength and water content is shown in Figure 9.

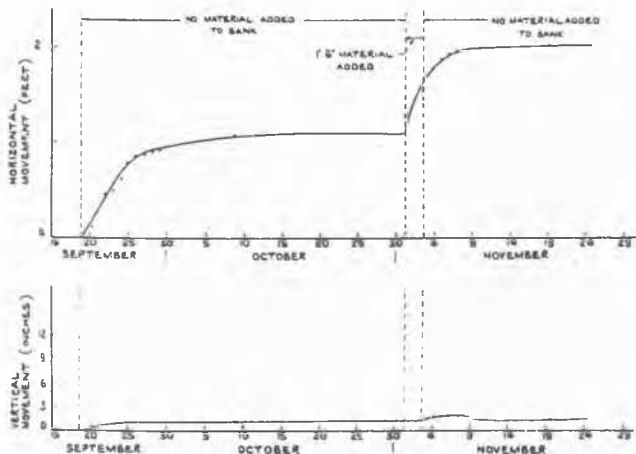
FIG.7

Investigation was concentrated on the cross section 100 feet north of the culvert where the height of the dam was greatest and deformation most pronounced. Shallow and deep observation points were established and bores and trial pits sunk to obtain samples for testing (Drawing 4) Movement of the deep observation points proved to be substantially the same as that of the adjacent surface point. The average movements of points E and F (Figure 7) are typical of the others.

Average movements of observation points E and F

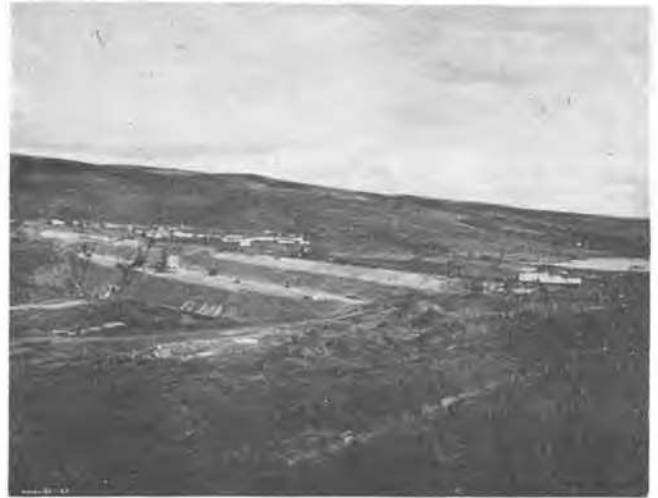
FIG.11

Muirhead reservoir. Upstream face of dam.

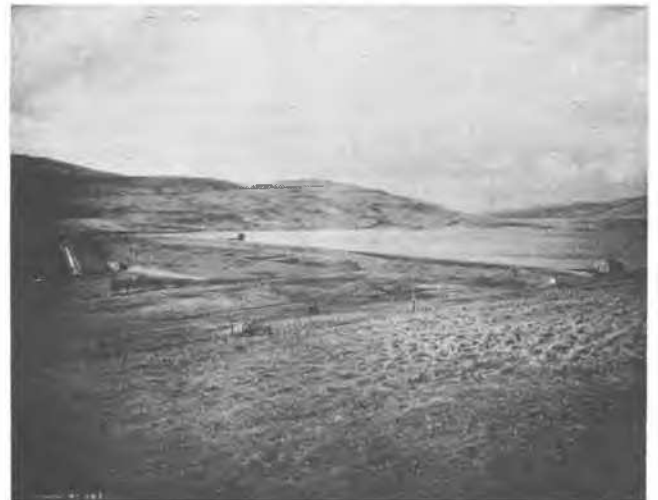
FIG.12

Muirhead reservoir
