DESCRIPTION OF A FLOW SLIDE IN LOOSE SAND

R.B. PECK

SUMMARY

This paper describes a flow slide that occurred in fine loose sand during reconstruction of a dock wall in East Chicago, Indiana in 1946. The flow occurred through a narrow opening made by the removal of a small portion of a sheet pile wall. Since no seepage pressures were involved, the primary cause of the occurrence appears to be the collapse of the extremely loose structure of the fine sand.

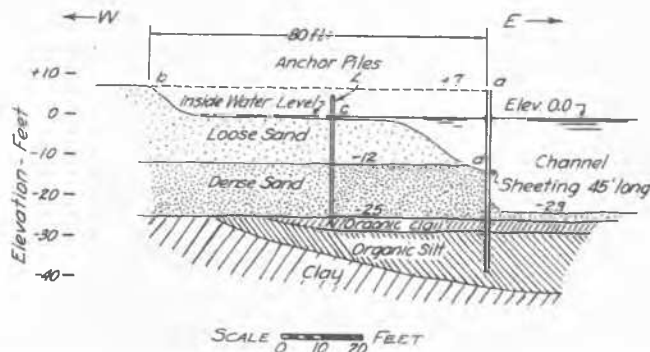
FIG. 1

Conditions prior to the slide are shown in Figure 1 which represents a cross-section through the dock wall. The outer face of the dock consisted of sheet piles 45 feet long. To the east of the sheet-pile wall was a canal with its water level at El. 0.0. The channel was maintained by dredging to El. -23. On the west side of the sheet piling the surface of the ground had a constant level at El. +7. A row of anchor piles 30 feet long was driven vertically at a distance of 40 feet from the sheet piling and was tied to it by means of steel rods at water level.

The material between El. +7 and El. -12 consisted principally of loose sand deposited by means of a hydraulic dredge. Most of this fill was pumped out of the channel during the construction of the dock. Between El. -12 and El. -25 was a natural deposit of beach sand

In preparation for the repairs, all of the material between El. +7 and El. 0.0. was removed to the west of the dock line for a distance of about 80 feet. In addition, a deeper pocket with a slope rising toward the west was excavated in the loose sand immediately behind the sheeting so that soil pressure did not act against the sheeting above about El. -14. Upon completion of these operations, conditions were as shown in Figure 1.

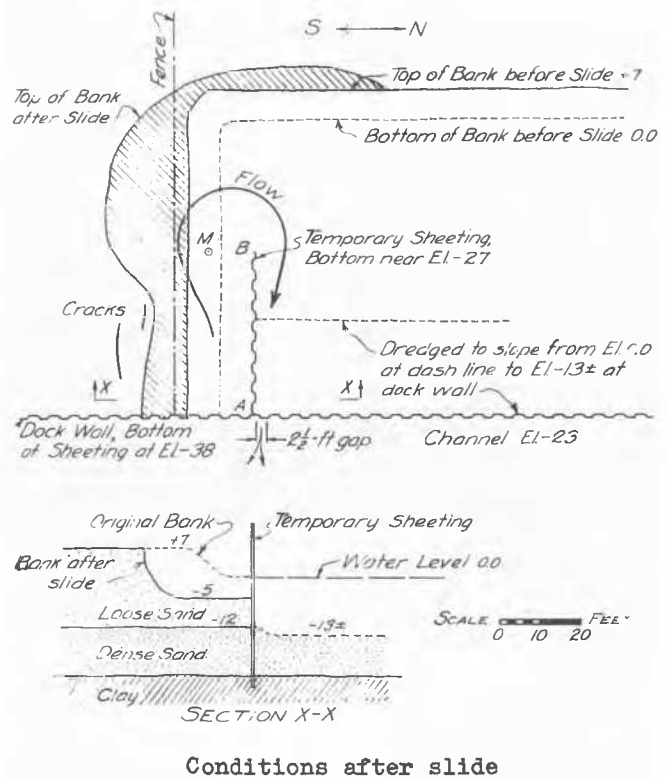
FIG.2

Inasmuch as the reconstruction operations were to extend to within a few feet of the south property line indicated by the fence in Figure 2, the contractor took additional measures to protect the adjacent property from possible damage by sloughing of the slopes. At a distance of about 20 feet north of the fence, a row of sheet piles AB was driven at right angles to the dock wall. This temporary piling extended to approximately El. -27. Hence it barely penetrated the clay and organic material beneath the sand. A cross-section through the temporary sheet pile wall just west of the dock wall is also shown in Figure 2. It indicates the manner in which the original bank near the property line was sloped from El. +7 to water level. At M, Figure 2, was located a mooring post that also extended to approximately El. -27.

By virtue of these preliminary operations, the contractor expected to be able to pull the sheet pile dock wall starting just north of point A with little difficulty and without the loss of much sand behind the dock line. However, upon removal of the first two piles, having a total width of $2\frac{1}{2}$ feet, sand began to flow through the narrow opening and continued to flow for about 30 minutes before the gap could be closed. During this time between 500 and 800 cubic yards of sand flowed through the gap.

The principal manifestation of the flow was the dropping of large chunks of sand into the water at the edge of the southern bank. These pieces first cracked away from the bank and then slumped into the water and disappeared. After the slide, the outline of the bank was as shown in Figure 2. Near the east end of the bank several cracks remained. The position of the ground surface just west of the bulkhead line is shown in Section XX. In corner A, the surface of the sand had descended from El. 0 to El. -5. At point B near the end of the temporary sheeting the depth was only slightly greater. At the place where the sheeting was removed, the surface of the sand was at about El. -11. Since the total distance from A to B around the end of the temporary sheeting and back to the gap was 80 feet, the final average slope was approximately 1 on 13.

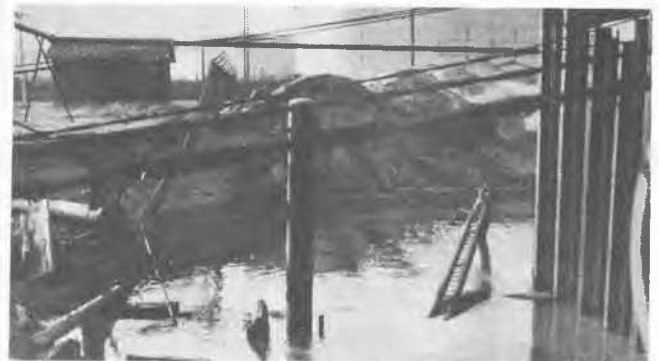
FIG.3

The photograph, Figure 3, shows conditions after the slide. At the rear of the view the fence can be seen in its original position.

Closer to the dock, it is seen that the fence has collapsed in the area involved in the slide. At the extreme right of the photograph can be seen the temporary sheet pile wall. It was still in position in spite of the fact that after the flow it had an embedment of only 12 to 15 feet. In the center of the photograph is the mooring post still in position and not tilted.

It is obvious from the drawings and the photograph that the slide was not a deep-seated phenomenon and that only the material above El. -12 was involved. Had the underlying sand layer been disturbed, the mooring post and the temporary sheeting would almost certainly have collapsed or moved. Inasmuch as the dock wall was provided with holes at water level to maintain the elevation of the water at the same level inside and outside the sheeting, no hydraulic head could have existed across the gap at the time the sheeting was removed. The relatively small disturbance caused by removing the support from

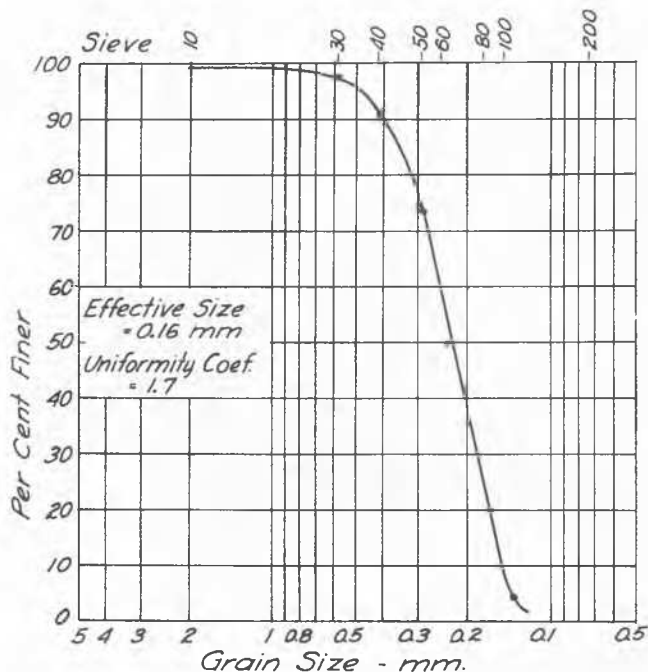
FIG. 4

Within the upper 12 feet, a single blow of the drop hammer was sufficient to advance the sampler as much as 22 inches. In many parts of the deposit the resistance to penetration was only one blow per foot. On the other hand, below El. -12 the penetration resistance varied between 10 and 15 blows. Hence, the lower sand appears to have been relatively loose but stable whereas the upper sand involved in the flow was abnormally loose and unstable. The grain size curve of the sample of one of the finer lenses in the hydraulically deposited soil is shown in Figure 4. It indicates that the individual lenses are extremely uniform. The fraction passing the 100-mesh sieve and retained on the 200 and that passing the 200 were examined under the microscope. Both consisted almost exclusively of angular quartz grains; very few rounded or sub-rounded grains were present. Grains passing the 200-mesh sieve were slightly more angular than those in the coarser fraction.

of a flow slide that occurred in very loose sand due to a relatively minor disturbance. The flow was confined exclusively to a uniform excessively loose hydraulic deposit having a penetration resistance, according to the procedure described in the text, of as little as one blow for 22 inches. On the other hand, the underlying sand which had a relative density somewhat greater (about 10 blows per foot), did not participate in the movement. Inasmuch as no seepage pressures were involved, it may be concluded that the flow was due to the spontaneous liquefaction of the excessively loose sand.
