IV c 3

CONTROL OF THE STABILITY OF A SLIDING SLOPE IN A RAILWAY CUT NEAR WETTEREN

L. MARIVOET
Ghent (Belgium)

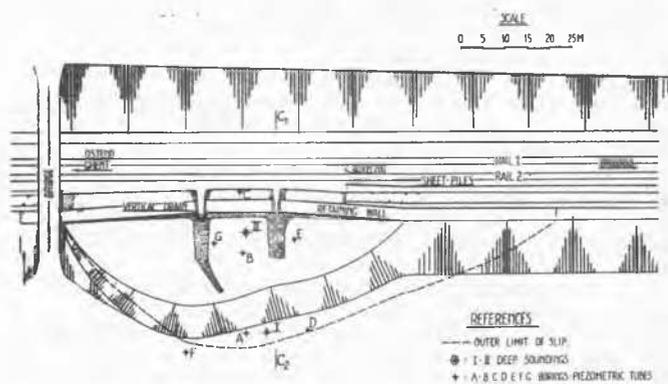
FIG.1

The site of the slip is shown in figure 1, in which a dotted line gives the limits of the area of slip. A cross-section through the sliding slope is seen in figure 2. A crack and subsidence near the top of the slope were observed. The approximate depth of the tension crack which had developed prior to the slide, was about 1 meter. Near the toe of the slope an upward movement of the rails had taken place. So when the failure occurred, in the median part of the slip zone, a difference of height of about 0,15 m was found between the outward rail 1 and the interior rail 2. The limit of the slide was visibly located between the two tracks.

Some previous movements had taken place at this point and had inspired some anxiety to the engineers of the S.N.C.F.B. Various measures had been taken in order to stabilize the slope. As can be seen in figures 1 and 2, at the toe of the slope a retaining wall in concrete had been erected, with the hope to maintain the profile. In front of this wall a mass of stones had been placed in order to provide a supplementary support for the wall. At some places a row of sheet-piles was found at the toe of the wall. However, it has appeared that the retaining wall was not founded sufficiently deep in order to have an effective effect, whilst the construction of the wall led to an increase of the waterpressure in the slope. Afterwards large openings were made in the wall and filled with drainage materials. Just behind the wall the slope was considerably flattened. But movement continued and in a further effort to remedy this situation, in 1928 a vertical circular drain was placed in front of the wall, what helped temporarily to reduce the waterpressure in the slope.

Plan of slip in a railway cut near Wetteren

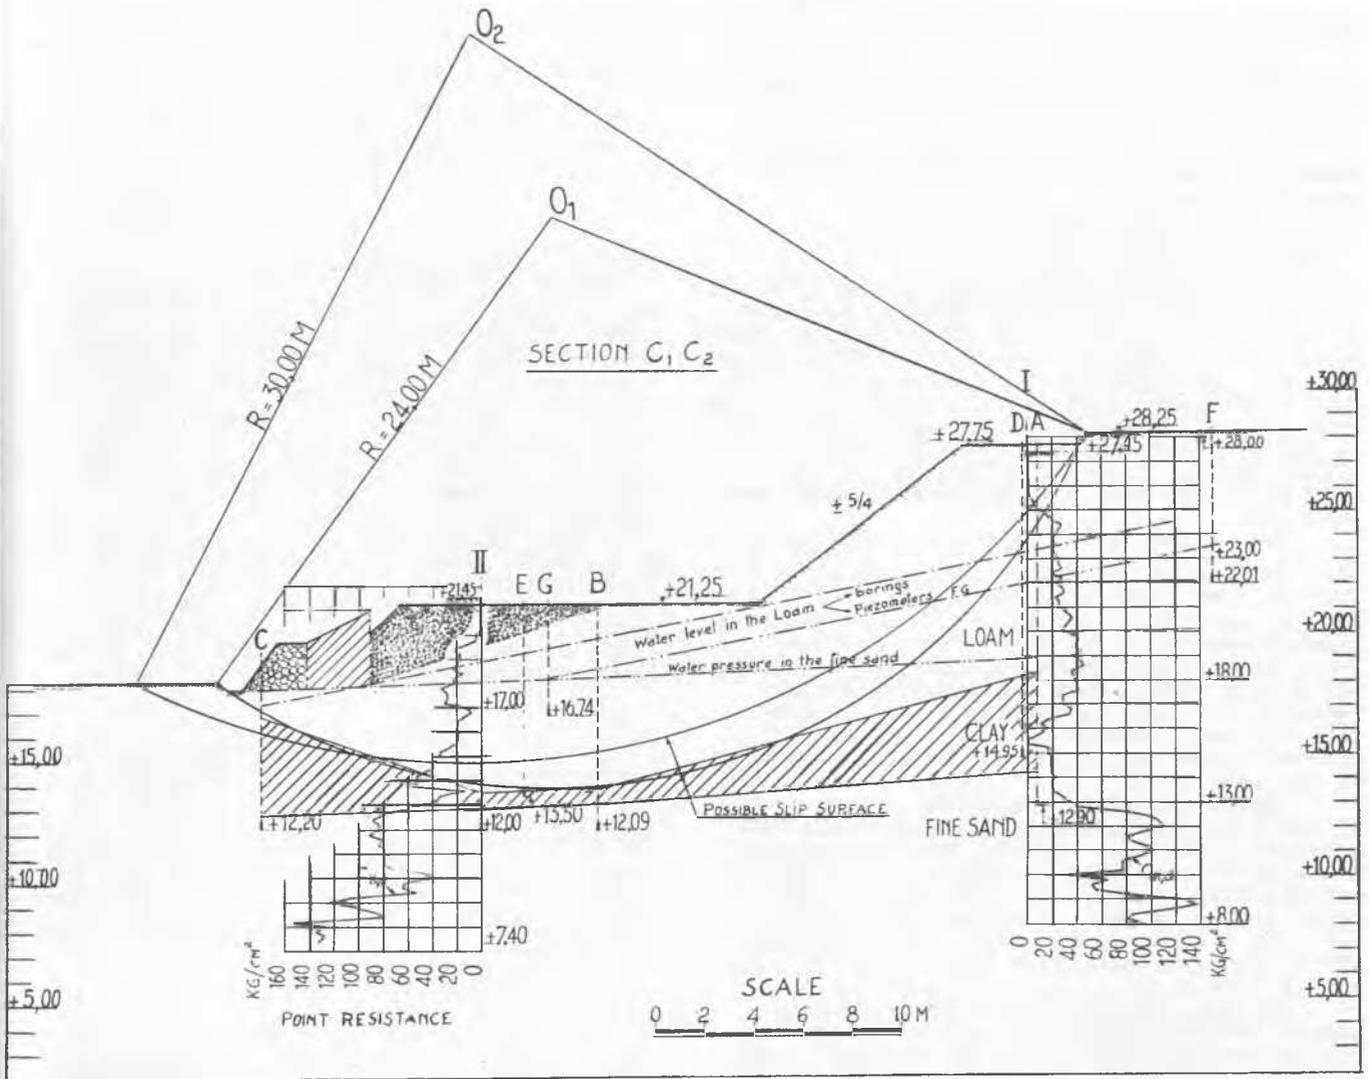
FIG.2

At deepsounding I, this last sand layer has been recognized to the level + 8,00. It has also been established that the thickness of the blue clay was very different from point to point. As shown in figure 2. where the clay

Cross-section of slip near Wetteren

layer is represented by a shaded area, the upper limit of this stratum is notably lower in the median part of the slope, where the thickness of the clay is reduced to about 1 meter.

The displacements of soil which were observed in the field, and the location of the zones of weakness found by testing the undisturbed samples make it possible to locate the slip surface with some accuracy. This surface could be approximated by one or other of the two circular surfaces shown in figure 2. These surfaces have respectively as centre, the points O_1 and O_2 and as radius, $R = 24$ meter and 30

meter. The former follows the upper limit of the clay layer, the latter travels over a great part through the under layer of the loam.

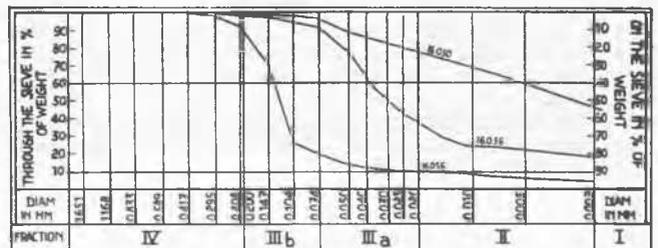
FIG.3

In figure 3 is shown the grain-size distribution of a typical sample taken in each of the encountered layers. The Atterberg limits and the plasticity-index of these samples are given in the following table:

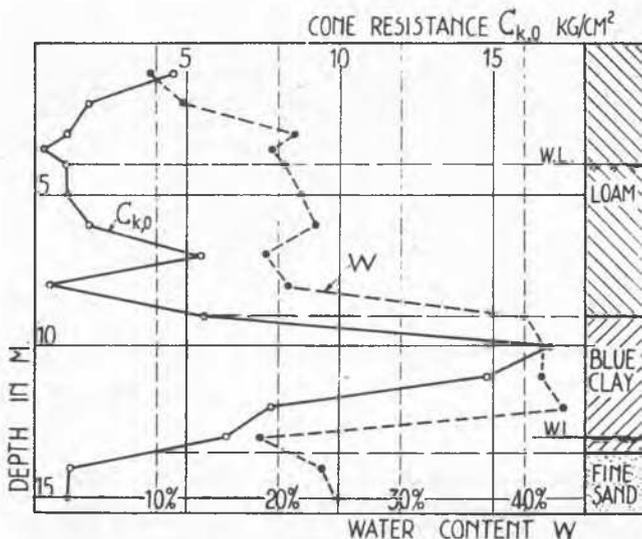
FIG.4

The variation of the cone resistance $C_{k,0}$ with the depth is illustrated by figure 4. A dotted curve gives also the variation of the natural water content. It may be seen that the highest values of the cone resistance are found in the clay stratum; these values indicate a clay with a firm consistency. On the contrary the loam and the fine sand present very low resistances; nevertheless lightly greater values are found in the capillary zone of the loam.

Variation of cone resistance and water content with depth

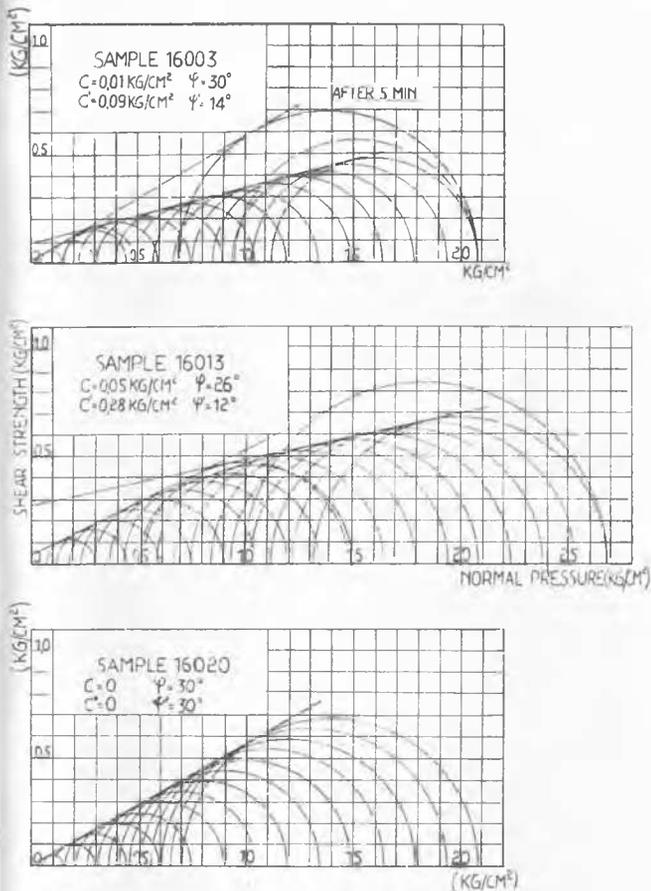
The shear resistance of the different strata was principally determined by testing the undisturbed samples in the triaxial compression apparatus. The results of such a test are expressed in figure 5. The test results are summarized in the following table, wherein the mean and the lowest values of the shear constants, obtained in the loam and the clay are given.

Results of cell tests
FIG.5

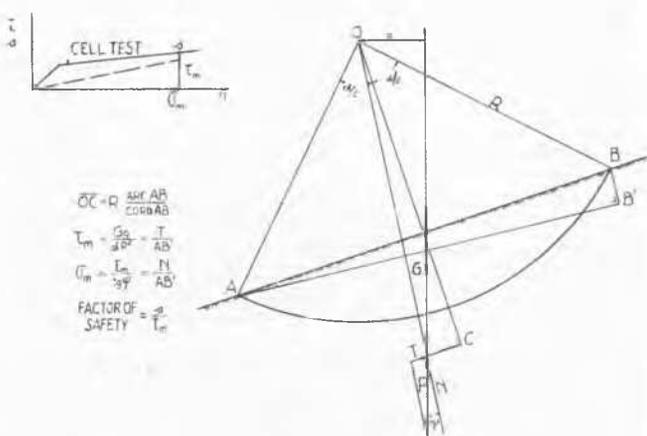
Principle of stability analysis
FIG.7

The stability computations made in connection with these rotational slip surfaces are based upon an approximative method suggested by M. Huizinga. The principle of this analysis is given by figure 7. It consists in calculating average values for the normal pressure σ_m and the tangential pressure τ_m along a chosen slip circle. The comparison between τ_m and the available shear strength s , which may be determined by triaxial compression tests, gives an indication of the margin of safety of the slip, with respect to the particular circle chosen.

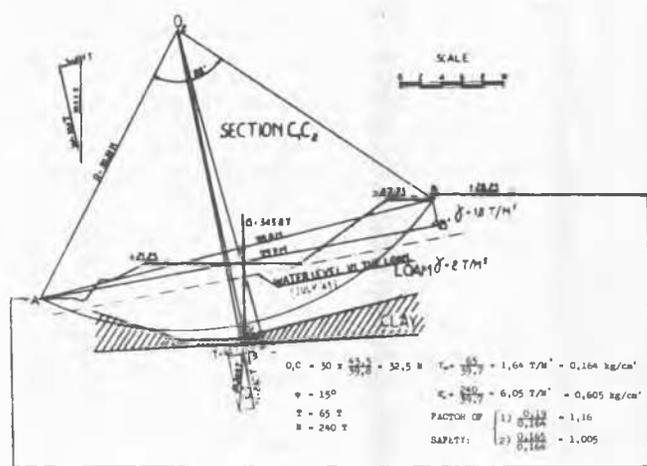
Example of stability analysis
FIG.8

An example of such an analysis, in relation with the circular slip O_2 , $R = 30$ meter is given in figure 8. The mean pressure σ_m is $0,605 \text{ kg/cm}^2$, whilst the mean value of τ_m is $0,164 \text{ kg/cm}^2$. With respect to the mean value of s obtained in the loam, the factor of safety is 1,16. If we consider the lowest values found in the loam (sample 16.000), the factor of safety is only 1,005. Similar calculations which have reference to the slip circle O_1 , $R = 24$ meter, have shown that in relation with the most unfavorable shear strengths obtained in the upper zone of the blue clay (sample 16028), the factor of safety was found to be equal to 1,10. It is of interest to note that the calculations which led to the safety values given above, assume that the water pressures in the loam correspond with the most unfavorable water-levels measured in the first days of July 1943.

Whatever may be the shear resistance to which can be referred, the results of the calculations show obviously, that in the assumed conditions, the soil masses limited by the chosen circular slip surfaces were in a state of equilibrium very close to the critical one. Then it is evident that in rainy seasons, when the water-level in the loam may rise considerably, the disturbing forces can exceed the restoring ones, and failure may occur.

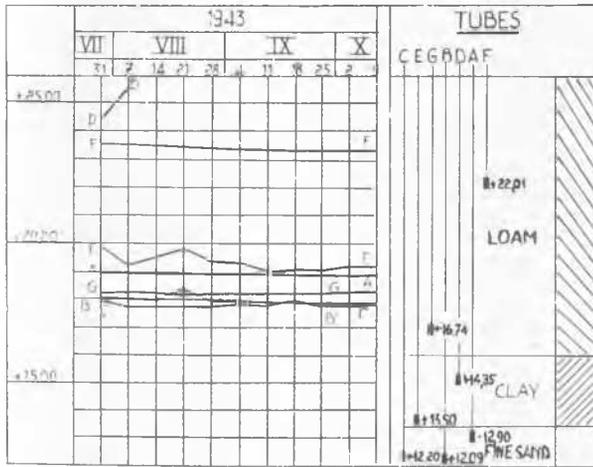
From observations in the piezometers, it was possible to draw the time-ground water level curves shown in figure 6. The measurements concern a period of about two months. Although no considerable changes were found, it may however be seen that during the summer 1943, some decrease of the water pressures have occurred. More important are the differences of the water-levels measured between the top and the base of the slope. (see also the cross-section in figure 2)

Variation of ground water pressure.
FIG.6

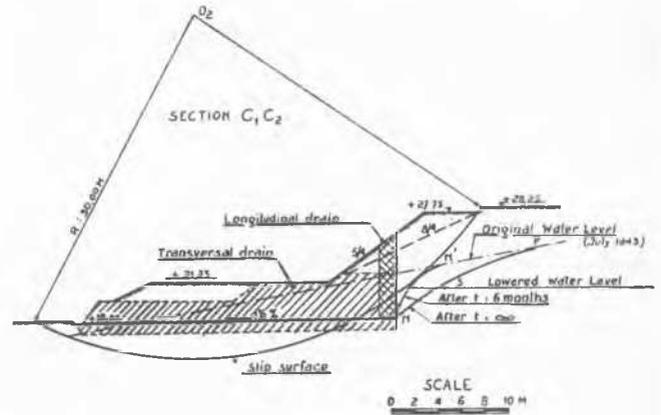
FIG. 9

Ground-water lowering by means of drains

Calculations indicate that if the phreatic water-level in the loam could be lowered at the level + 18,00 (figure 9), the factor of safety

would be increased by 30%. On the other hand, if the slope at the top would be 8/4 instead of about 5/4, an increase of 20% would be possible (fig. 9). Together these measures might lead to an increase of stability of 50%.

In order to lower the water table in the loam, it is necessary to drain the soil. For instance the lowering of the water table can be accomplished by constructing within the soil at the top the slope, a longitudinal drain. With the object to establish an adequate position for this drainage, an estimation was made about the position of the lowered water-table with a drain which base would be located at the level + 18,00. In these computations, it was assumed that the layer of loam had a constant and uniform coefficient of permeability, namely $k = 10^{-6} \text{ cm/sec}$. The curve NN' in figure 9 gives the position of the water-table after a drainage time of 6 months. The curve NSP corresponds to an infinite time of drainage. In fact, the average permeability of the loam may be greater than what was allowed in the computations; besides, in some samples a coefficient of permeability of the order of 10^{-5} cm/sec has been found from tests. Therefore, the curves NN' and NSP are to be considered as upper limits.

The construction of a longitudinal drain was found to make out a very expensive solution. Therefore it was decided to substitute the longitudinal drain by a system of transversal drains, which would penetrate to a sufficient depth into the earth of the slope. Three of these drains were really executed, at intervals of about 25 meter. The filter materials of the drains have been judiciously chosen (gravel and coarse sand) in such a way that the loam particles were held back and could not be washed through the voids of the drain. As complementary measure, material was removed from the top of the slope, so that a more flat profile was obtained. It seems that the taken measures proved successful, for since 1943 no further movement of the slope had taken place.
