TWO FAILURES WITH CUT-OFF WALLS

Ir. T.K. HUIZINGA

Director of the Laboratory of Soil Mechanics, Delft, Holland.

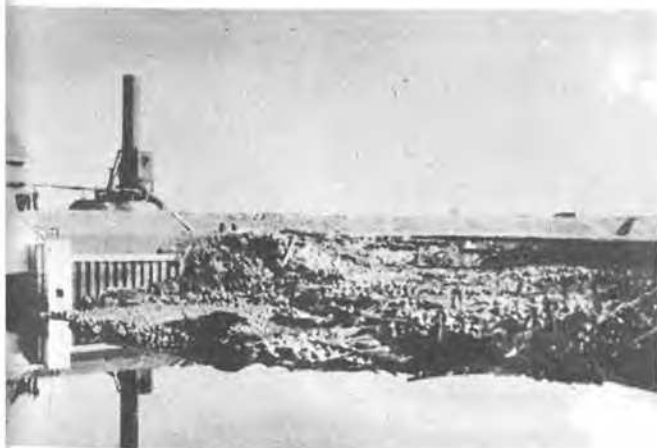
PHOT. 1

For the construction of the lock and the pumping station for the North East Polder at Urk (Fig. 1), carried out within a dewatered area of the IJsselmeer, enclosed by an earth dam drainage by well points was applied to maintain the groundwater level in the thus formed site at about 9,50 m - N.A.P. By the beginning of September 1945 the groundwork was almost completed. With a view to put in operation the mechanical installations, namely the filling of the cooling water system and the boilers, it was decided to fill the harbour basin ahead of the pumping station carefully from the IJsselmeer and to convey the required amount of water thence to the pumphouse through the pressure pipes. Some days after the actual filling and no signs of alarm having been noticed, suddenly, directly West of the pumphouse a spring started, ejecting with considerable force water containing lumps of clay, peat and sand. The water level of the filled harbour basin subsided quickly, showing a vortex motion at the mouth of the pressure pipes. In addition some slides occurred, a fairly large one at the South bank of the basin covering the stone revetment of the bottom and by doing so throttling the flow so much that in the end, after the water table in the basin had dropped about 1 meter, the flow was checked (foto 1). Subsequently, by way of precaution, the harbour basin was emptied. During the next few days the ground at some places under the pressure pipes collapsed, resulting in two craters, one to each side.

Evidently piping has developed from the entrance of the water at the vortex on the revetment of the bottom of the basin, to the outlet at the boil at the West front of the pumphouse. The path of it is not known.

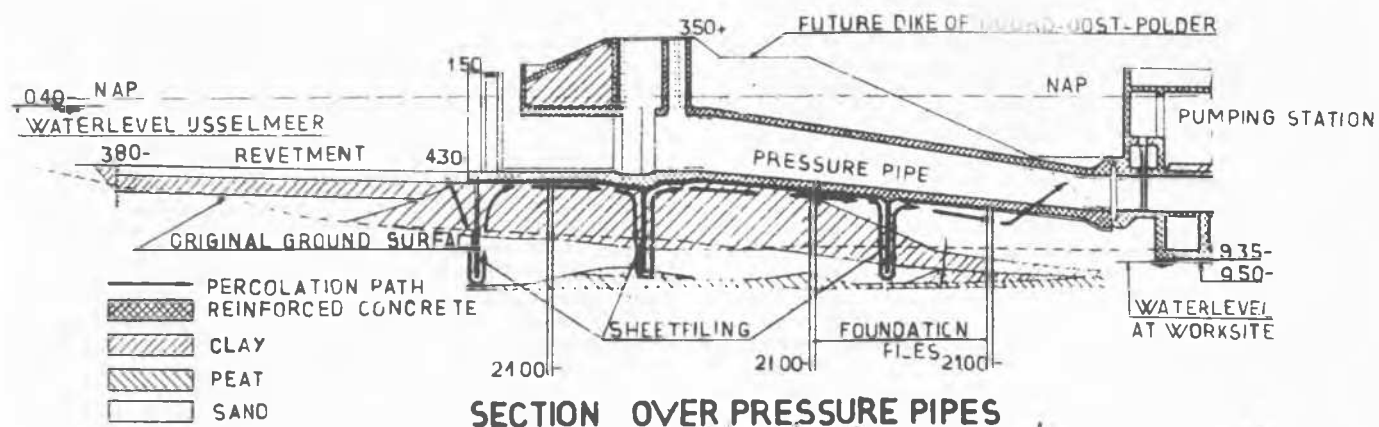
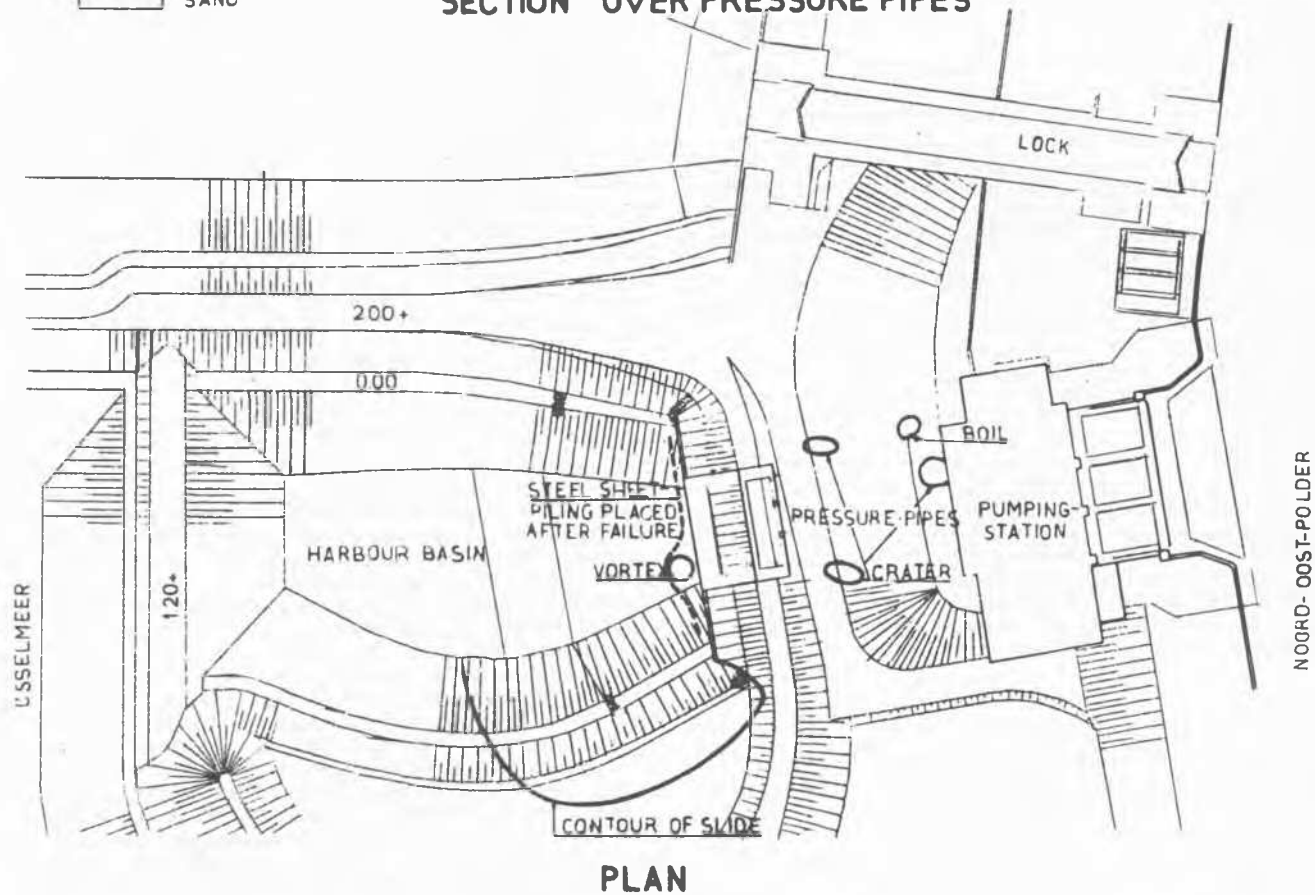
FIG. 1

Free water from the harbour basin can have reached the first cut-off through the revetment, causing a considerable hydrostatic pressure on the sheet piling which must deflect against the soft clay. As a result the joint between the sheet piles and the adjacent clay mass on the upstream side opens up and the water pressure in the sand mass at the toe of the piles rises. In this sand mass the passage of water is impeded by the presence of the underlying peat layer.

Also at the back of the first cut-off now the hydrostatic pressure rises. The result is that the piles bend backwards somewhat. In doing so, erosion in the sand mass at the back can develop and the water can reach the foundation floor of the pressure pipes. Intimate contact of the clay with the foundation floor cannot be assumed, because the deposited clay, especially at the sides may have settled under the weight of the body of the dike. Therefore after a short time the hydrostatic pressure under the pressure pipes between first and second cut-off will rise and the same phenomena will happen at the second cut-off. After repeating itself once more at the third cut-off, "boiling" may be produced beyond, owing to insufficient overburden. Ultimately retrogressive internal erosion will cause a continuous stream of water, leading to failure.

Failure Dam Urk

sion round the toes of the sheet piling would probably not have materialized. Altogether it seems that the cause of the failure must be found in the deflection of the sheet piling after the filling of the harbour basin at a time of low hydrostatic pressure in the deep sand layer.

Repairs consisted mainly in the driving of a cut-off wall of ample length at the front round the vortex pool and the extension beyond it of the reinforced concrete foundation floor of the pressure pipes.

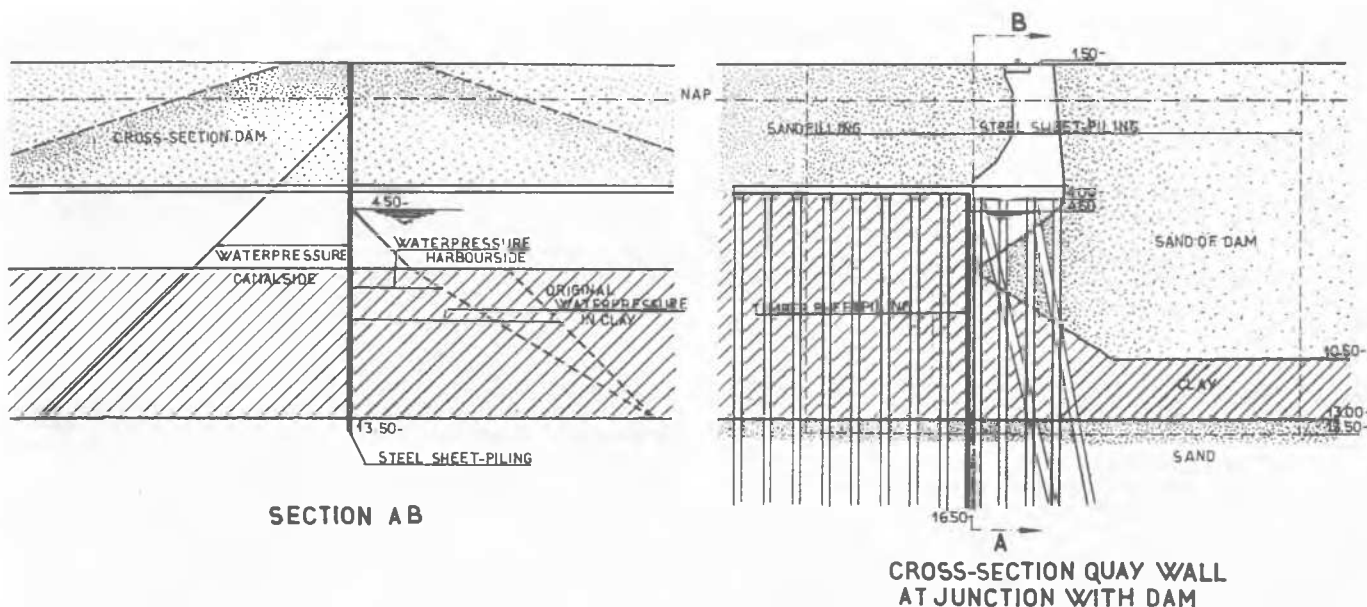
FIG.2

Failure Dam Coenhaven

A second accident with possibly similar causes happened shortly at the reconstruction of the Coen Harbour at Amsterdam. The design and construction of the existing quay walls may be found in fig. 2. Planning the repairs of these war-damaged structures it was decided to lower the water level to just below the continuous reinforced concrete floor in order to be able to inspect the front piles below the face and to work above water level when repairing the superstructure. To this end an earth dam was designed in the entrance channel to the harbour basin, connected to the quay wall at both ends. In order to avoid slides in the body of the dam the slopes were laid flat and at the low water side drainage was laid at water level. Where the dam joined the existing quay wall, a 20 meter long wall of steel sheet piling was provided parallel to the axis of the dam, cutting 10 m into the earth dam and 10 m into the quay walls.

After the construction of the dam was almost completed - only a clay cover had still to be laid in order to forestall failure brought about by the entrance of excessive rainwater - the water within the harbour basin was slowly pumped out. When the required level had been reached after a fortnight and successfully maintained during almost 3 days, failure of the dam occurred at the Western connection to the quay wall. Various failure theories were

It is to be noted that the water on the high water side is in free communication with the one side of the steel sheet piling by way of the empty space under the face of the quay wall i.e. in front of the auxiliary timber sheet piling. At the low water side, where the same free communication is possible, the hydrostatic pressure is thereby lowered with the water level of the harbour area. Therefore a considerable water pressure is acting on the steel sheet piling.

In order to be able to drive the steel sheet cut-off piling through the quay wall, the by explosive action damaged reinforced concrete floor was forcibly split over the full width by driving a steel beam through it and thus pushing the reinforcing bars apart. By this action the auxiliary timber sheet piling must also have been split or pushed aside. The steel sheet piling has been driven straight through this gap. It seems probable that through this gap the first discharge of water from the deep sand layer has taken place. More and more soil particles will have been washed out, causing ultimate failure by retrogressive erosion.
