ANALYTICAL STUDIES OF PANAMA CANAL SLIDES

WILSON V. BINGER

Chief, Soils and Geology Branch, Missouri River Division, Corps of Engineers,  
Department of the Army, United States of America

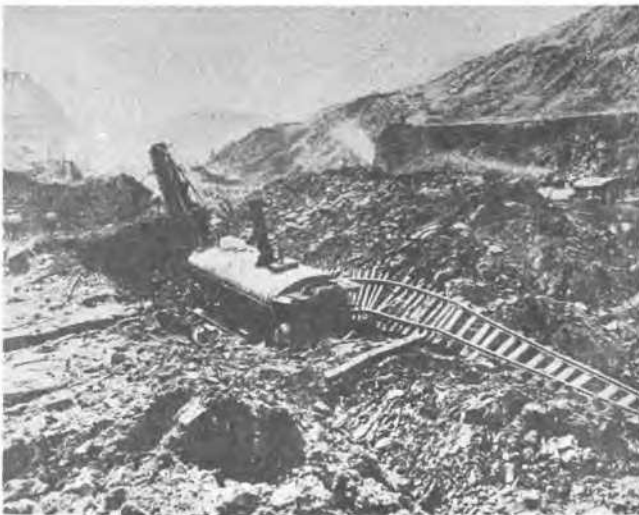
FIG.2

East Culebra slide showing upheaved material between stations 1746 and 1758. Looking south, Febr. 6, 1913.

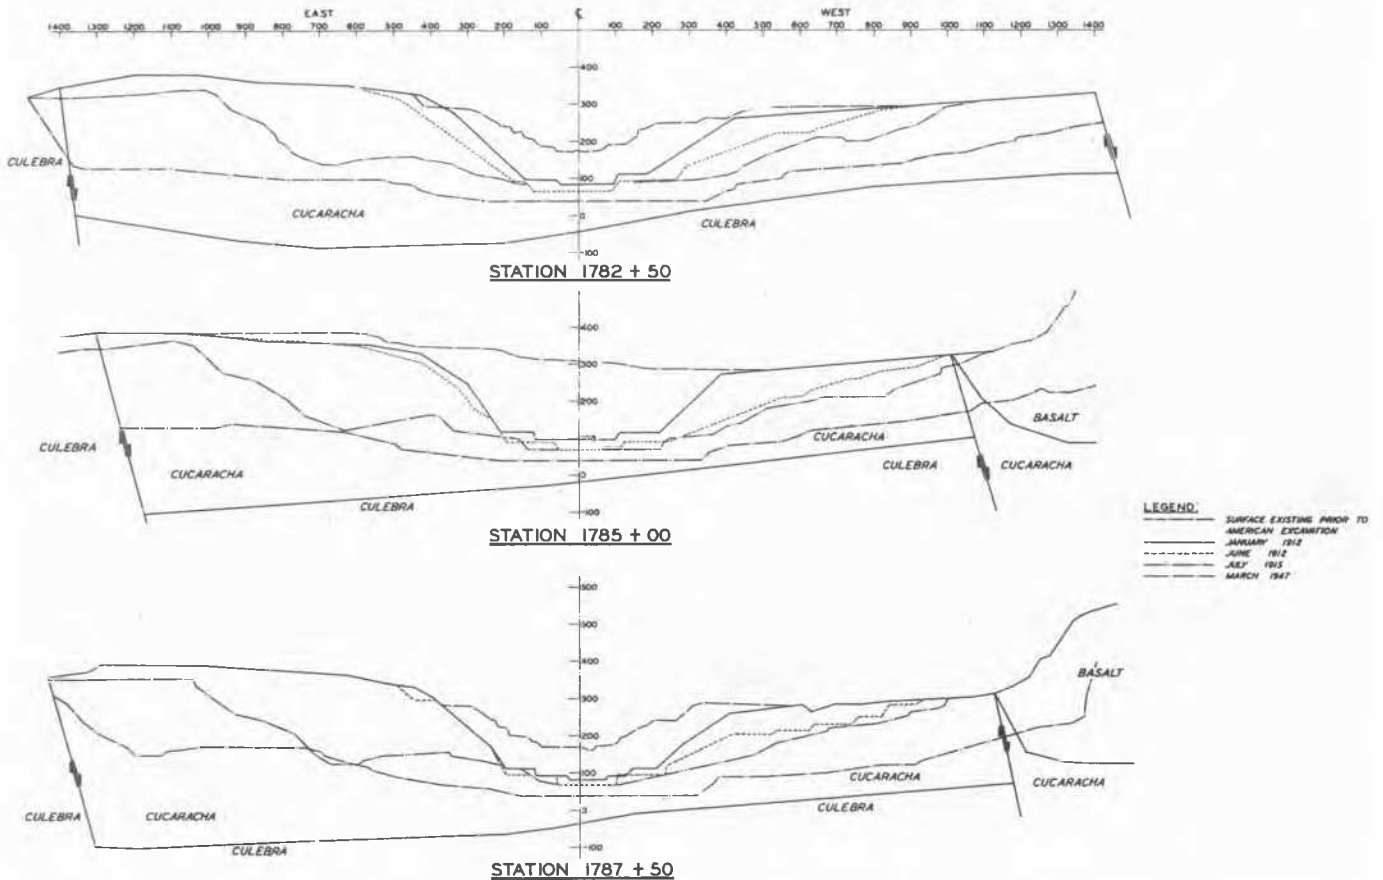
FIG.3

East and West Culebra slides progress of slide movement.

of Stations 1782-50, 1785-00, and 1737,50, respectively, are shown with results of analyses thereon. In Figure 3 it may be seen that the East Culebra Slide between January and June 1912 consisted merely of surface movements, but the other slides studied appear to be of the deep-deformation type.

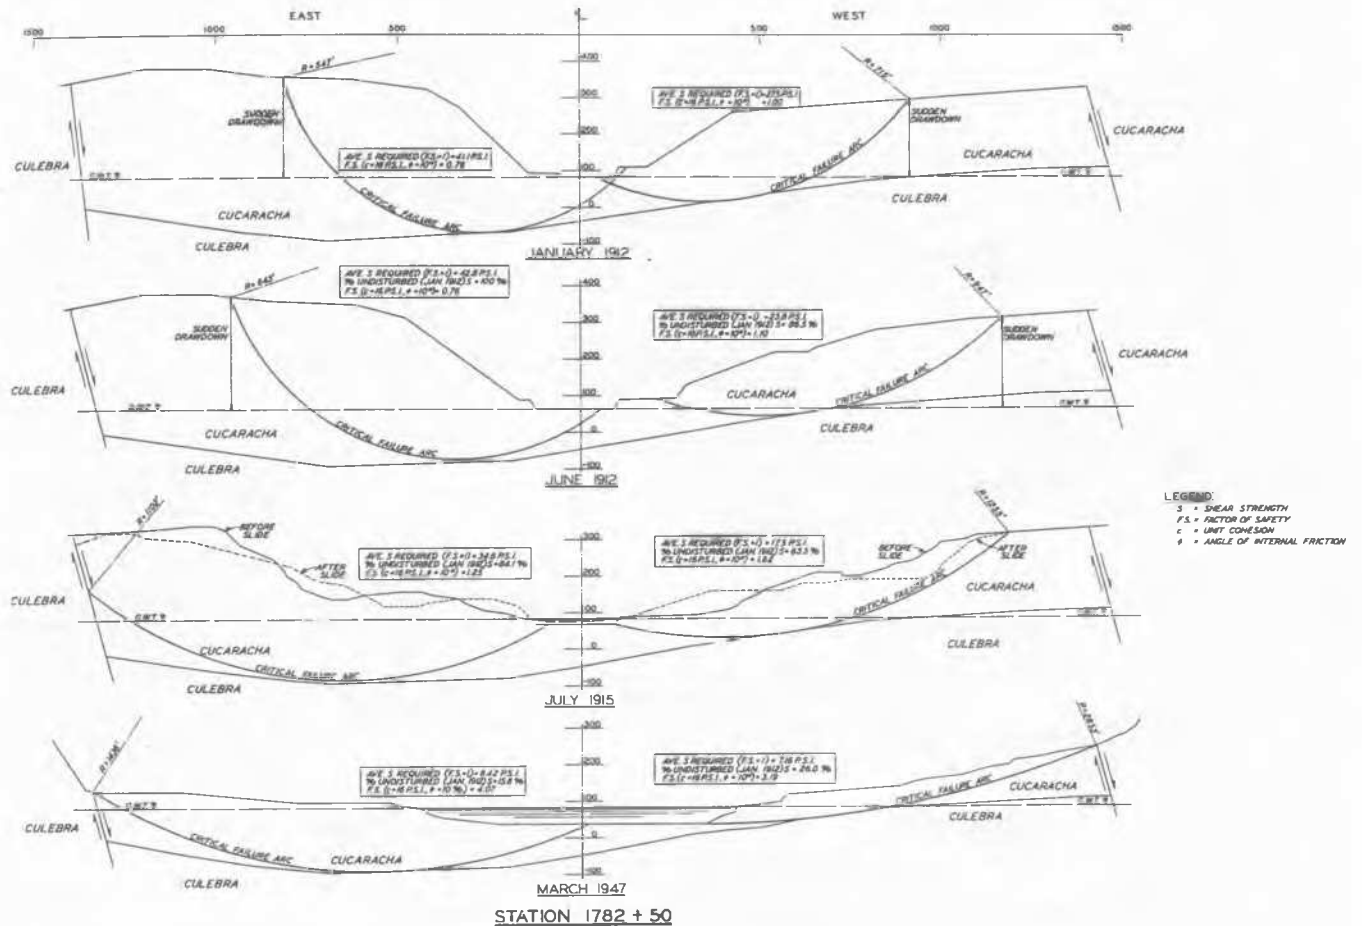
FIG. 4

East and West Culebra slides stability analyses station 1782 + 50.

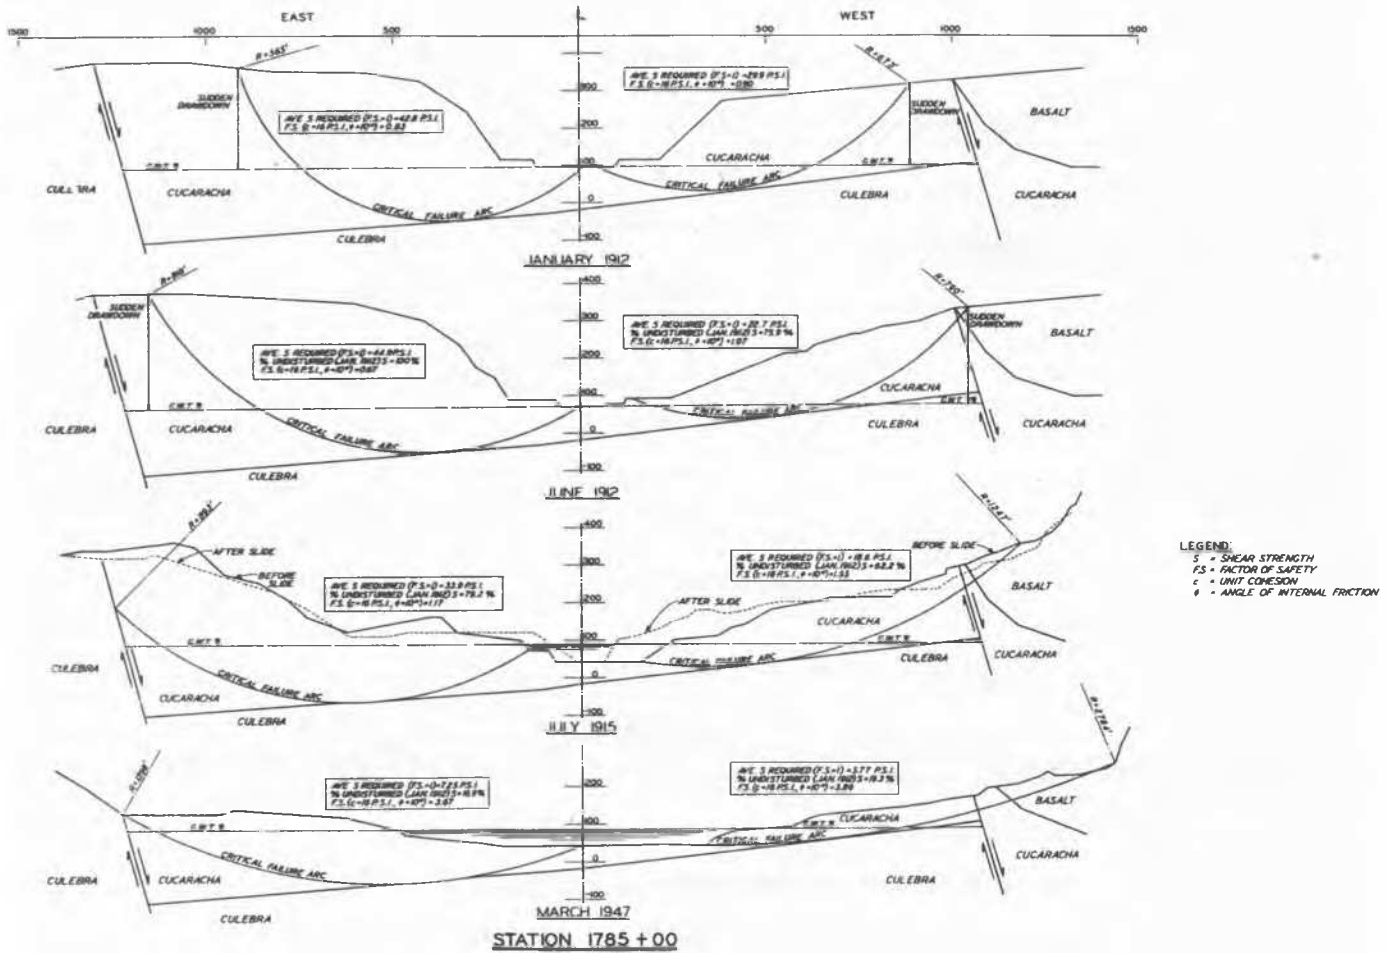
FIG.5

East and West Culebra slides—stability analyses—station 1785 + 00.

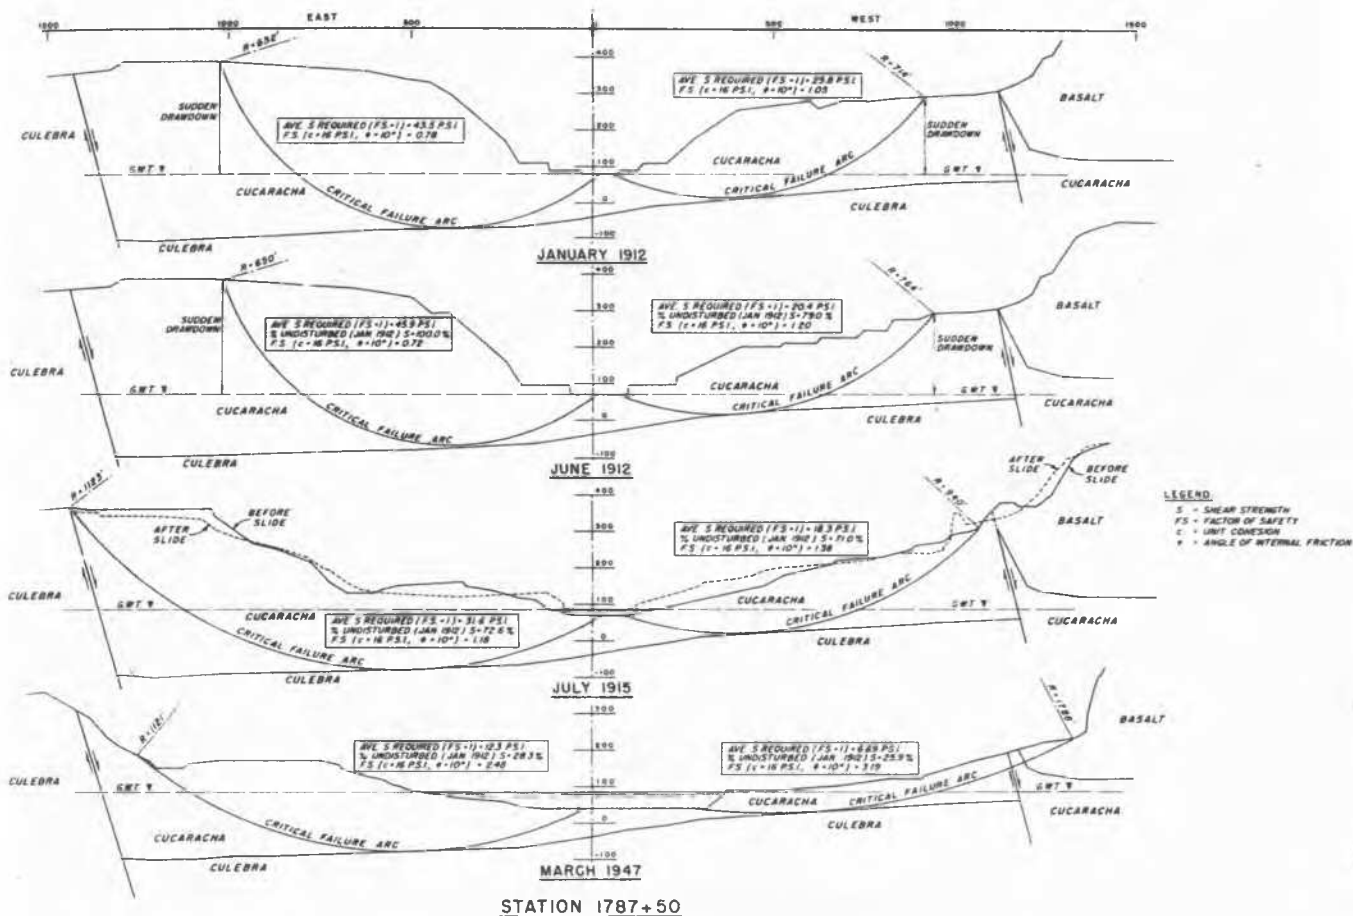
FIG.6

East and West Culebra slides-stability analyses-station 1787 + 50.

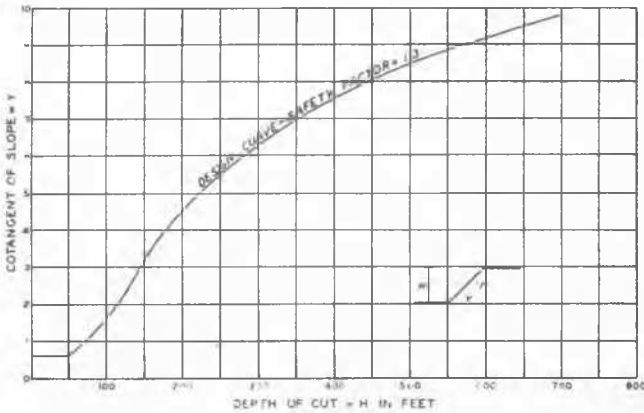
FIG.8

the Cucaracha formation have been designed according to the curve shown in Figure 8. This curve, a plot of required cotangent of slope versus depth of cut, is based on a factor of safety of 1.3, an assumption of sudden drawdown, a unit weight for Cucaracha of 135 pounds per cubic foot, and strength values for the Cucaracha of cohesion,  $c$ , = 16 pounds per square inch, and angle of friction,  $\phi$ , =  $10^\circ$ . This friction angle was determined from sliding friction tests made on blocks of solid clay shale polished to simulate slickensides. The value of 16 pounds per square inch for the cohesion was then determined from analysis of a standing bank of a cut about 200 feet deep in Cucaracha, on the west side of the Canal just south of Zion Hill.

In order to check the design slope curve, the apparent factors of safety of the various sections were computed using the same value of cohesion equal to 16 pounds per square inch, and angle of friction equal to 10 degrees. From the results of these studies, Figures 4 through 7, it appears that the slope curve shown in Figure 8 is conservative for the design of statically safe slopes. For the three January 1912 sections of the East Culebra Slide studies, the average apparent factor of safety was found to be 0.79 ranging from 0.76 to 0.83. For the three West Culebra Slides on the same date, the average apparent factor of safety was found to be 0.98, ranging from 0.90 to 1.05. If the actual factor

of safety in these cases approximated 1.0 (as it must have, since the major slides had not started) then the strength assumption  $\phi = 10^\circ$ ,  $c = 16 \text{ psi}$ ) used must be conservative. Therefore, the design factor of safety of 1.3 for the present Cucaracha slope curve, based on the same assumptions, may furnish an actual factor of safety higher than 1.3. The present design slope curve would require slopes for the east bank approximately four times as flat as those actually cut prior to January 1913. Since it is observed that in January 1912, the east slopes were apparently more severely oversteepened than the west slopes, when compared with the present Cucaracha slope curve, it is to be expected that the factors of safety of the east side would prove to be lower than those on the west side. This was found to be so, as mentioned above. The apparent factor of safety, using present design criteria, was calculated for each section on each date studied and was found to increase as the slope becomes flatter. These values are given in Figure 7. An increase in the apparent factor of safety as the failure progresses is, of course, to be expected, because the factor of safety is computed on the basis of the undisturbed design shear strength while the overturning forces diminish.

Cucaracha formation-excavation slope curves
