### SMALL HOUSE FOUNDATION DESIGN

J.E. JENNINGS, M.Sc., A.M.I.C.E.

This paper deals with the design of the foundations of small buildings and houses. A theoretical approach combined with a programme of practical observation work is outlined and records of movements experienced in certain buildings are also given.

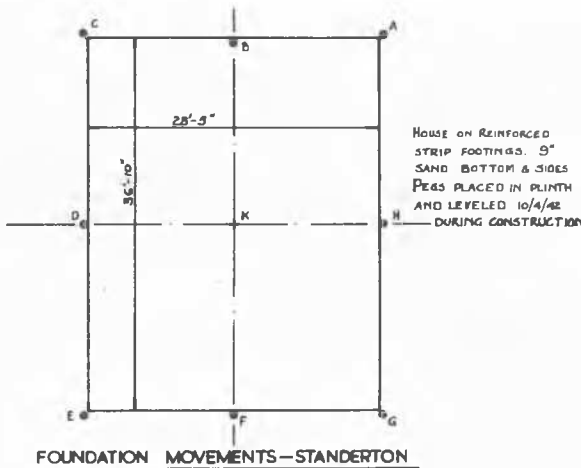
FIG. 1

FOUNDATION MOVEMENTS—STANDERTON

Pic. No.	Recorded Movement cm		
	20/8/42	17/7/46	17/9/47
A	+0.06	+4.16	+4.27
B	-0.25	+4.86	+5.00
C	-0.91	+5.85	+5.48
D	-0.08	+4.38	+4.64
E	+0.15	+3.91	+3.98
F	+0.58	+3.53	+3.73
G	+0.52	+2.67	+2.97
H	+0.27	+3.25	+3.41
K	+0.28	+4.04	+4.27

In the field, observations are proceeding on the settlements of approximately 15 small buildings erected on a variety of soils. Levels are being very carefully observed and as far as possible these are being tied into fixed bench marks on rock so that records of the absolute movements of structures can also be obtained. In the course of this work it has been disconcerting to note that some structures are showing rises instead of settlements and typical examples of two cases of this nature are given in Figures 1 and 2.

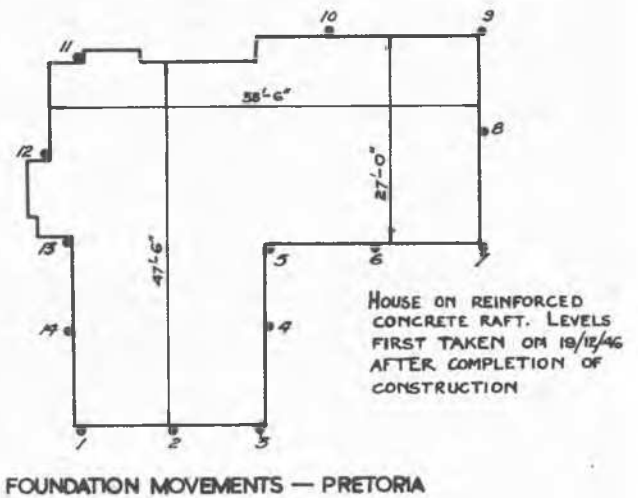
FIG.2

PEG No.	MOVEMENT TO 7/10/47
1	+0.21cm
2	+0.51 "
3	+0.76 "
4	+0.56 "
5	+0.36 "
6	+0.01 "
7	-0.02 "
8	-0.02 "
9	-0.13 "
10	-0.04 "
11	-0.29 "
12	-0.26 "
13	-0.10 "
14	+0.02 "
