UNDERPINNING AND UNDER-DRAINAGE TO CHECK EARTH SLIDING AND SETTLEMENTS

AT A LARGE CEMENT PLANT

Carlton S. PROCTOR

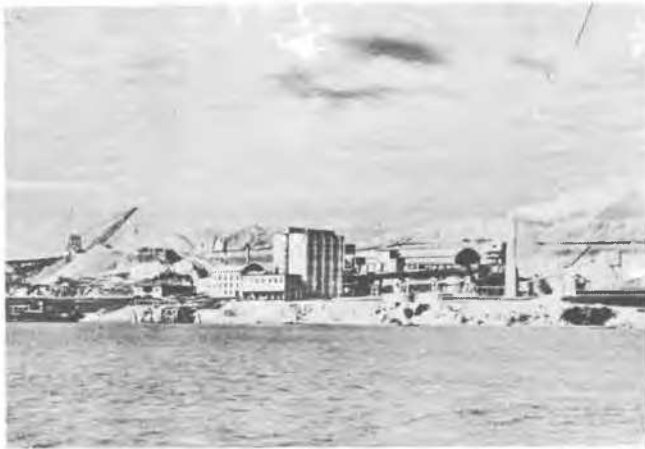
FIG.1

Fig. 1 is a general view of the plant.

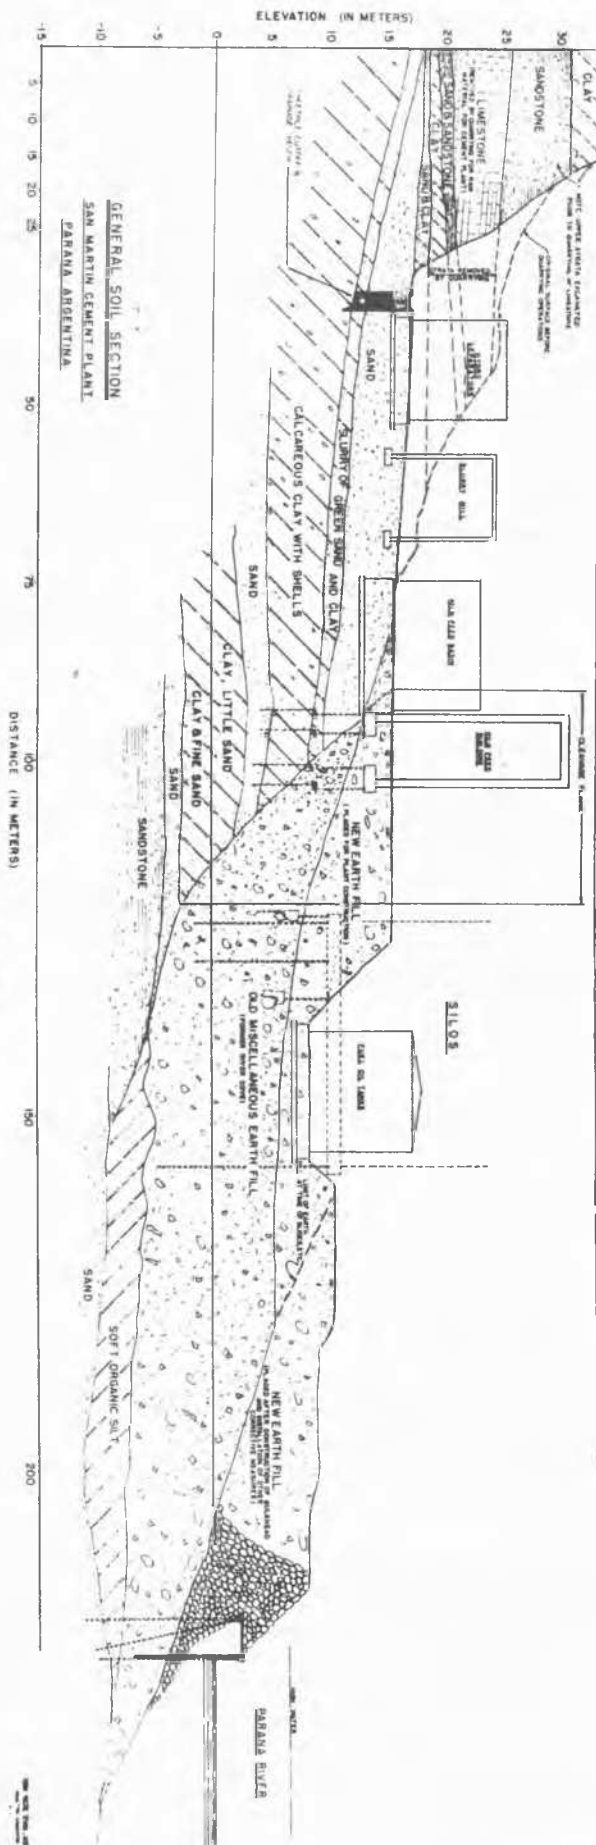
FIG. 3

Fig. 3 is a typical soil profile.

On Fig. 3 it will be noted that in situ the limestone and upper clay deposits overlie a bed of sand, which is in turn underlain by a thick bed of clay, the top surface of which dips sharply towards the river. Coincident with the start of boring operations and other preliminary construction work, the stripping of the overburden from the limestone was started and the limestone and its underlying clay deposit were quarried and stock piled.

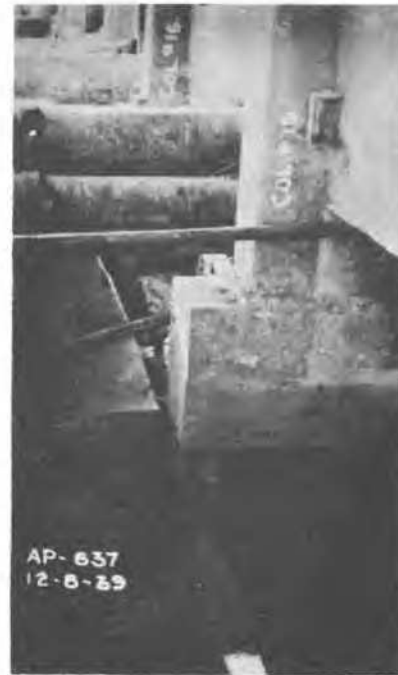
Excavation for power house underpinning.

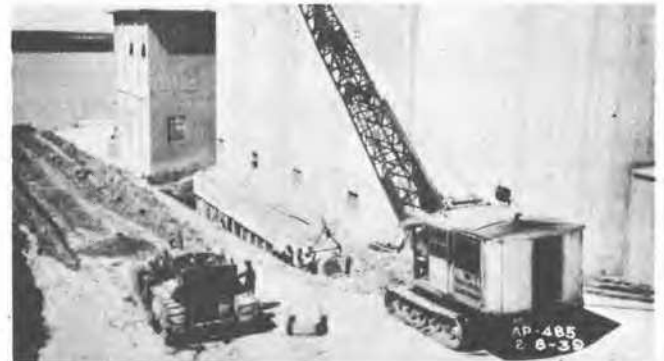
General view of excavation on west side for underpinning of silos.

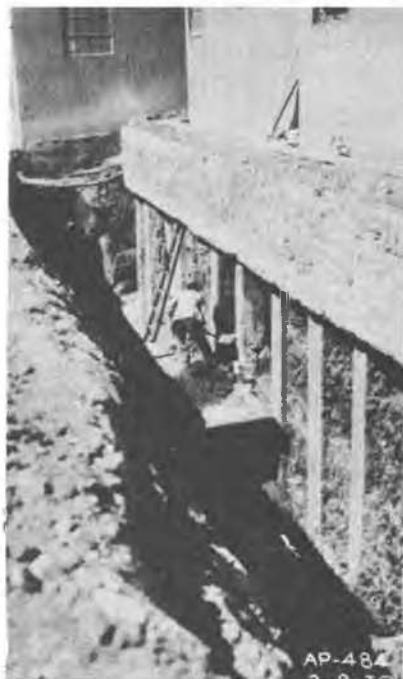
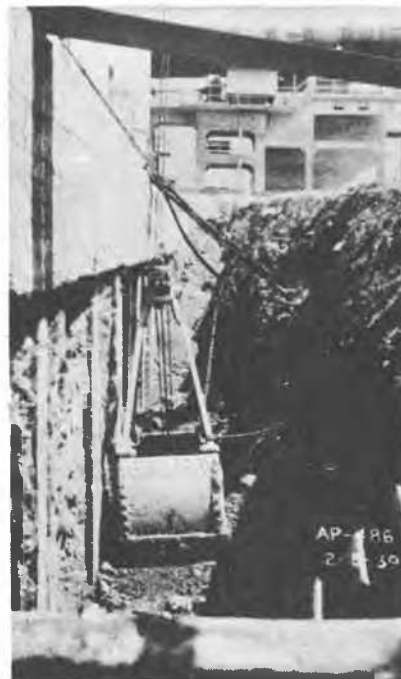
Excavation for underpinning of silos.

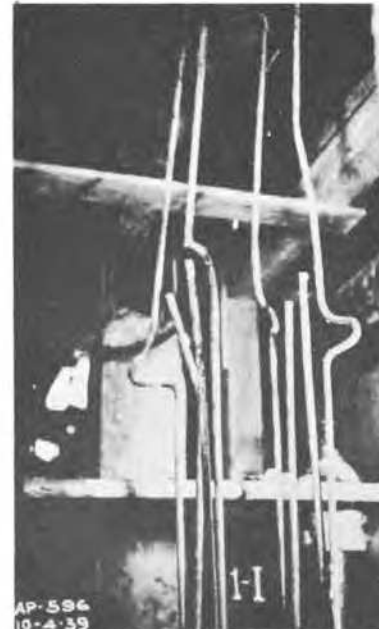
Vertical reinforcement 8 - 18 mm. bars except last 4 Ft. against slab which has 4 - 18 mm. bars.

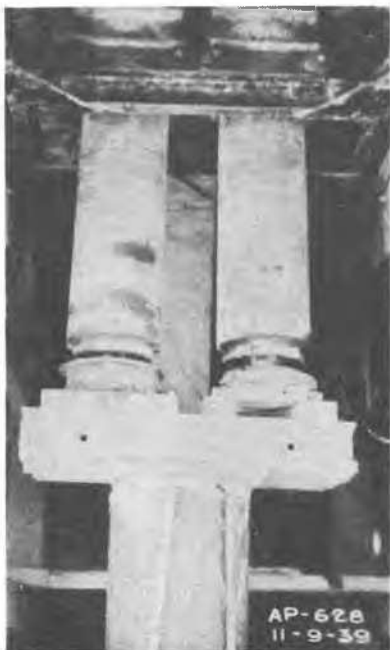
Two small jacks operating jointly.

ing above the cut. By the use of inverted 150 ton hydraulic jacks these piles were forced down until their tops were flush with the floor of the trench and each pile was then built up to the level of the underside of the jack (while the jack was in operation on other piles) and the jacking operation was repeated on the built up pile. By successive build-up and jacking, such piles were sunk to refusal in the compact sand beneath the river-bed silt.

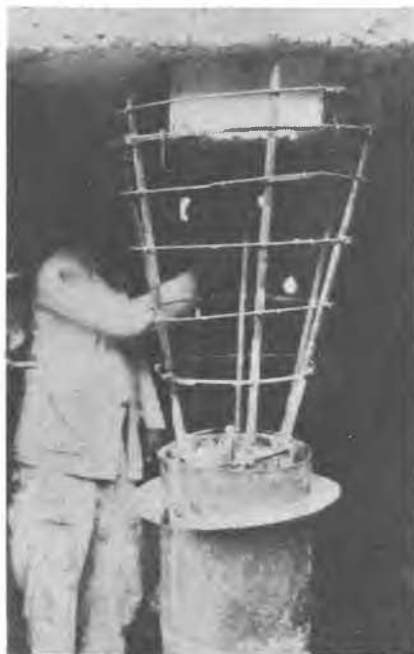
Typical bell reinforcing at top of jacked piles.

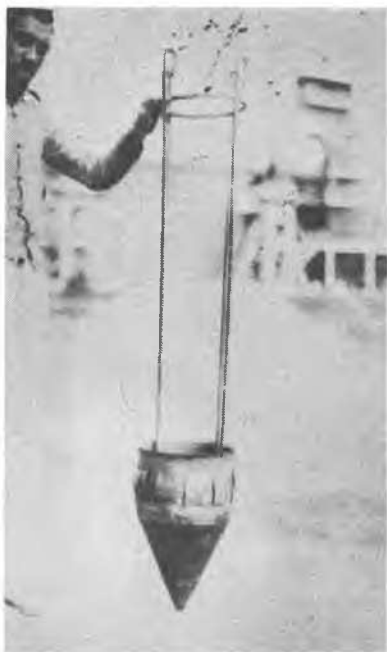
Showing a pipe point.

But the majority of the piles, particularly under the silo, had hit sandstone boulders during their installation and many of them had been destroyed as pile supports through over-driving. Many had not penetrated below the level to which excavation was carried for the underpinning operations and many were found to be badly shattered, split and twisted when exposed. Where such piles could be removed, open ended 12" diameter steel piles, sleeve connected, were jacked down to replace them, and where they could not be removed, steel-pipe piles were installed between the old piles. Originally it was intended to jack and blow out these steel piles, always leaving a small plug of soil in the bottom to prevent blow-ins until the desired level had been reached, after which the piles were to be concreted and then seated to refusal resistance under the jack. But the old fill with its large content of sandstone offered such high resistance to the jacking of steel pipe-piles that it was necessary to keep the piles blown out practically to their cutting edge level. Therefore when the pile points reached the water bearing silts and sandy silts, these materials blew up into the pipes. To avoid the serious hazard of such losses of soil under the loaded silos and power house, the pile jacking was held up when each pipe pile was still in the fill and when it had closely approached the top of the silt deposit. The pipe was then blown out below its cutting edge and a pointed steel shoe was lowered into the bottom of the pile and held in place by supporting wires. (See illustration of the pile point shoe) The pile was then concreted, and after the concrete filling had set up, jacking was continued

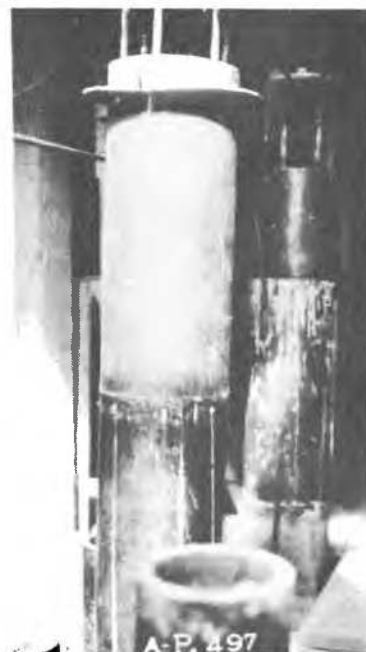
Steel forms in place for pile extension.

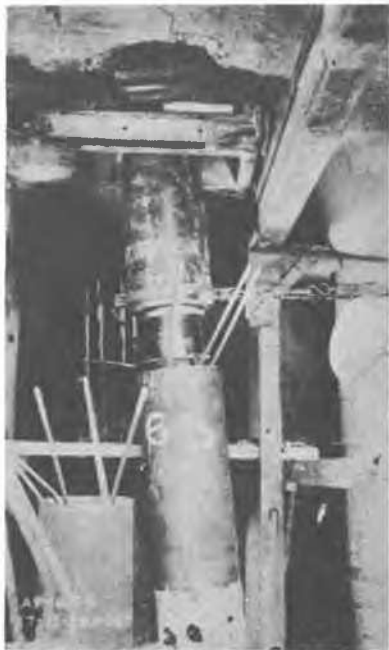
Large jack in inclined position over batter pile.

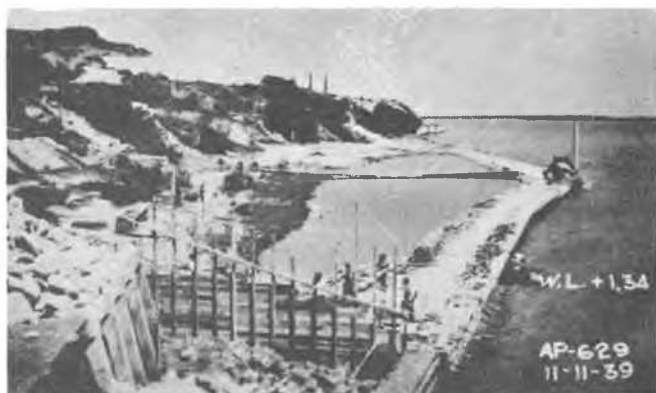
General view of Bulkhead extension also showing dumping of rip-rap on the outside of the Bulkhead.

A relieving platform type bulkhead along the shore property line permitted the placement of fill and roadway and acted as a final contribution to the stabilization of the plant area.

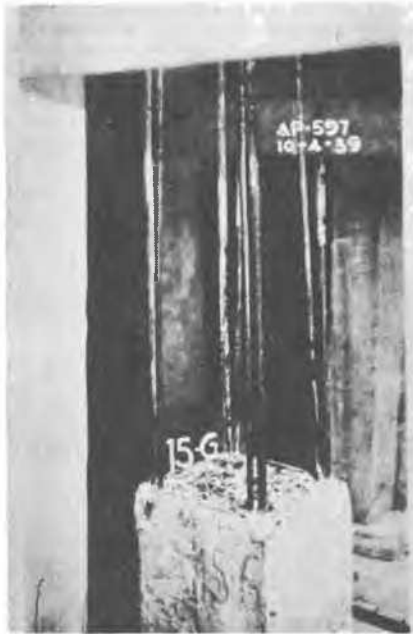
Vertical reinforcement 4 - 12 mm. and 4 - 18 mm. bars in piles 15-E,F and G. These piles were not broken.
