### FAILURE OF A BIG RETAINING WALL AT "WIENFLUSS" CREEK-SHORE IN VIENNA. VI

Dr. R.F. TILLMANN  
(Vienna, Austria)

#### INTRODUCTION.

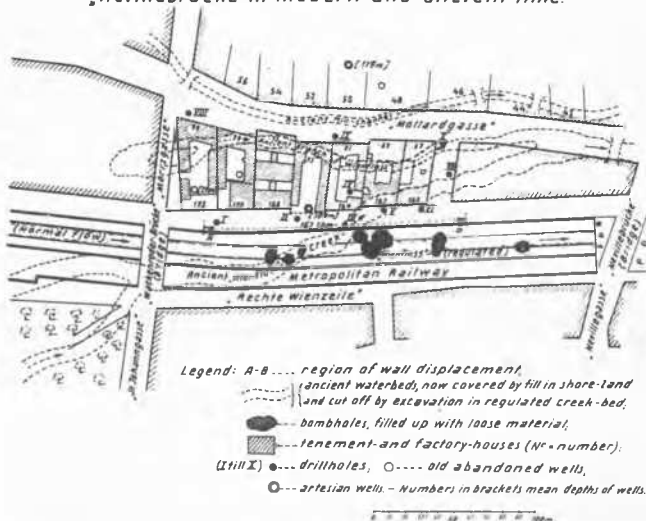
FIG.1

#### Situation

of „Linke Wienzeile“-street between „Wackerroderbrücke“ and „Nevillebrücke“ in modern and ancient time.

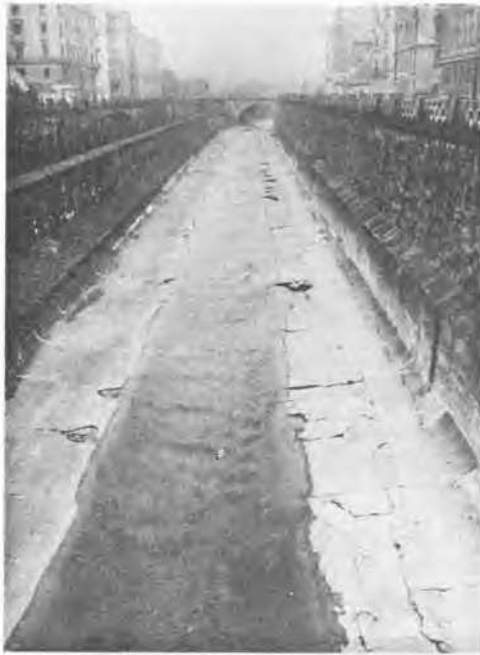
FIG.4

On April 23rd 1946 the above mentioned wall almost suddenly moved outside simultaneously tilting creek-ward. Dimensions of that retaining wall and the extent and manner of its displacement are to be seen in figure 3. The photos in figures 4 and 5 illustrate by view the immediate effects of that wall displacement. Figure 6 shows the steadily diminishing progress of wall movement after its first big step.

Downstream view of "Wienfluss"-creek, taken from "Wackenroderbrücke" in April 1946, immediately after displacement of left shore wall.

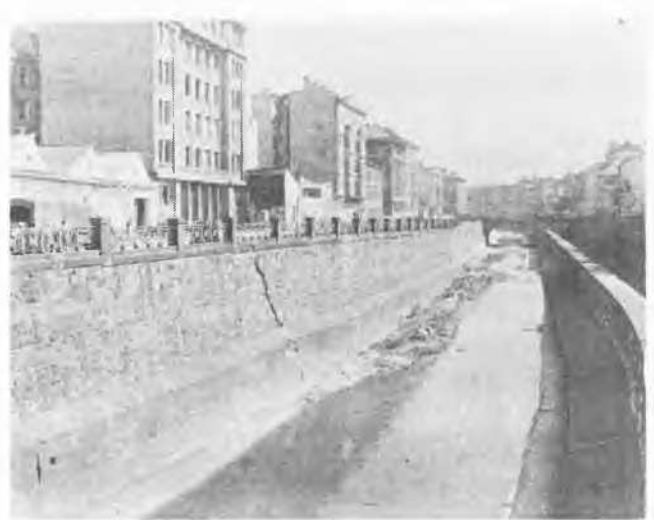
FIG.2

Upstream view of "Wienfluss"-creek, taken from "Nevillebrücke" in 1941.

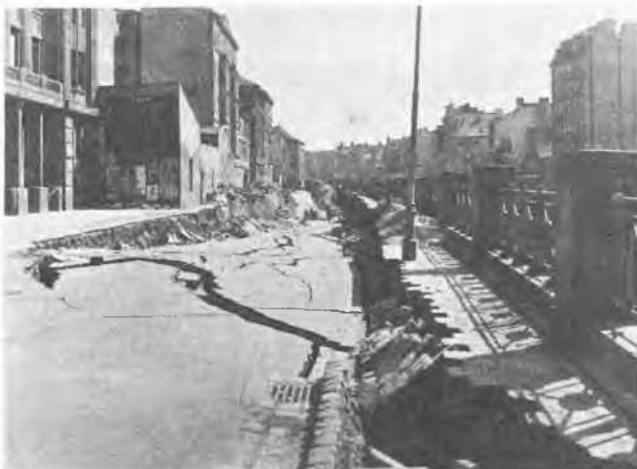
FIG.5

Downsettled "Linke Wientelle"-street on back of displaced creek wall. View downstream, taken in April 1946 immediately after wall displacement.

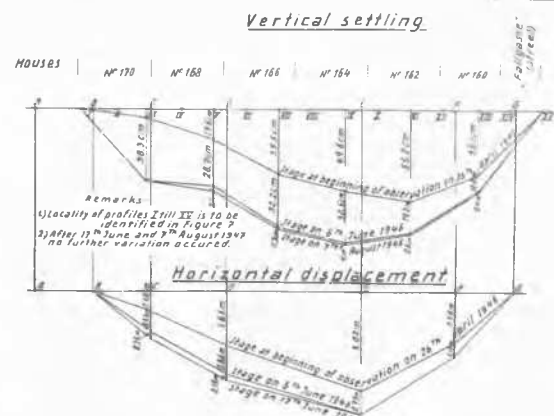
FIG.6

Measures of foundation movements of the displaced wall.

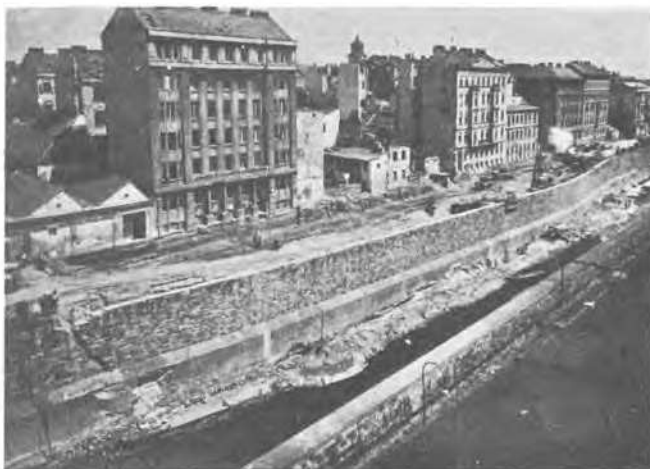
FIG.9

Outside front view of the displaced shore wall, taken downstream from a roof at right shore on 27th May 1946.

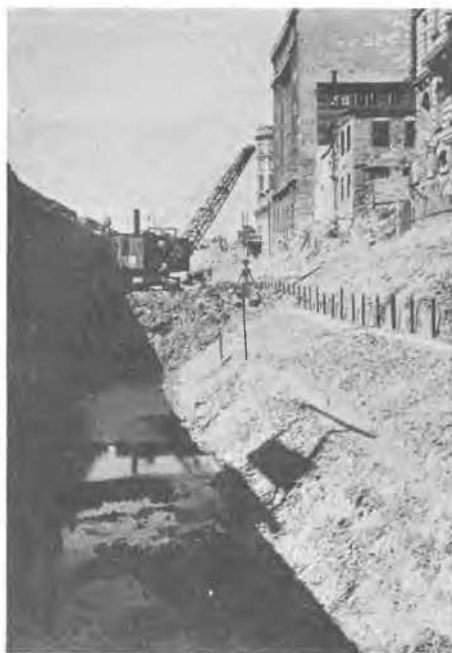
FIG.10

View of excavation behind the displaced wall, taken upstream from bottom of the trench on 3rd August 1946.

Vienna municipal building office (department on bridge building and reclamation service) immediately after that catastrophe started repairwork by engaging 3 Vienna constructors, head of them being "A. Porr A.G.". First all earth material resting on the wall back had to be removed in order to avoid further sliding of the retaining wall. A further progress of wall travelling would have been of disastrous consequences, i.e. breaking down of the damaged wall into the creek-bed, obstructing of the latter by concrete and masonry blocks and so provoking danger of inundation, interruption of municipal railway function etc. The photo in figure 9 shows the front of the deformed retaining wall and the creek-sole damages as evident during excavation work. The cut (see photo in figure 10) had an average slope ratio of about 1:2 and was secured against transversal outside movement by 3 rows of rammed steel piles (old railway rails) arranged in lines, about parallel to creek-axis. At the bottom of the cut is to be seen the level of water, seaped in part out from the slope, but to a greater extent from the creek-bed. That water has been removed by

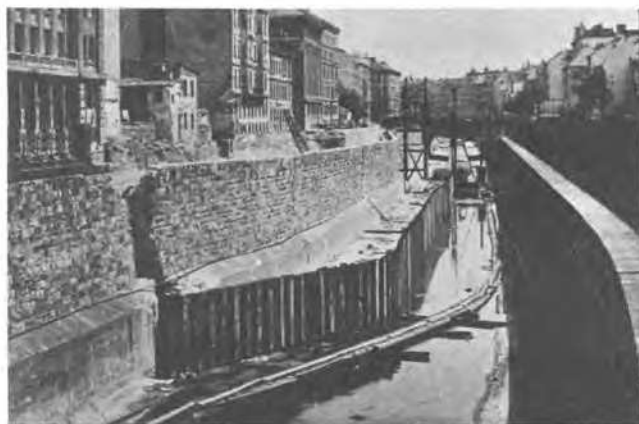
FIG.11

nearly continuous pumping. The output of the artesian well next house Nr. 166 is rather constant and amounts to about 1,2 liters per second. It has been conducted by gravity through a pipeline into the creek during repairwork of the wall. The area for that work had been closed up against the creek by means of sheetpiling (see photo in figure 11).

Downstream view of sheetpiling, taken on 3rd August 1946.

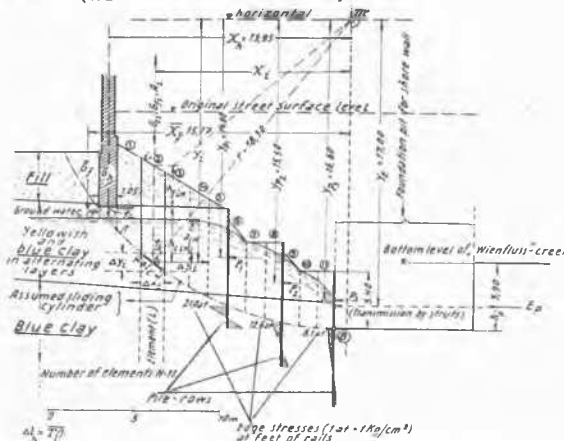
FIG.12

Safety ( $\gamma$ ) against sliding of the slope in the cut, a typical cross section of which is schematically designed in figure 12, was computed following the usual methods as described by general terms in the same figure. Sliding area has been assumed to be a circular cylinder-following the regula of Prof. Fellenius (Sweden) - with central point  $\pi$  and including the edges B and T. By substituting the characteristics of soil, as found by soil mechanical tests, and the dimensions to be taken from the cross section, the moments decident for stability resulted from the formulae (figure 12) as follows: (t m = tons x meter):

$$\gamma = \frac{4870,03}{1730,10} = 2,82 \text{ (average)}$$

$$\gamma_{\min} = \frac{2966,53}{1730,10} = 1,72 \text{ (minimum)}$$

That result seemed to have proved sufficient stability of the slope and security enough for the houses on its top. Notwithstanding that favourable prognose the aforementioned houses were thoroughly observed in the meantime during repairwork of the retaining wall was going on. Those houses had all been damaged by bombing more or less, and therefore all existant fissures and other injuries were conciously stated

Typical cross section of the cut behind the wall.  
(next the artesian well).

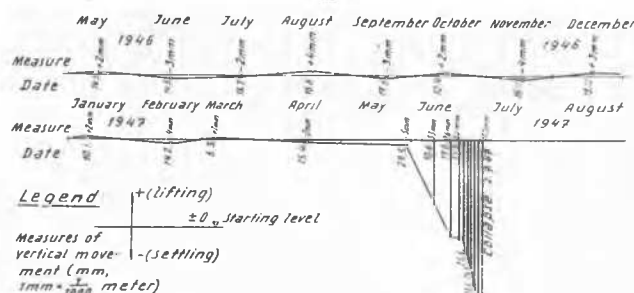
FIG.13

Observation of settling of house Nr 168 (front wall).

and noted before starting of wall repairwork and since continuously inspected. At the same time fix points of the houses were observed by levelling. Results of that inspection may be drawn from figure 13. It shows a nearly periodically varying vertical movement of the house Nr. 168 with amplitudes of 1 till 4 mm during about a year of observation. These movements were evidently concordant with variations of meteorological conditions. No tendency of monotonous settling of that house in eventual consequence of disturbances of stability could

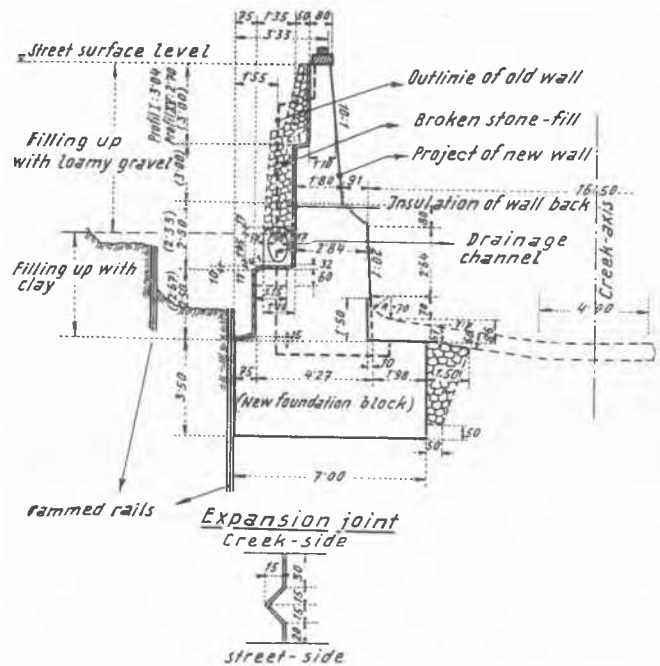
FIG.14

### Typical cross-section of former and of reconstructed wall.

Reconstruction of the retaining wall was first intended to be performed by sectional underpinning, rolling back and adjusting the displaced wall by means of steel roll sets, to be inserted, and connecting the old replaced masonry with the new basement, in order to save material, time and money. By lack of labourers and timber, as well as by frequent outfall of electric current progress of work was considerably reduced with respect to the original program. So winter calamities intervened and effected a further detainment of work, at the same time damaging the clay ground and the old concrete masonry of the displaced wall by frost. Clay walls in pits, excavated under some parts of the old retaining wall in order to underpin it, began to break out locally, a huge block of frozen concrete fell down, etc. Under such conditions the first program had to be abandoned with respect to dangers in connection with it and to the high cost to spend, if it should be fulfilled in safety. In spring 1947 therefore a new rebuilding plan was decided for further realisation. That project conceives the erection of a completely new concrete shore-wall after having demolished the old one. Sole level and size of foundation block hereby in the same as in the first plan. (See figure 14). An advanced stage of demolition of the old wall and construction of the new concrete-foundation is shown by the photo in figure 15. One may easily recognise in that picture individual concrete blocks arranged between the creekward raft foundation of the wall and the retaining construction at the foot of cut-slope, in order to sustain the latter construction.

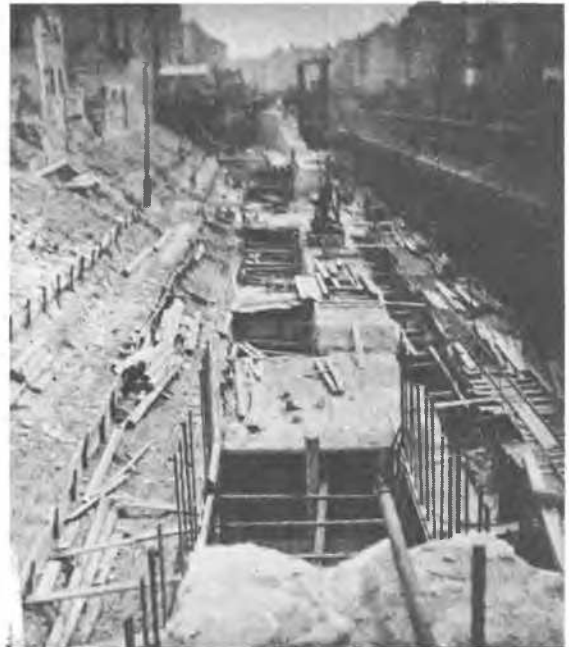
FIG.15

Downstream view of stage of repairwork on 2 nd July 1947.

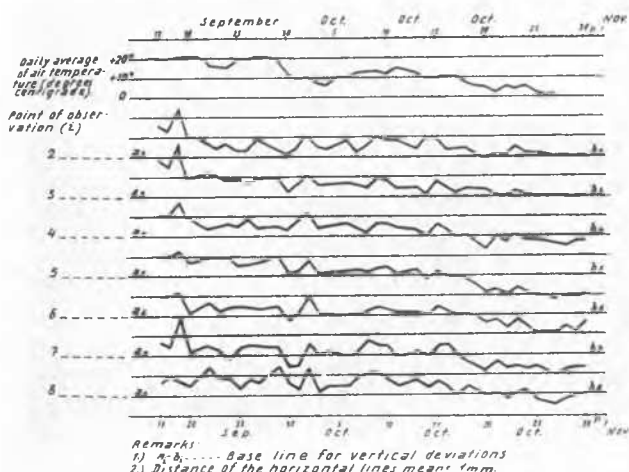
FIG.20

Vertical movement of houses Nr. 162 and 160 from middle of September to beginning of November 1947, as compared with variation of air temperature.

After collapse of the houses Nr. 166 and 168 the behaviour of still standing houses nr. 162 and 160 has been observed with extraordinary care. The results of precise levelling of fix points on front walls of these houses (see figure 20) show distinctly a perfect stability of the flats and a rather synchronous character

of their little vertical movements with variations of air temperature.
