A STUDY OF RETAINING WALL FAILURES

RALPH B. PECK

SUMMARY

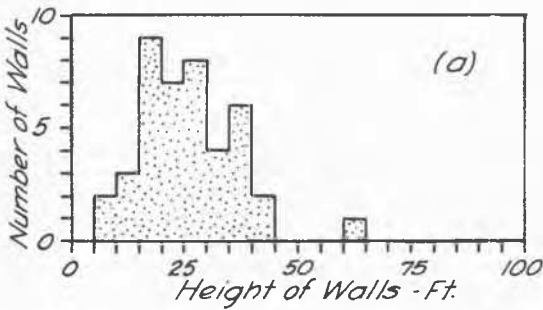
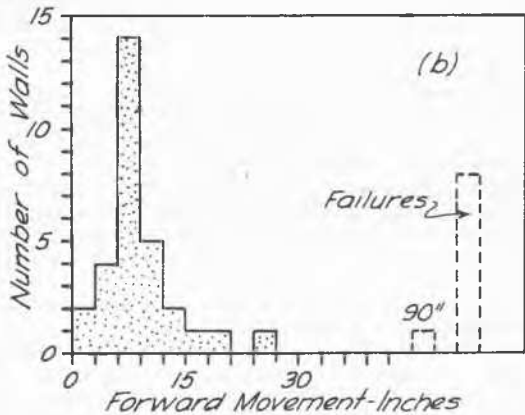
FIG.2

The unsatisfactory walls and abutments are classified in Figure 2a according to their height. In Figure 2b they are classified in

accordance with the magnitude of the movement they experienced. The majority experienced forward movements of 6 to 12 inches. This is probably an indication that movements less than 6 inches are commonly not a matter of concern and it suggests that movements smaller than about 3 inches are usually considered quite normal and satisfactory.

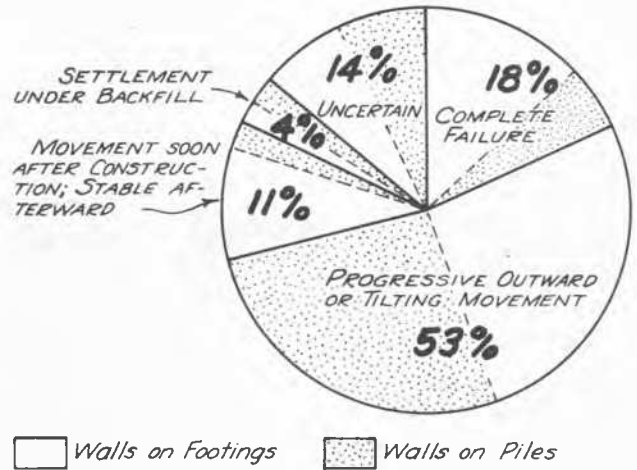
FIG.3

In Figure 3, the walls are classified in accordance with the type of movement that they experienced. It may be observed that about 18% failed completely. That is, they either overturned, broke structurally, or were considered in such imminent danger of collapse that they had to be strengthened or removed and replaced. Over half of the walls experienced a progressive outward or tilting movement.

Figure 3 also indicates that almost half of the unsatisfactory walls were supported on piles. This fact suggests that there was general recognition of unsatisfactory foundation conditions and that an attempt to improve the foundations was made by providing pile support. Nevertheless, it does not appear that the mere use of piles, even including batter piles, was sufficient to prevent excessive movement of the walls.

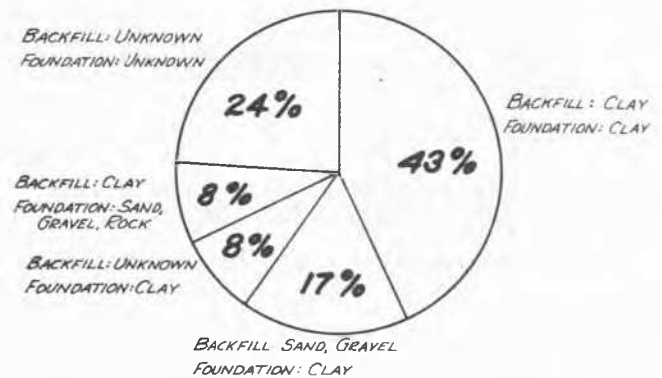
FIG.4

Figure 4 shows the foundation and backfill materials associated with those walls that experienced progressive outward or tilting movements. It may be observed that in every reported example of progressive movement where there

was sufficient information to classify the soils, clay occurred in the foundation or in the backfill, and in most instances occurred in both. This suggests that present design procedures and those that have been used in the past must be quite conservative when foundation conditions are good and when the backfill consists of sand or gravel. On the other hand, it also suggests that the factor of safety of walls founded on clay or backfilled with clay is probably on the average much lower than believed by the designers.

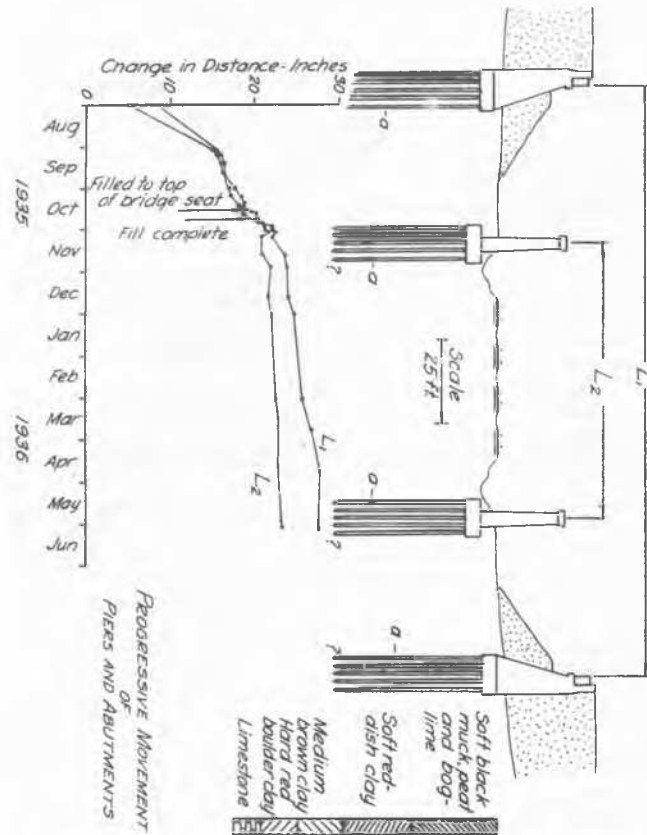
Progressive movement of piers and abutments
FIG. 6

Figure 6 shows the pertinent data concerning a typical example of progressive forward movement of large magnitude. The piles may have penetrated the soft material and rested on the medium clay at a depth of 40 ft, but the records indicate that more likely they terminated near the points marked *a*, within the soft clay deposit.

The two abutments and two intermediate piers for the bridge were completed and backfilling was in progress when movements of all four elements of the substructure were observed. Measurements were made with the results indicated on Figure 6. It may be noted that the distance *L*₂ between the intermediate piers decreased almost as much as the distance *L*₁ between abutments. This means that the movement was deep-seated and involved the lateral squeeze or flow of clay toward the center of the bridge from each end. Such a movement could hardly be caused other than by overloading the clay stratum by the weight of the backfill.

Under the weight of the fill, the bearing capacity of the soft reddish clay and overlying material was probably approached and a slow lateral flow or creep was initiated by the excessive shearing forces. The lateral pressure against the abutment was probably not excessive because the abutments were of the open type and the fill was allowed to extend through them.

This example demonstrates that the lateral forces acting against a vertical section through an abutment supporting a high fill may be very great, considerably greater than the forces due to the active earth pressure against the abutment itself. This fact was demonstrated clearly by the behavior of a structure built during the war to store iron ore. The structure consisted of two parallel retaining walls about 30 ft high and 275 ft apart. The walls were tied to each other by a series of steel rods located just below the ground surface. A deep deposit of medium clay was located beneath the structure. The behavior of the walls was observed by means of strain observations on the tie rods. At the yield point of the rods, their capacity to resist the horizontal forces against the retaining walls was 70,000 pounds per lineal foot of wall. When the iron ore was piled to a height of 22 ft, the rods reached their yield point strain. Yet, according to any rational method of computation, the active earth pressure of the ore against the walls could not have exceeded about 16,000 pounds per lineal foot. Therefore, the actual horizontal forces exerted against the walls and their foundations were over four times the computed earth pressures. Independent observations demonstrated that the ultimate bearing capacity of the clay beneath the storage yard was 2.6 tons per sq ft whereas the weight of 22 ft of ore was 1.8 tons per sq ft. Therefore, the factor of safety against a bearing capacity failure was only about 1.4. At such a low factor of safety, excessive and continuous horizontal deformations in the subsoil are to be expected.

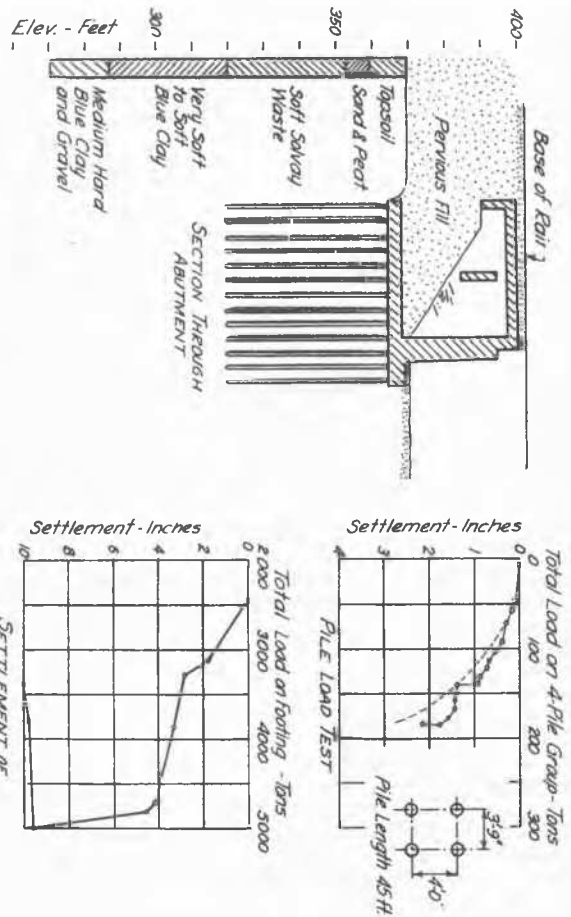
Failure of abutment due to exceeding bearing capacity of subsoil
FIG. 5

The first example is illustrated in Figure 5 which shows the pertinent data concerning one of a pair of open abutments constructed for a grade separation. It was recognized that the foundation for the abutments would require pile support and the structure was founded upon cast-in-place concrete piles having an embedment of 45 ft. One group of four of these piles was tested with the results shown in the figure. On the basis of the test, it appears that the average shearing resistance of the soil was approximately 0.17 ton per sq ft.

To lighten the load on the abutments as much as possible and at the same time to reduce the active earth pressure of the railroad embankment, the abutments were made hollow and it was specified that the fill should slope downward toward the toe. In spite of these precautions, each abutment began to settle during construction and when the total dead load reached 5000 tons each abutment began to tilt toward the fill and to sink into the ground. At this stage the average settlement increased very rapidly from 4 inches to almost 10

inches, whereupon the fill was removed and the design altered in such a way that no fill rested upon the bases of the abutments when the bridge was completed.

On the assumption that the average shearing resistance of the soft subsoil was 0.17 ton per sq ft, the total ultimate bearing capacity of the base of the abutment should have been approximately 5300 tons. This value is in reasonable agreement with the observed load at failure. Hence, it appears quite obvious that the failure of the abutment was caused by overloading the subsoil and that it had little if any relation to the active earth pressure against the abutment.
