HORIZONTAL PRESSURES ON PILE FOUNDATIONS

C. FRANK Ass. City Engineer Rotterdam

G.C. BOONSTRA Engineer Dept. of Highways and Bridges. (Netherlands).

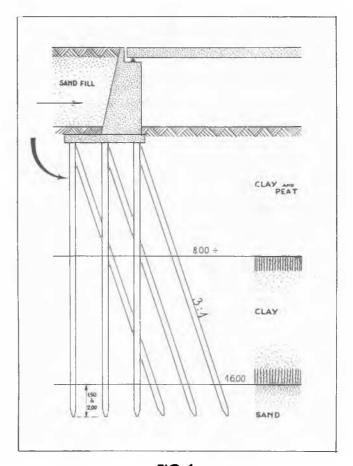
FIG. 1

This fill increases the water-pressure in the clay and peat layers and may result in substantial horizontal pressure on the abutments of bridges and their foundations (fig. 1).

It was been noticed that this pressure sometimes led to slight horizontal movements in the clay and peat layers, resulting in deflection and even breakage of the piles.

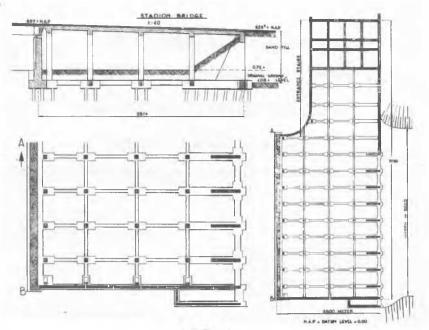
FIG. 2

1. Bridge over the marshalling yard near the "Stadion" in Rotterdam (fig. 2).

The abutments consist of a reinforced concrete structure, 29 x 77 m. The latter dimension perpendicular to the axis of the bridge, included the wide stairs leading to the sports ground (fig. 2). The fill consisted of sand and earth and to a minimum level of 7 m above ground. The entire abutment moved a few cm, point A 3 cm and B 13 cm.

To reduce the horizontal earth pressure, no end wall was erected, the piles consequently being especially affected by this pressure. The piles were reinforced concrete with a cross section of 0.40x0.40m.No vertical movement could be recorded. Water pressure cells indicated a considerable increase in water pressure, which could not be reduced by sand cores. When the earth fill was replaced by coarse debris, with an average weight of 1 ton per mo, the movement stopped.

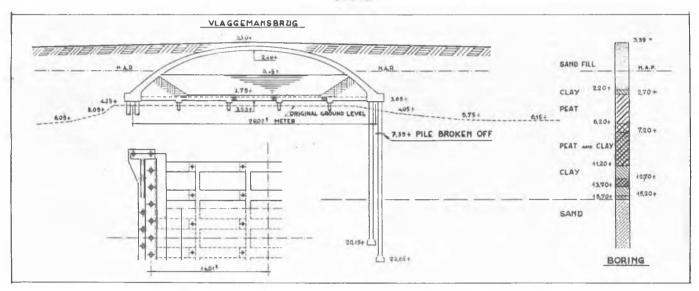
FIG. 3

2. The Vlaggemansbrug over the Noorderkanaal, Rotterdam (fig. 3).
This is an archbridge with reinforced con-

crete ties. No abutments were necessary. In 1926 the site was filled in with sand up to El. + 0.35 m. In 1936 the foundation pit was excavated and after the piles were rammed in, the concrete arch constructed and filled in with sand up to El. + 3.39 m. Finally the tierods were concreted. No movement of the soil was observed during erection. After water had been admitted to the canal a counter pressure developed, which. in the opinion of the authors, would eliminate all danger of soil movement.

During the winter of 1938/1939 however, it proved that the piles on one side of the bridge were snapped off at El. - 7.35 m caus-

ing a settlement of more than 0.30 m. A steel tube, 0,60 m in diameter, with holes closing like a sliding sash, was used for examination. This tube was sunk into the earth behind a pile; a sliding sash was opened and a hole was dug out through the peat and clay layers in horizontal direction, as far as the pile. A photograph of the fracture was taken

An analysis made by the Laboratory for Soil Mechanics at Delft showed that the cause of this accident could be attributed to the increased water pressure, whereby the soft layers had suffered a horizontal plastic movement, finally leading to breakage of the piles.1). The deep sand layer and the sand fill were not affected by this horizontal movement, but only the peat and clay layers in between. The extent of this movement depended on the shearing resistance of this type of soil and on the horizontal pressure, caused by the difference in level between the fill and the bottom of

the canal. There was no loss of equilibrium in this case. As the bottom of the canal did not rise the soil must have been compressed horizontally. This phenomenon might be called horizontal settlement.

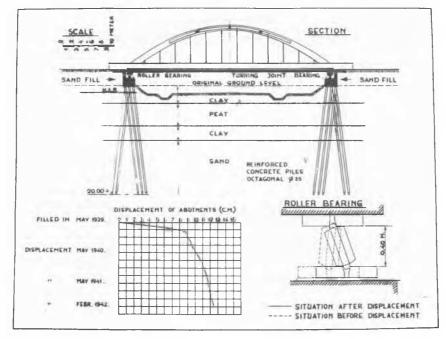
FIG. 5

3. Highway viaduct at Sliedrecht (fig. 5).

From the date of filling (May 1939) until the beginning of 1947 the distance between the abutments decreased about 14 cm.

At the beginning of 1947 the roller bearings (fig. 5) were readjusted in order to prevent tilting over.

From May 1939 up to February 1942 records of the horizontal movement were made (fig. 5). Due to the war this could not be continued, but during the period from Febr. 1942 up to the beginning of 1947 this movement is believed not to have been more than 2 cm.

during the first 3 or 4 months was substantial (about 9 cm). Afterwards it gradually decreas-

Investigations made by the Laboratory for Soil Mechanics at Delft proved that the water pressure under the fill surpassed that in the layers under the midspan of the structure. The displacements were attributed hereto.

be followed for special reasons.
In Holland the abutments of bridges show a tendency to horizontal movement even in cases of soil improvement. On designing this fact must be taken into account. Movable bearing allow some displacement of the abutment. B tween abutment and bridge deck an expansion joint should be applied, allowing a displacement of the abutment to a large extent.

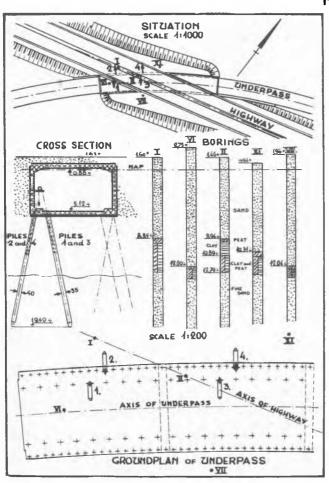
FIG. 6

4. Underpass in the highway Utrecht-the Hague

The cross section of this underpass shows a rigid concrete structure. The method of soil improvement has been carried out here. However, the possibility that the deep layers of clay and peat would affect the concrete piles horizontally still existed. It was then decided to examine the behaviour of these piles with regard to bending. A measuring device was design ed in collaboration with the Laboratory for Soil Mechanics at Delft. For this purpose a steel tube was cast in in the core of the test piles and a steel wire fixed at the bottom of the hole in the centre of the pile. At the upper end the steel tube was closed with a plug with a centre hole. The steel wire passed through this hole and was stretched by means of a pul-

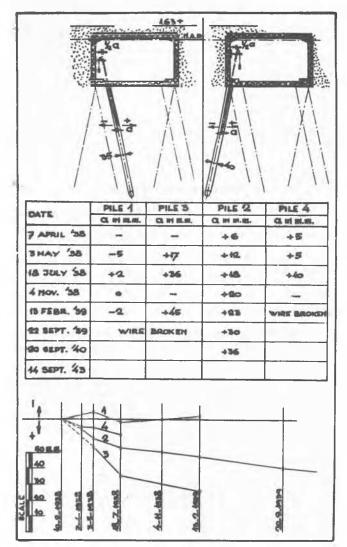
FIG. 7

ley and counter weight. The pulley was movable, see the particulars of fig. 7.

fig.7. Unfortunately the wires of piles 1, 3 and 4 broke after some time. Only the test on pile 2 could be continued for a longer period. A deflection in the direction of the soil and water pressure is indicated with + ; a deflec-

During the first 4 or 5 months pile 2 was subject to important bending forces due to the horizontal soil and water pressure on the pile, fig. 7. Thereafter the bending did not increase were much crease very much.

With reference to the inward inclination of batter pile 3 it was expected that the weight of the overlaying sand fill would cause this pile to bend in the negative direction. The diagram however shows a deflection in the positive direction, due to a considerable in-

Although the figures show some discrepan-it is clearly shown that piles in this position are subjected to considerable deflection and that an additional dead load may finally lead to breakage.
