LLOYD F. RADER

Unique construction methods were employed in constructing a wood pile foundations in rehabilitation of steel girder type wharf on the Mississippi River at the U.S. Naval Station, New Orleans, Louisiana, during World War II. New wood piles were driven by a pile-driving rig which was supported on the existing steel girders, and concrete caps were constructed on the tops of the wood piles to provide adequate support under the old steel girders. The methods employed made it possible to utilize the existing steel girders and beams of the wharf and to place the wharf in operating condition to meet a time deadline.

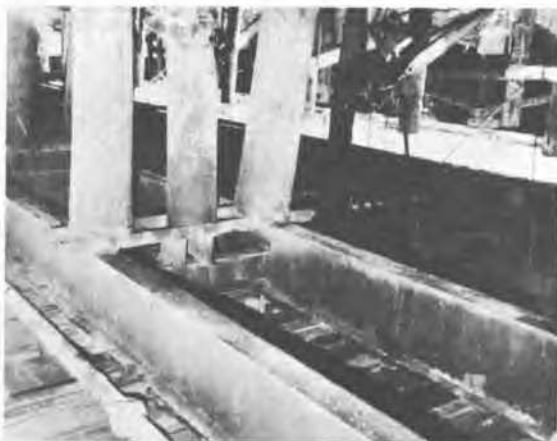
FIG. 1

The condition of the wharf in September 1941 is shown in Fig. 1. Many of the piles had rotted and all were in a deteriorated and unsafe condition. The picture also shows that the steel girders and cross-beams were corroded, particularly on the flanges. A detailed examination showed, however, that the badly corroded flange sections could be sufficiently strengthened by welding on new steel sections to salvage the steel members. The rust on other portions of the girders and beams was not serious, and practically all rivets and connections were sound. The timber decking and railroad ties were in poor condition and required replacements.

Condition of old wharf in September 1941.

The supply of steel beams of the sizes required was critical, and a considerable period of time would be required to procure new steel members. Time was of importance and would not permit any delay in getting this wharf in operating condition. It was, therefore, not feasible to consider the purchase of new structural steel beams and girders. The choice lay then between rehabilitating the old steel girder and beam wharf, or building an entirely new wharf with all timber members. The first method, salvaging the old steel girders and beams, was considered preferable in that it would provide a superior structure and would conserve heavy timber members which were very much in demand for other construction. This decision was based on the premise, however, that the existing steel girders and beams could be kept assembled in place and intact; it was recognized that it would be a difficult and time-consuming operation to disassemble and reassemble the steel structure. A method of driving wood piles under the steel girders had to be devised. It was not feasible to employ a pile-driving rig mounted on a barge floating in the river owing to the width of the wharf and the fact that the wharf was located at the edge of the river.

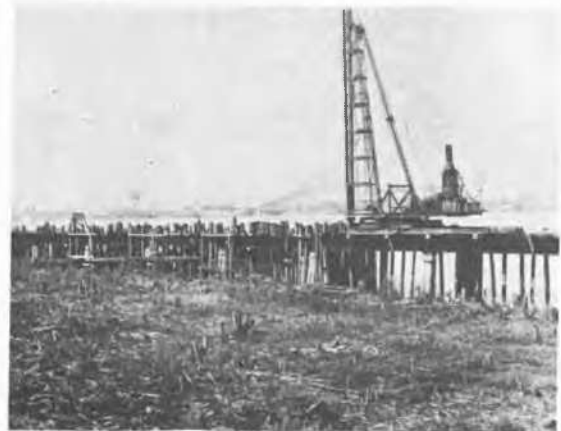
FIG. 2

Fig. 2 illustrates the method which was employed of carrying the piledriving rig on the top of the steel girder and beam frame after the old timber decking had been removed. The rig is of skid type and has a No. 1 Vulcan 5,000 pound single-acting steam hammer. At the left is shown the new piling which was driven. These piles were later cut off to a level below the bottom of the steel girders. The problem of providing proper support from the tops of the wood piles to the underneath side of the steel girders was solved by building concrete caps on the tops of the pile clusters as shown in Fig. 3.

Pile driving rig No. 1 Vulcan 5,000-pound single-acting steam hammer on top of old steel girder frame.

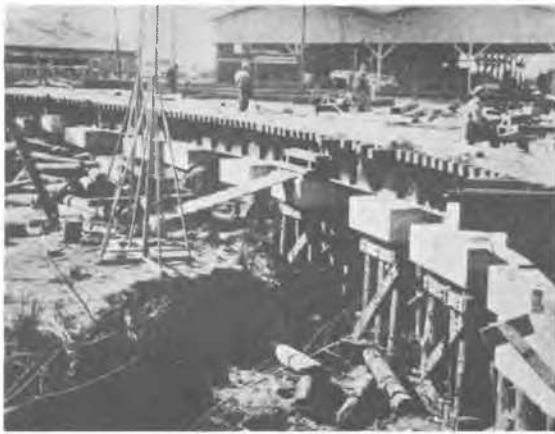
FIG. 3

Curved approach to wharf showing concrete caps on pile clusters.

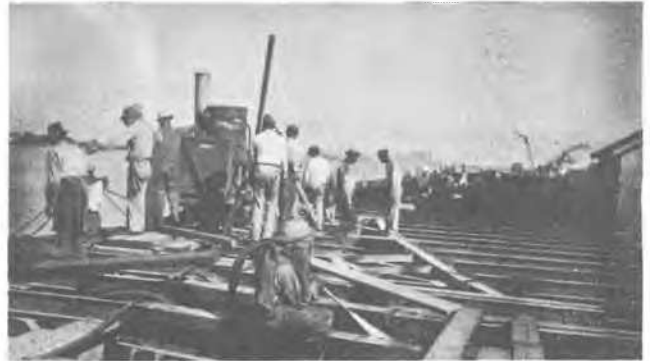
FIG. 5

Sand blasting, cleaning, and painting steel beams on wharf.

Sand blasting, cleaning, and painting of the structural steel members after the removal of the old timber decking is illustrated by Fig. 5. An air compressor for the sand blast is shown at the left. Bad sections (particularly on the flanges) were burned out by torch and new sections welded in place to reinforce the beams. There was a buffer, consisting of timber stringers and steel springs, along the river side of the wharf to cushion blows from ships. At the left in Fig. 5, men are seen in the work of disassembling this buffer. The springs were removed, cleaned, painted, and then reassembled in place. The footing for the workmen was bad because of the removal of the decking, but fortunately, no men fell through a great deal of the work was done at night.

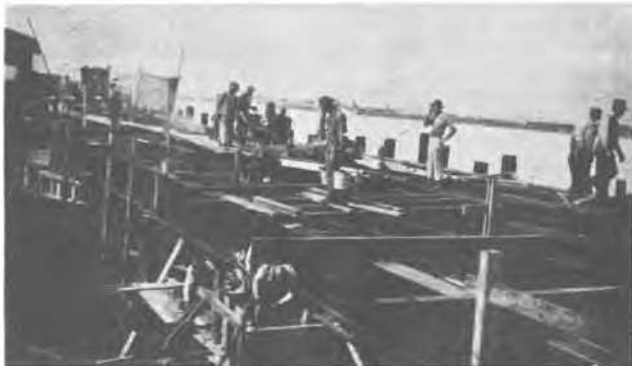
FIG. 4

Fig. 4 shows the building of forms on the tops of pile clusters for the construction of the concrete caps. By vibrating the concrete, honeycombing of the concrete was avoided. Shims were placed under the girders on top of

Building forms for concrete caps for wharf.

the concrete caps to take up the load evenly and bring the girders to correct elevation. The pile clusters were braced. Old wood piles were then removed.

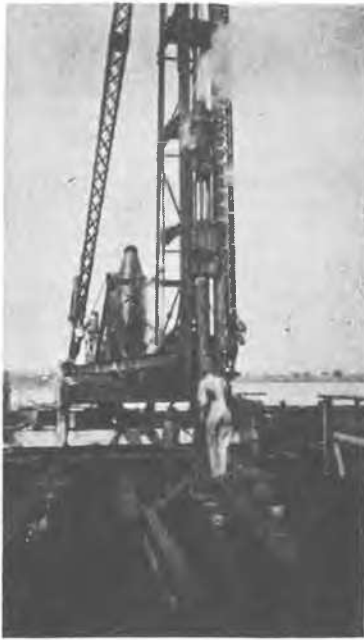
FIG. 7

different piles. It was found necessary to jet most of the piles while they were being driven in order to get them down. The jetting apparatus may be seen in Fig. 2. Fig. 7 gives a close-up view of the pile driving operations. The inspector counted the total number of blows required to drive the pile. The penetration under the last blow was determined. This was taken as the average penetration under the last ten blows of the hammer. In calculating the safe bearing capacity, the U.S. Navy use the

Pile driving operations on wharf.

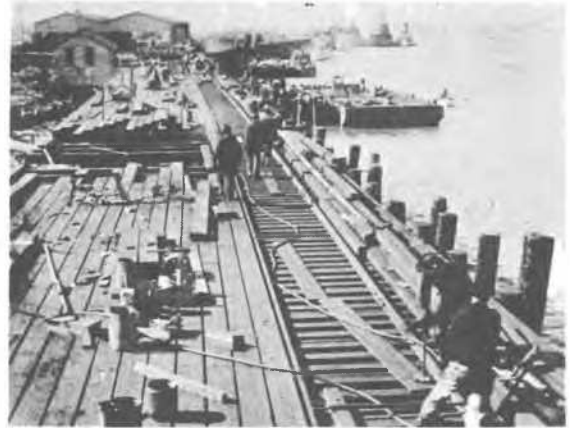
FIG. 9

Facing west - construction of timber decking and railroad track.

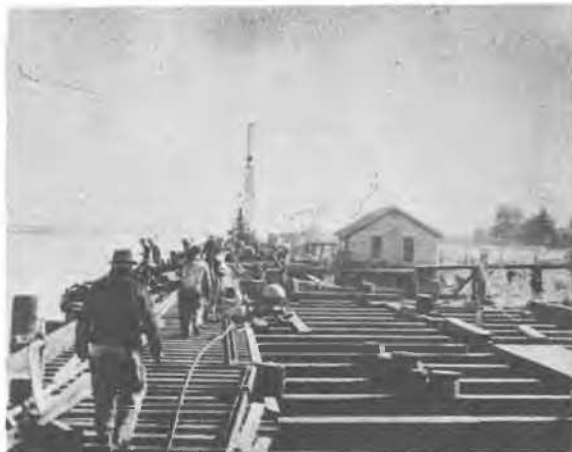
FIG. 8

Looking east - wharf reconstruction - laying railroad rails.

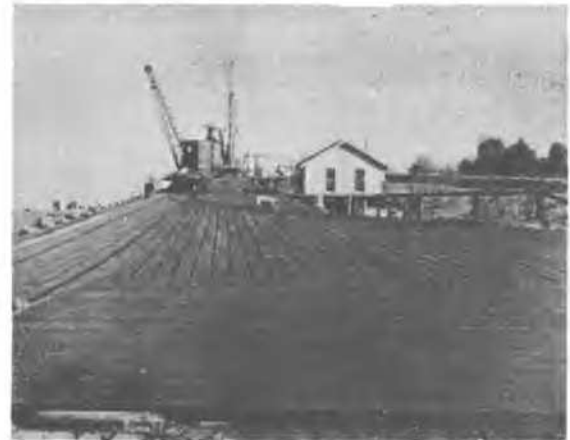
FIG. 10

Reconstructed wharf showing locomotive crane and Mississippi River levee.

The work was done under pressure. The contractor's men worked day and night, Sundays and holidays, to complete this wharf early in 1942 as shown in Fig. 10. (The river levee may be seen at the right). A supply depot, ship repair base, and barracks were also built so that ships coming to the wharf at the Naval Station could be outfitted with equipment and supplies, repaired, and manned to go to sea to combat enemy submarines as well as to join the fleets of the U.S. Navy in the Atlantic and Pacific Oceans. The methods used in rehabilitation of the wharf made it possible to have the wharf ready in the hour of need.
