# DKSField investigation of liquefaction-induced damage due to the 2016 Meinong earthquake in the Shi-Din area of Taiwan

**ABSTRACT:** The M 6.4 Meinong earthquake occurred at 3:57:27 a.m. local time on 6 February 2016 in Taiwan (19:57:27 on 5 February 2016 UTC). The earthquake, which took place just before New Year's Eve celebrations for the Lunar Year of the Monkey, killed at least 117 people. Liquefaction damage due to the earthquake occurred in the Shi-Din area in the Annan District of Tainan City. Damage observed in the area includes excessive soil boiling, lateral spreading of a sloped road, and tilting and settling of houses with shallow foundations. Soil profile in this zone is: the first 9m beneath the ground surface is consisted of loose sandy soils and silts with low SPT- N value, and followed by soft clayey soils and stiffer sandy layer to 20m depth. After the earthquake, houses built in continuous shallow foundation were found to experience maximum settlement 15 cm which is less than the ones built in individual shallow foundation experiencing the maximum settlement 120 cm and significant tilt. The main purpose of this paper is to document and analyze geotechnical pro

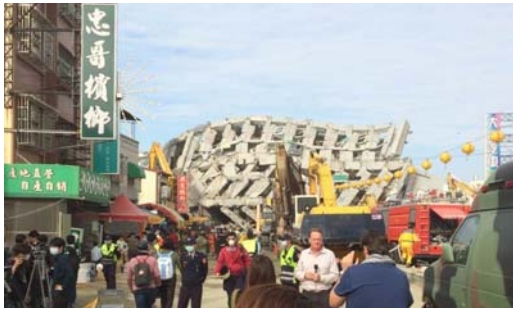
The magnitude 6.4 Meinong earthquake rattled Taiwan at 3:57:27 a.m. on 6 February 2016 (19:57:27 on 5 February 2016 UTC), one day before Chinese New Year's Eve. 116 people died in the structural collapse of a 16-floor building (Figure 1) in the worst-hit area of Tainan city. In particular, the coastal area of Shi-Din (meaning the top of the stream in Chinese) in Tainan consists mostly of soft soils that presented the most numerous geotechnical problems as a result of this earthquake. Observed effects in the area, where more than 300 houses locate in, include sand boils, settlement and tilting of buildings with shallow foundations, lateral spreading, and damage to diaphragm walls in buildings.

Figure 1. The severest damaged spot in 2016 Meinong earthquake. 116 deaths are reported in this collapsed 16th floor building due to structure damage.

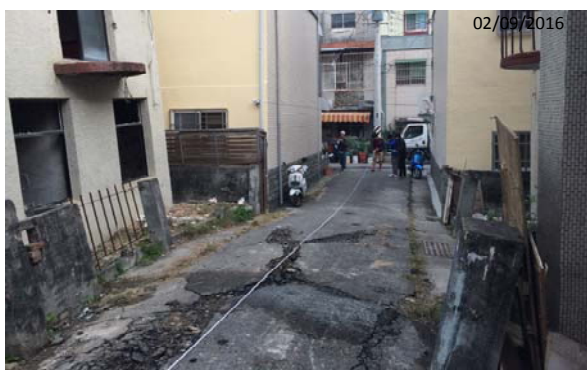
Locality No. 1: Lateral flow of liquefied soils on a sloping layer. A 15 cm elevation difference from south to the north at locality No. 1 is the result of lateral ground movement beneath liquefied soils (Figure 3). The horizontal movement is measured to be 12.5 cm with a vertical settlement of 3-5 cm at the top. The maximum heave at the middle of the road is measured to be 7 cm. Two abandoned houses have sat at this locality for around 30 years and both of their front slabs have an elevation difference of 55 cm with the original front road after the quake. It was alleged by the neighbors that the 25 cm out of the 55 cm took place because of the 2016 Meinong earthquake. The settlement before earthquake is indicative of consolidation of the soft clayey soil deposits beneath the foundations. Excessive liquefied deposits on the ground surface are found with a thickness of 25 cm in this locality. Sixteen houses at top of the sloped ground are kept from being dragged down slope by their continuous shallow foundations.

Figure 3(a). Lateral spread at Locality 1. The heave at the middle of the road is as much as 5-7 cm.

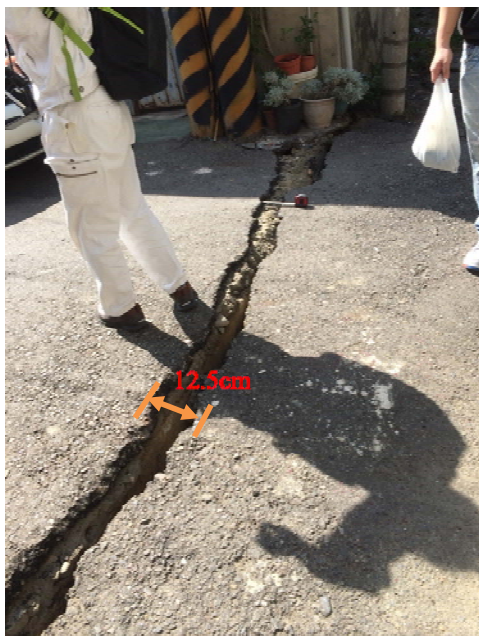
Figure 3(b). Lateral spread at Locality 1. The 12.5cm gap at the top of the slopped road.

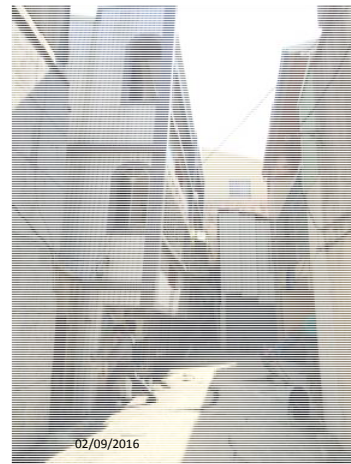
Two individual houses, each with three floors were studied at this location. A larger house with a length of 10.0 m and a width of 10.0 m settled into the ground to a maximum depth of 120 cm and a second smaller house with relatively smaller area with a length of 9.0 m and a width of 8.0 m exhibited 30 cm of settlement. The two houses have separate foundations that are aligned with each other in a west-east direction, separated by a distance of only 3 m. Therefore, the settlement of the houses pushed soils to the roadway running between the houses, an

area relatively free of overburden, and thereby heaving up the road. In addition, because the space between the two settled foundations is narrower than the widths of the buildings, both of the houses tilted toward the central roadway. The first house, with its heavier mass, tilted more than the second house, and both of the W-E facing features fit the direction of the earthquake recorded at station Tainan, the closest station, with a peak ground acceleration of 0.23g to the west. Other than tilting to the west, the first house also steeply tilted to the south because of an open space on its south side. The second house, however, showed much less north-south directional tilt because of the brick structure on its south side. Figure 4(a)(b) shows the settlement and tilt of the houses.

Figure 4(a). Two shallow founded houses at Locality 2 settled in Shi-Din area. The white house on the left side of the picture settled maximum 120 cm and the yellow house on the right side settled 30 cm. The middle of the road was heaved up.

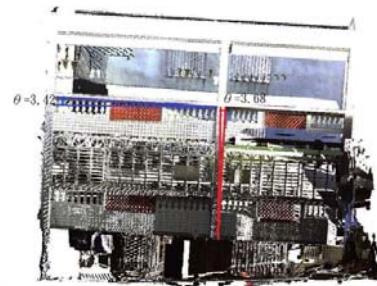
Figure 4(b). The front view shown by object-based point cloud analysis

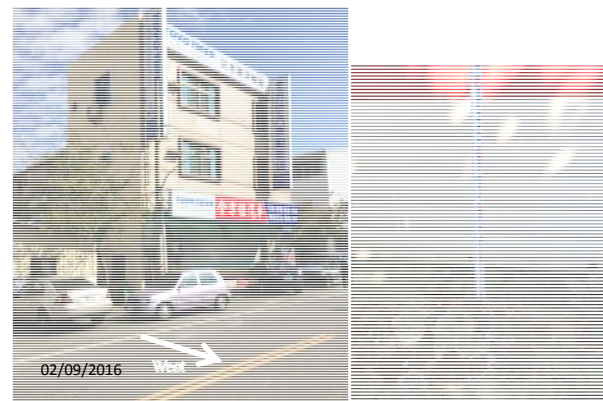
This building, used as a car repair center, is taller and heavier than its neighbors with an individual shallow foundation as shown in Figure 5. After the earthquake, the house was found to tilt to the west. The settlement of its shallow foundations amounted to 20 cm, and a pipeline in front of the house was bent at an angle of 30°. The houses closest to this building are all two-story houses with continuous foundations. These houses experienced limited settlement and very little interior cracking. Such minimal damage suggests that when liquefaction-induced soil instability is minimized, foundations – and the buildings constructed on them – can avoid structural damage in this region. Also, such observations reveal that in addition to the serious consideration of earthquake hazards in the structural design of buildings, we should also consider the geotechnical design, especially related to soft and liquefiable soils.

Figure 5(a) and (b) The car repair center faces to the west side with an individual shallow foundation at Locality 3 settled 20 cm and slightly tilted to the west.

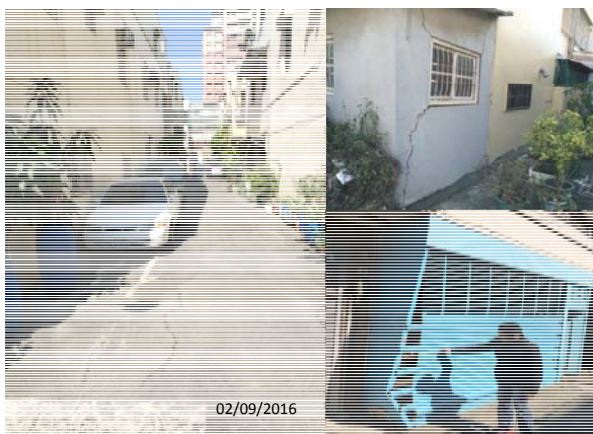
Ejected soil deposits spread around on the ground surface with a thickness of 3 cm. Many liquefied soils could be found between the walls of houses and on the ground. Inside some extended structures, liquefied soils were spread on the ground surface. Soils were mostly extruded from the interfaces between new and old structures where cracks and fissures exist. Note that pipeline construction had just been carried out at locality No. 4 by a pipe jacking method within the two months leading up to the earthquake. On a two-way road at locality No. 4, the lane that the pipeline travels beneath was found to have a greater amount of sand boiling on the ground surface and also relatively larger settlement.

The row houses at locality No. 5 settled considerably less than those at locality No. 4. Due to uniform settlement, the structure of houses did not suffer too much obvious damage, but major problem occurs on structural extensions. Most of the houses at this locality extend the use of their back gardens into indoor areas enclosed by walls and covered by roofs. The extended areas showed obvious differential settlement relative to the main structures. Cracks were found in both walls and floors. In addition, soil footprint could be found in toilets, bathrooms, drainage pipes and cracks in structural interfaces.

Figure 6 shows the general phenomenon of continuous shallow house foundations at locality Nos. 4 and 5. Most of the 30- to 40-year-old main house structures remain in a sound condition, but extensions, which sometimes were only 10-20 years old, were often deformed due to differential settlement.

Figure 6. The settlement on the road and shallow founded houses settled on at Locality 4 and 5. Some damages were found on the extended structure and mostly the main structure remains fine

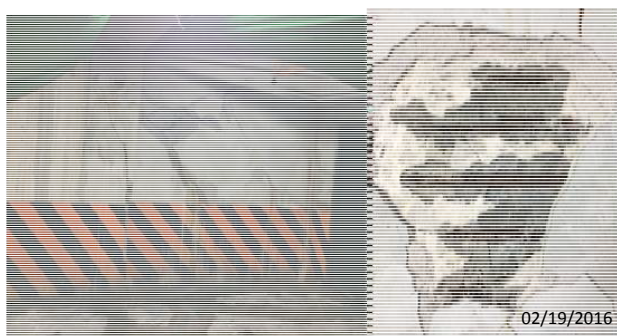
The tallest buildings in the Shi-Din area are several 13-story buildings with 1 basement level, which were constructed by the same contractor 18 years ago (see Building C in Figure 2). The location of the buildings is close to the northern drainage system, which has a relatively higher elevation and where no liquefaction occurrence has been observed. The earthquake induced damage was found at diaphragm wall and 3 different columns. The damaged spot of the wall and columns is all around 1.5 m beneath the ground surface and it was accompanied by groundwater leakage. It also can be seen (Figure 7) that the steels inside the damaged spot have already rusted heavily, thereby revealing that a detailed examination of the strength of the walls and columns should be carried out.

Figure 7 the damages of the walls and columns of basement of a relative tall building (Building C) in Shi- Din area. The rusted steels were found inside the cracks of the wall.
