Geotechnical problems of expressway construction in landslide area in East Slovakia

Miloslav Kopecký, Jana Frankovská

Faculty of Civil Engineering, Slovak University of Technology in Bratislava, Slovakia, jana.frankovska@stuba.sk

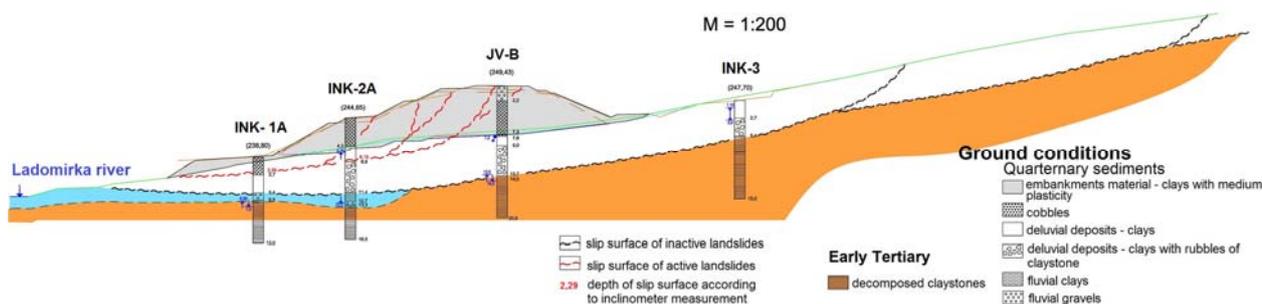
The slope, upon which the embankment was built (approximately 8.0 m high), is an old landslide extending into the route of the R4 expressway at 3.15 to 3.52 km (Fig. 2) with length of about 400 m and width of 200 to 350 m. The landslide itself originated during the erosion of river Ladomirka. It is proven by the insertion of landslide toe into the river sediments (Fig. 3).

Figure.3. Engineering-geological profile of the landslide with embankment in 3,275 km

The course of slip surface of the embankment landslide (Fig. 3) was interpreted on the basis of inclinometer measurements results and slip surface ends in the top of the embankment. It was discovered that the slip surface intervened into the embankment soil up to 2 m and thus the embankment

construction did not make the slip surface of older landslides active (about 5-7 m below the original terrain – ground surface). Stability calculations confirmed that the rigidity of the embankment itself had an impact on the overall stability.

Moreover, they confirmed that the main cause of the failure is a slow creep deformation of body of the embankment along the ground. The slip surface of older landslides was therefore not made active by the embankment construction. The fact that the subsoil of the embankment was not improved before the construction is thus the critical condition of formation of the embankment landslide. It was requested by the conclusion of engineering- geological investigation.

The speed of the embankment construction certainly had its share on the failure of the embankment body. The first part of the embankment in 2008 and also the second part in the spring of 2009 were finished in a very short time. Sudden additional load of subsoil caused a steep increase in pore pressure in the soil forming the embankment subsoil, which was saturated with groundwater.

In the end, dismantling of the original embankment and construction of drainage ribs in the original embankment subsoil was the solution of remediation geotechnical works. The embankment was built again after the drainage ribs construction and it shows no further deformation up to now.

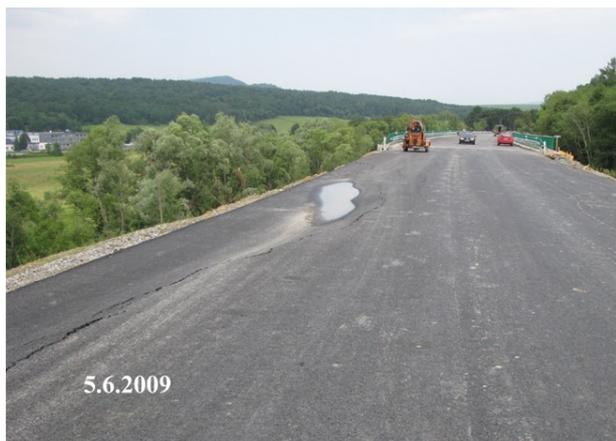
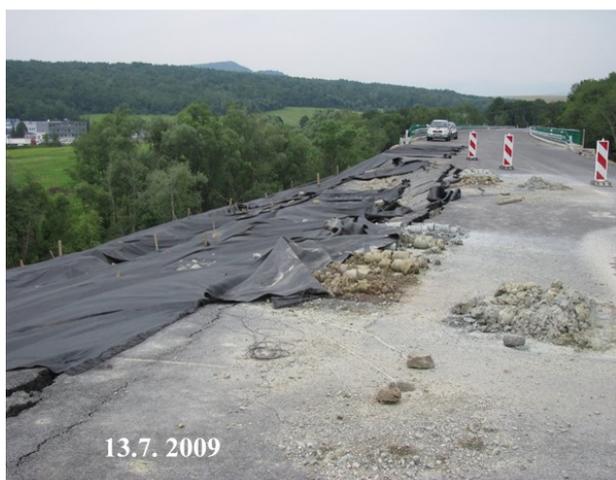
Detailed analysis showed that the first and, in the light of the further development, the critical deformations of the embankment happened before it was built to the final height in August 2008. Afterwards, cracks extending as far as the right side of the road appeared in June 2009. A significant activation over the existing slip surfaces and the complete destruction of the embankment (Fig. 4) occurred during the excavation of

longitudinal depth drain at the foot of the embankment in July 2009.

Figure 4. Comparison of the cracks in the road (scarp zone of landslide) between 5/6/2009 and 13/7/2009

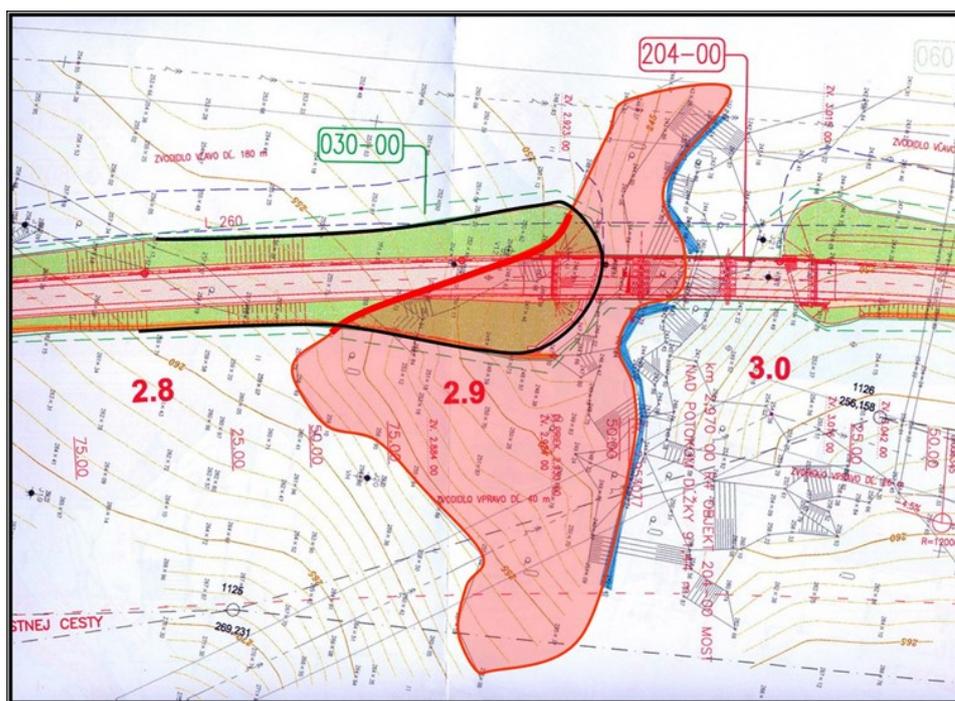
To decrease the cost of the construction, it was decided to shorten the length of bridges, which meant construction of higher embankments on the slopes above the bridging valleys of side tributaries of the river Ladamirka. This way, the embankment was built on an active landslide at 2.85 to 2.95 km. Shortly after the embankment construction, a crack has appeared there which copied the scarp zone of landslide (Fig. 5) precisely. There was a movement of Gabion Wall at the foot of the embankment by about 60 cm, while the slip surface was extruding the bottom of the stream, causing the risk of the closure of the valley and damming the stream.

Figure 5. Location of embankment cone of bridge support on the active landslide (red area).

This situation was resolved by removing the embankments with landslides and extending the bridge by two fields.

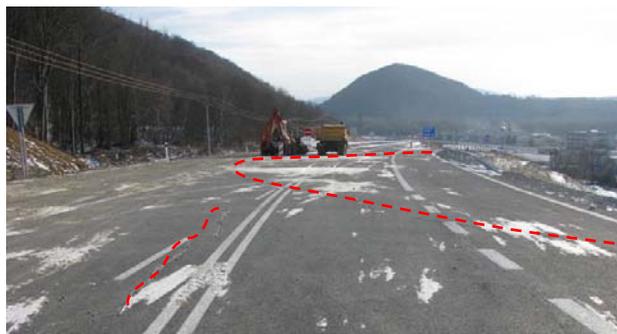
Cracks of a horseshoe shape appeared on the asphalt surface shortly after it was laid down (Fig. 6). Movement of the body of the embankment along the original subsoil (about 1.0 to 2.0 m below the original ground surface) was detected by subsequent inclinometer instrumentation. As in the case of site No.1, there was no modification of the subsoil before the embankment construction.

Figure 6. Cracks in embankment at approximately 0.9 km

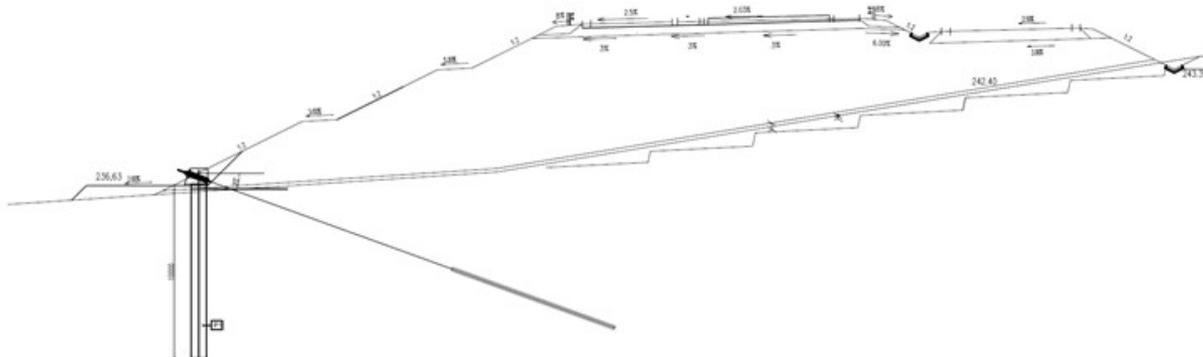
Figure 7. Embankment remediation by anchored pile wall at landslide toe

The final solution to ensure the stability of the embankment with its subsoil was executed by construction of an anchored pile wall with height of 10 meters (Fig. 7).
