Lessons learned from the 2015 Soerkjosen shoreline landslide in Norway

Steinar Nordal, *Norwegian University of Science and Technology*, steinar.nordal@ntnu.no

ABSTRACT: Soft and partly sensitive clays along the fjords of northern Norway pose a challenge for infrastructure. Learning from failures is essential in providing guidelines for future geotechnical work in such areas. A shoreline landslide with a volume up to 1.4 million m³ took place close to Soerkjosen in northern Norway during the night from the 9th to the 10th of May 2015. The shoreline slumped into the sea over a distance of more than 1 km and parts of a harbor were destroyed. No persons were killed, but after the slide the traffic had to take a 700 km detour through Finland to pass the site. The slide took place in a fjord with steep mountainsides and a large river delta. There was ongoing road construction prior to the event, including rock blasting. The authors of this paper took part in the investigation group that concluded that the stability was lowered to a critical level already in November 2014 when a breakwater / embankment was widened by filling crushed rock into the sea for a road crossing. The actual sli

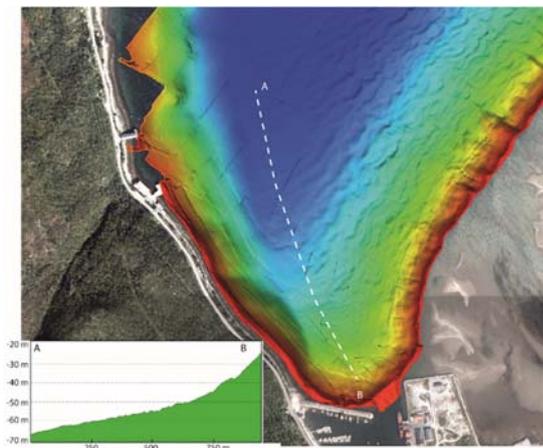
Figure 2. Bathymetry image prior to the landslide showing a smooth seafloor with no traces of previous slides. The wave pattern is related to sedimentation of sand (i.e. sand waves) and is normal in delta areas. Data courtesy of the Geological Survey of Norway (NGU).

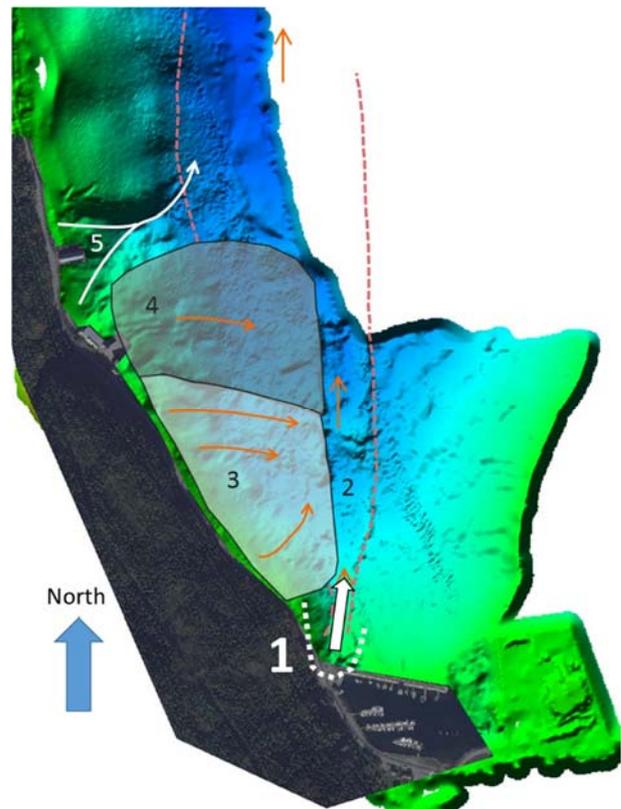
A morphological analysis of the seafloor showed that the landslide started in south (lower end) at the harbour, where the fill placed in November 2014 slid into the fjord. This initial slide moved about 200.000 m³ of soil dominated by loose to medium dense silts and sands. The slide rapidly transformed into a debris flow as it accelerated northwards on the seabed due to the large elevation differences (more than 50 meter). The erosive force of the debris flow is thought to have removed the toe of the slopes along the western shoreline which then became unstable and subsequently failed. While the initial slide was

deep, the secondary slides (3 – 5 in Fig. 3) were rather shallow. Bathymetry data shows that the soil mass from slide 3 to 5 is flowing over the mass from the initial slide, marked 1 on Fig. 3.

Figure 3. High resolution bathymetry with aerial photo after the slide. The interpreted sequence of event based on morphological analysis of the seafloor is shown with arrows and indicated by the numbering.

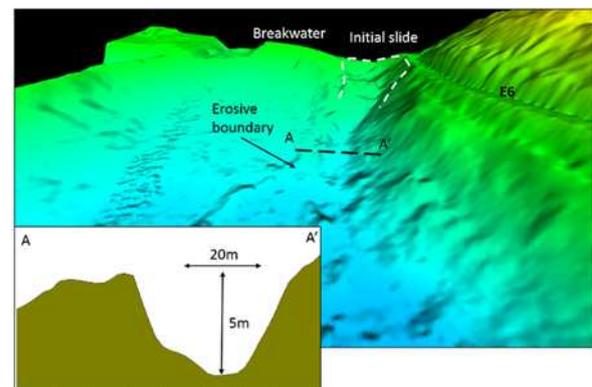
Figure 4. The initial slide left a scar and an erosion channel along the foot of the mountainside slopes when the mass accelerated downslope and changed into a disintegrated debris flow.

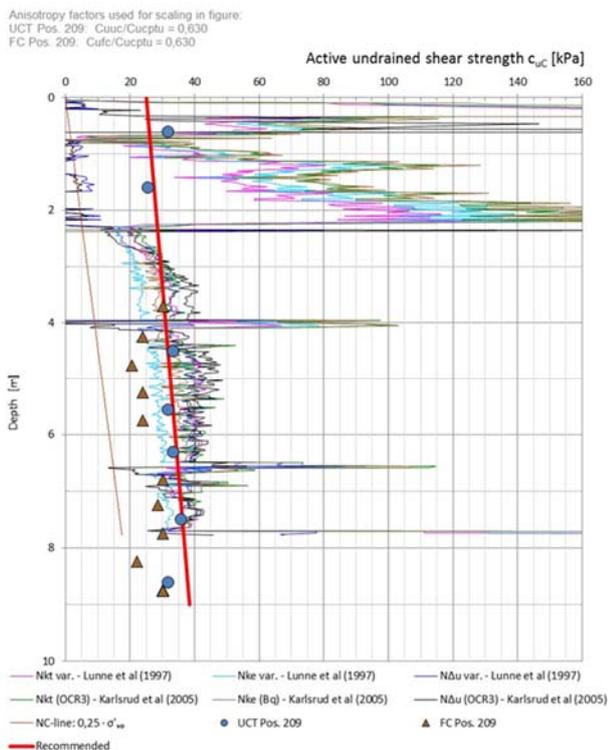
the area that was missed in the original investigations. The soft clay layer is rather shallow behind the backscarp of the initial slide, but is found deeper towards the north under thick layers of silt and sand (up to 20 m). This may explain why the clay layer was missed in the original investigation. The original investigations did not go sufficiently deep in this area to encounter the clay layer. Figure 5 presents undrained shear strength interpretations in the clay based on CPTU results and laboratory investigations. The sounding on Fig. 5 was carried out in the fjord inside the evacuated landslide scar near the pier at a water depth of 7 m. Before the landslide, this location was covered by 14 m of sand and rock fill up to an elevation of +4 m.a.s.l. In the sounding on Fig. 5 the top of the clay has an undrained shear strength varying between 25 to 30 kPa and is covered by sand and debris from the landslide.

Figure 5. Undrained active shear strength results from soil investigations performed after the slide within the evacuated scar. The failure surface corresponds to the top of the clay layer now covered by sand and landslide debris.

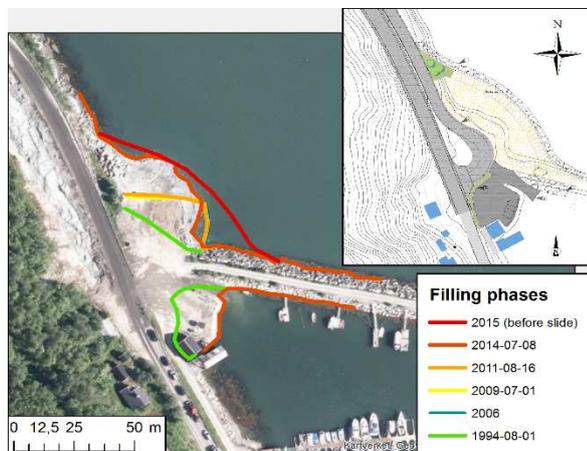
Figure 6. Map showing the widening of the breakwater and road crossing since 1994. The 2015 landslide started in this area. The area sunk and moved north into the sea. The extent of the fill has been defined from available aerial photography and satellite imagery.

The breakwater at Soerkjosen was first constructed in 1977. Satellite imagery and aerial photography also show that there has been filling in several phases between 2006-2014 (Figs. 6-7).

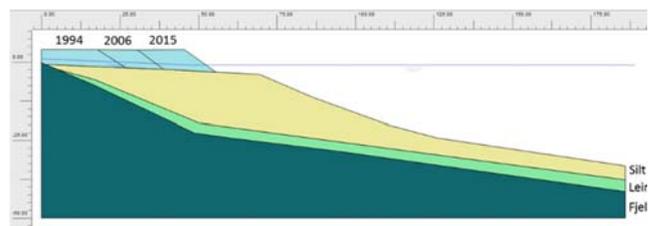
New slope stability calculations were performed by the investigation group on several cross sections along the 1000 meter long slide-affected shoreline. The stability calculations confirmed most of the work done during the original design of the road work, with one exception. The newly discovered clay layer under the breakwater was shown to be critical for the stability of the slope. Calculations were performed using the limit equilibrium package GeoSuite and the finite element code PLAXIS. The two programs gave almost identical results with a safety factor slightly above 1.0 after the last phase of filling in November 2014. Adding the effect of the rain in May 2015 a safety factor of 1.0 was computed.

Figure 7. A cross section in NE-SW direction through the harbor pier showing soil layering and the extension of the fill since 1994. The 1994 condition was probably unchanged since 1977, when the pier was first built. The 2015 case includes water saturation and high pore pressures.

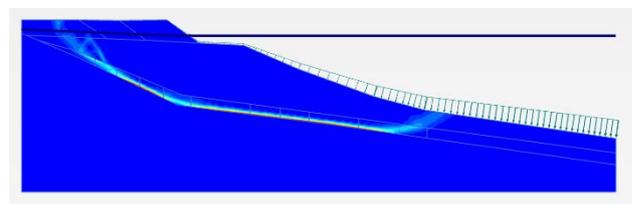
Figure 8. Adding the fill of 2014 and introducing the water and pore-water conditions of May 2015 gave this failure mechanism and a safety factor of 1.0 from PLAXIS. The failure mechanism compares well with the morphology of the landslide and changes in water depth observed from high resolution bathymetry data.

In order to simulate the conditions at the time of the slide in May 2015, the external water level was lowered by 1 meter to fit with the tidal level just before the slide. The unit weight of the fill above the sea level was increased to 19,5 kN/m³ to simulate full saturation while the pore pressure in the silt and sand was kept at 1 meter excess pressure at depth. The pore pressure changes at depth had almost no effect since here the undrained strength of the clay controlled the problem.

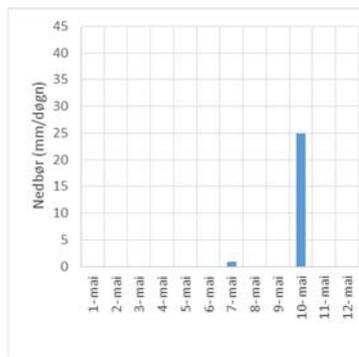
It was raining heavily in the afternoon on the 9th of May at Soerkjosen and a significant snowmelt took place during that period of time adding to the amount of water that came down

the steep mountainsides and filled all ditches and culverts with water. Eye witnesses have described the amount of water as extraordinary.

Figure 9. Precipitation in mm in the last 24 hours before 7 am on the 10th of May. Significant snowmelt must be added to understand the effect of this rain.

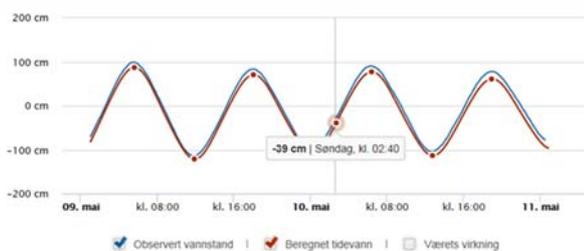
Previous studies have shown that near-shore landslides frequently occur during periods of low tide through a mechanism similar to that of the rapid draw-down condition in earth dams. (i.e., the pore pressure in the sub-aerial part of the deposits does not have time to reach steady state conditions for the groundwater flow; Kramer 1988). The support along the slope is minimum at low tides. In the case of Soerkjosen, a combination of low tide, high pore pressures and full saturation of the embankment material is an unfavourable condition. In extreme cases as here, where the embankment had an minimal safety margin after extending it in November 2014 the unfavourable combination is believed to have triggered the landslide. The consequences were large due to existence of sensitive clay and flow susceptible materials.

Figure 10. The graph shows the variation in sea level due to tidal variations. The tide was just 39 cm below the mean water level when the slide was observed. Around midnight the sea level was about 1 meter below mean water level.
