# CONSTRUCTION OF DEEP FOUNDATION DITCH UNDER A RECONSTRUCTED MULTI-STOREY BUILDING ON WEAK SOILS IN CENTRAL PART OF MEGA CITY

**ABSTRACT:** The paper deals with the complex reconstruction of the buildings foundations of the 19-th century as a complete overhaul of the Hotel in Historic Center of St. Petersburg in conditions of weak soil base. The renovated building is located between the existing houses which made necessary to secure and strengthen the foundations of the reconstructed Hotel and adjacent houses. Details are given the of design of reinforced foundations, pits fencing and their technology, which provided the reliability of the reconstructed and minimal settlements of the adjacent buildings. Monitoring results of developments of the settlements of buildings are analyzed and conclusions about an opportunity of the construction of underground space in the reconstructed building near to the neighboring buildings are made.

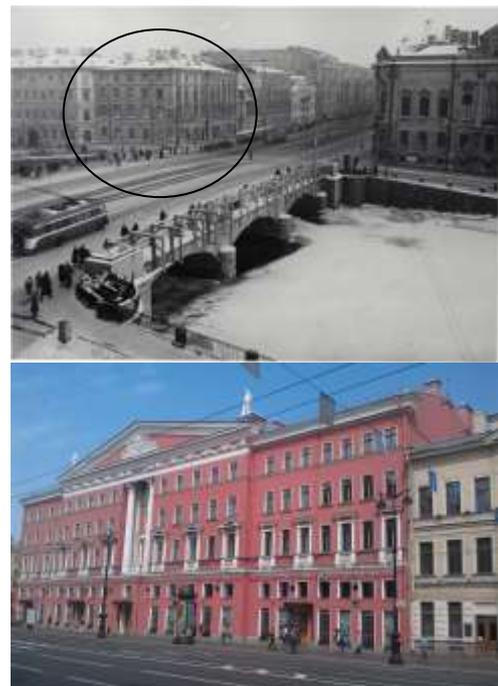
Being reconstructed as a hotel in the central part of Saint Petersburg (a corner of the Fontanka Embankment and Nevsky Prospekt), the former administrative building is a 6-storey building with the cast-in-situ reinforced concrete frame 24,0 m high with the maximum height of 27,7 m. The building was damaged by the direct hit of an aerial bomb (Figure 1, a).

Figure 1. View of Building 68, Nevsky Prospekt. a) before reconstruction in 1944; b) after reconstruction in 2012

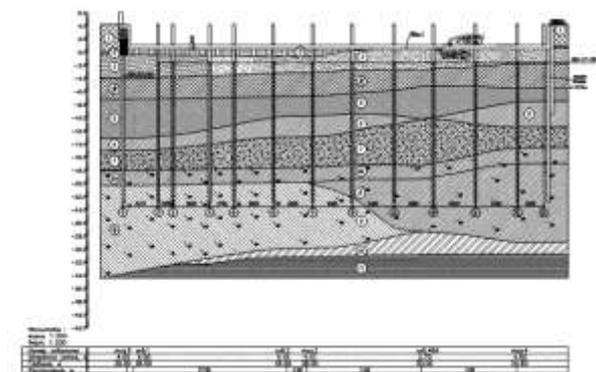
Figure 2 Engineering and geological bed profile across Construction Site

It should be noted that the recent lacustrine-and-marine deposits (ml IV) and glacial deposits (lg III) are thixotropic soils with a tendency for the transformation into the flow state when exposed to dynamic action and for the deterioration of the strength and deformation properties.

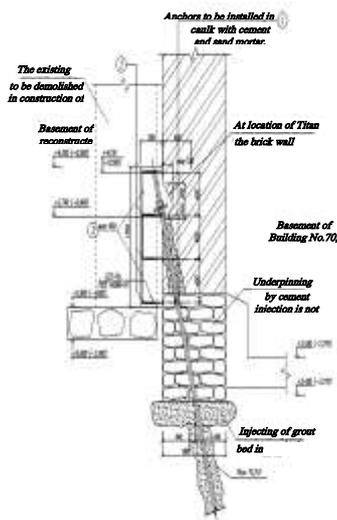
Figure 3. Schematic view of Titan pile construction

OOO Geoizol carried out the underpinning of the foundation in the structures adjacent to the Construction Site. The underpinning of the foundations included the injection underpinning of the foundation body by injecting cement grout and the construction of 75 inclined anchor Titan 73/75 piles 25 m long and 200 mm in diameter from the bed surface using the HUTTE HBR 202D Rig. The boreholes for the anchor piles were drilled without casing piles by the percussive-rotary drilling method, with the pressure feed of flushing cement grout via the internal channel of the rod (Figure 3). Under the foundations of Building No.70, there were installed 35 piles.

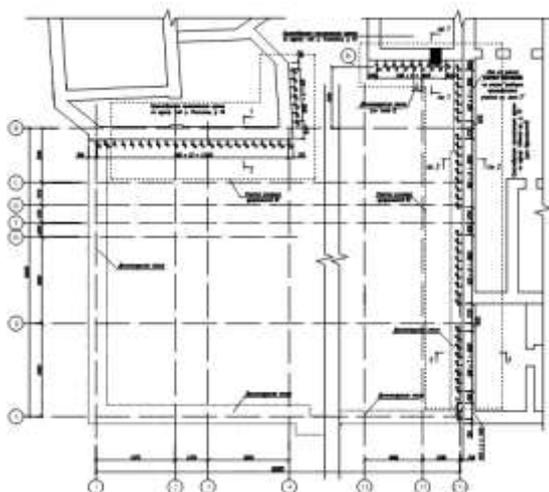
Figure 4. Layout of underpinning Titan piles for foundations of buildings adjacent to Construction Site

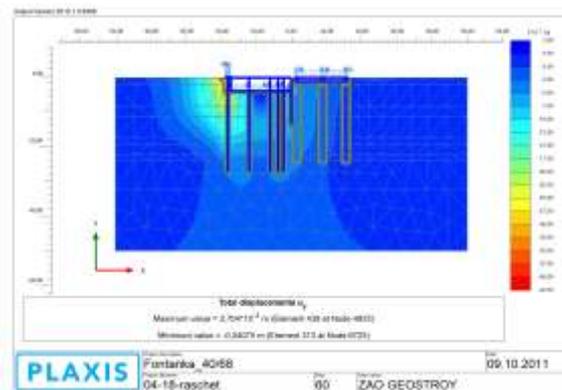
Figure 5. Assessment of design deformation of adjacent buildings in numerical modeling of pit excavation.

Initially, provision was made to use metal pile sheeting with the penetration depth of 27, 0 m and the construction of a diaphragm wall for the sheet piling. At the Detailed Design Stage, check calculations were made that allowed reducing the penetration depth of the pile sheeting based on the safety condition and abandoning the expensive solution involving the diaphragm wall construction. In the following, the sheet piling, the pit support and excavation, the construction of borrowed piles and foundation slab were carried out based on the ZAO Geostroy design( Figure 5) \*.

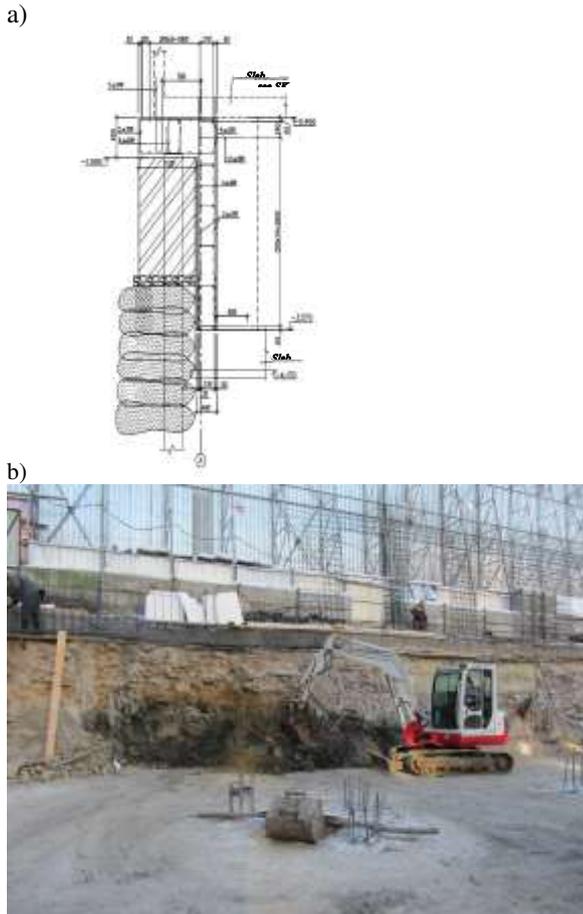
Figure 6. Schematic view of foundation underpinning using jet-grouting pile technology (a) and works to demolish soil-cement areas for construction of protecting wall (b)

Along the existing foundation on the internal side, jet-grouting piles were constructed that were spaced at 450 mm to a depth of at least 2 m from the existing foundation beds (Figure 6).

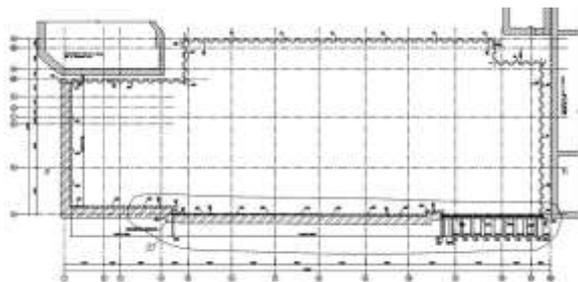
Figure 7. Layout of pile sheeting and completed jet-grouting

Figure 7 shows the layout of the pile sheeting made using jet-grouting technology and drilled cast-in-situ pile sheeting.

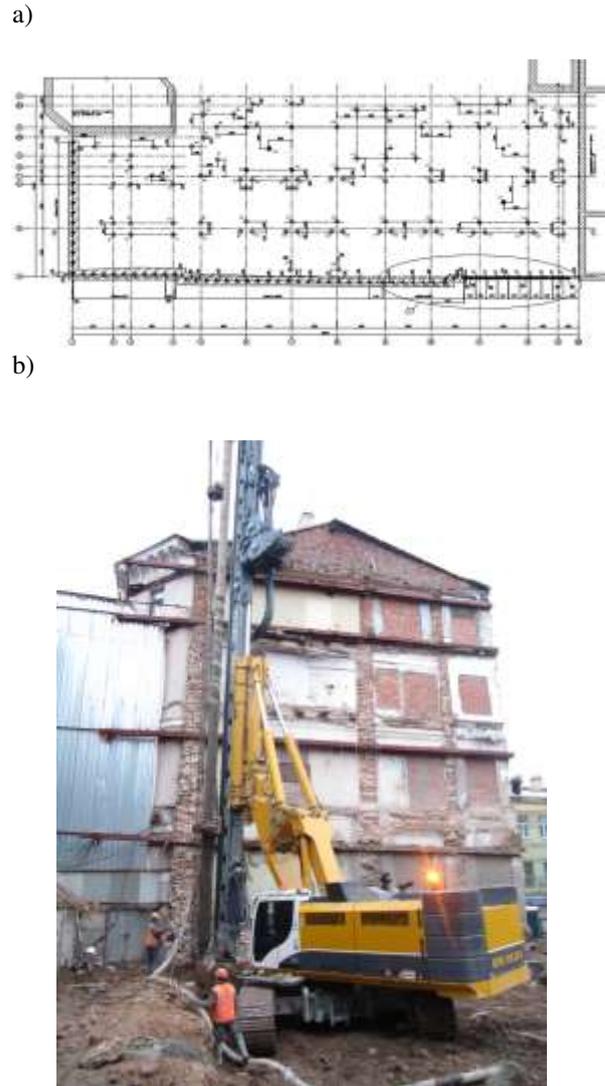
Figure 8. Plan of pile field of drilled cast-in-situ piles (a) and view of drilling rig in process of pile construction (b).

Made on the basis of Bauer technology, drilled cast-in-situ piles 550 mm in diameter and 27 m in length from the ground surface were used to construct a pile foundation for the building frame. In total, 162 drilled cast-in-situ piles were made. Figure 8 shows a layout of the piles.

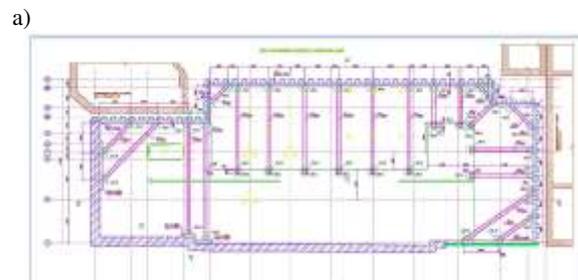
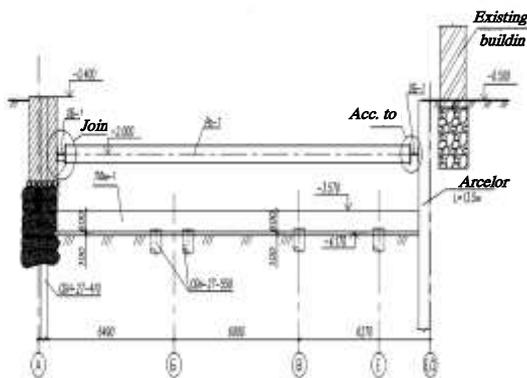
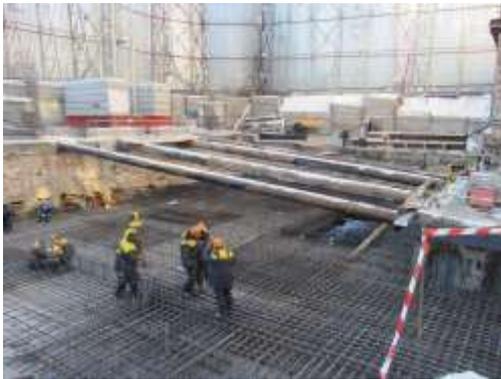
Figure 9. Plan (a) and schematic view (b) of horizontal brace installation in opening the pit; c) view of pit in process of making reinforcement using bracing structures\*.

In order to provide the stability of the pile sheeting in excavating the pit, horizontal braces were installed that were made of metal pipes (Figure 9).
