Reinforcement of Transportation Infrastructure, The Cable Car Network of La Paz (Bolivia)

Freddy Lopez

Friedr. Ischebeck GmbH, Ennepetal, Germany

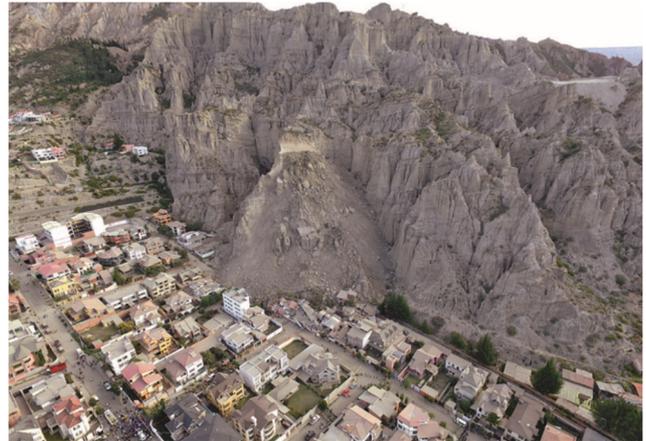
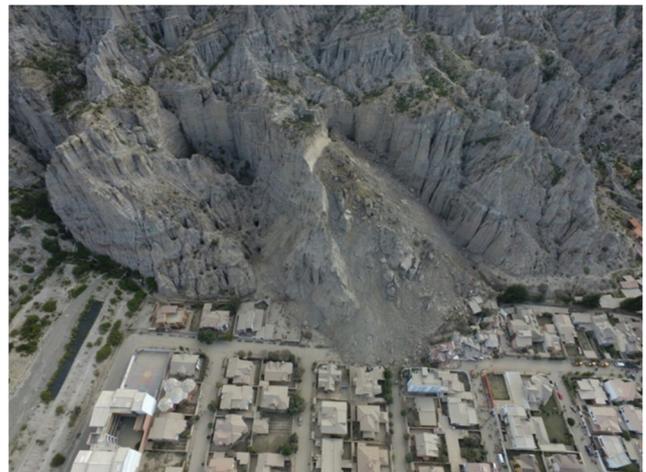
At 16:00 hours (local time) on February 15 2017, a 40m-tall, massive clayey cliff collapsed, destroying at least 8 houses in the quarter of *Auquisamaña* (District of Calacoto, Macrodistrict South) as presented in Figure 4:

Figure 4. Aerial views of the *Auquisamaña*-Landslide

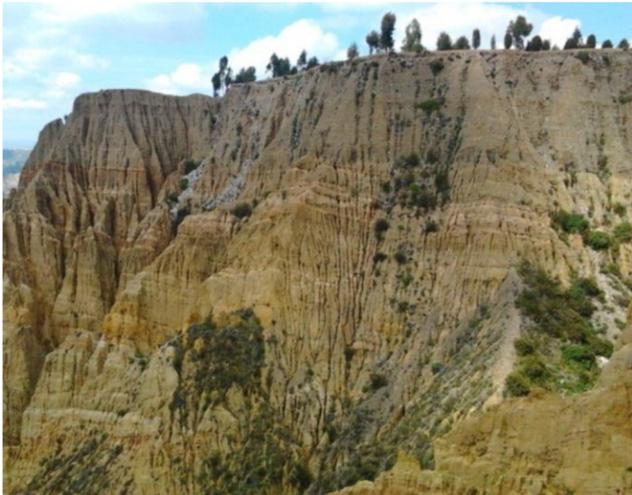
Figure 7. Evidence of jointing in the La Paz-Formation: Outcrop in Rosaspampa, DEGIR-GAMLP (2011)

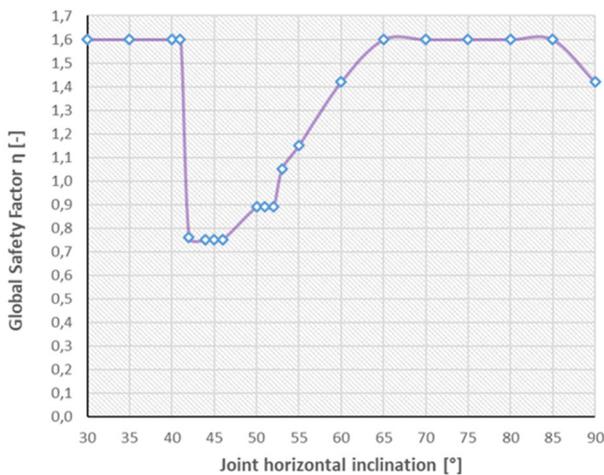
The results of the sensitivity analysis are presented in Figure 8. A global safety factor $\eta < 1.0$ was obtained for a joint (horizontal) inclination between $50^\circ - 53^\circ$.

Figure 8. Global safety factor Vs. Joint inclination

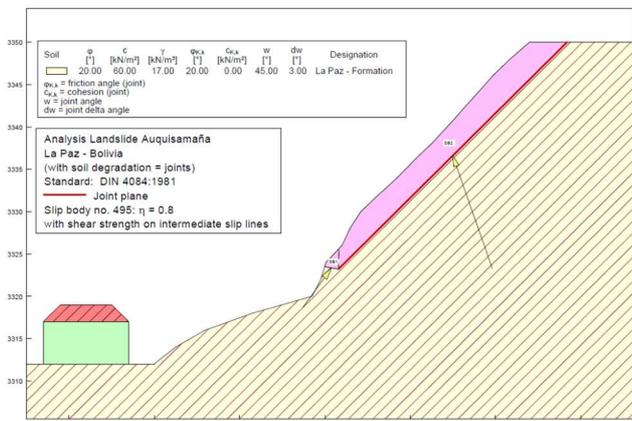
Figure 9. Critical slip body (No. 495): Joint inclination = 45° and correspondent safety factor $\eta = 0.75$

Under these conditions, if it was possible to calibrate the model and to obtain the critical slip body, for which the failure was verified, showing a good agreement with the collapsed cliff (Figure 9).

The results of the analysis suggest that the collapse of the 40m-tall clayey cliff was triggered by a “degradation process” of the constitutive materials, as a result of the repeated exposition to humidity-dryness-cycles over the time. This condition might

have caused the presence of joints in the over-consolidated clays, with the correspondent reduction of the shear strength.

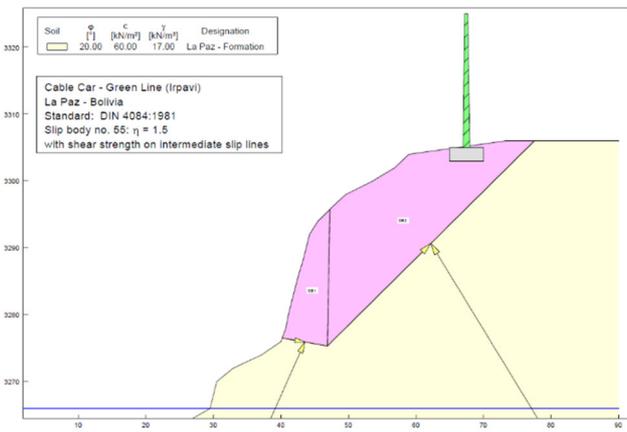
The geotechnical parameters presented in Table 3 were used for the calculations, since they were considered to be representative enough for the location. Figure 13 presents the result of the calculations, with a more than satisfactory global safety factor of $\eta = 1.5$.

Figure 13. Critical slip body (No. 55): Safety factor $\eta = 1.5$

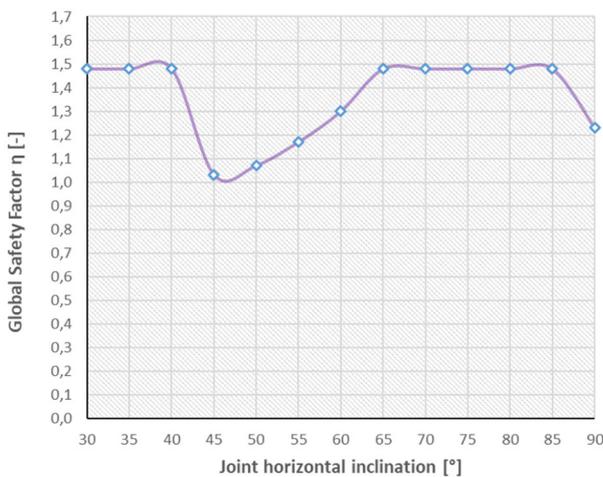
Figure 14. Global safety factor Vs. Joint inclination

The results of the study show that, as a general case, a global safety factor $\eta > 1.0$ could be obtained for every analysed joint inclination, verifying the overall stability of the clayey cliff; however, a significant reduction of the global safety factor was observed for joints with (horizontal) inclinations between $45^\circ - 60^\circ$ (i.e. Figure 15).

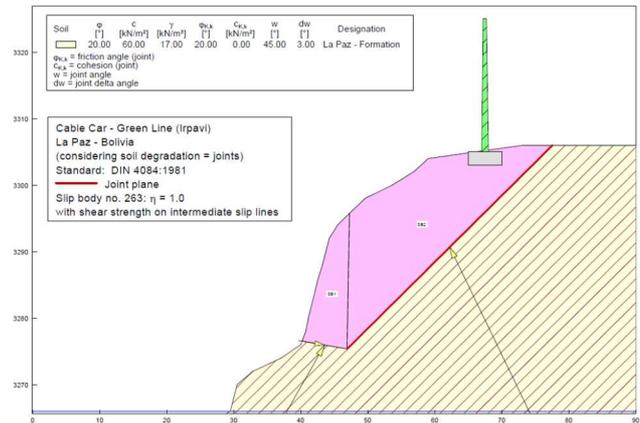
Figure 15. Critical slip body (No. 263): Joint inclination = 45° and correspondent safety factor $\eta = 1.03$

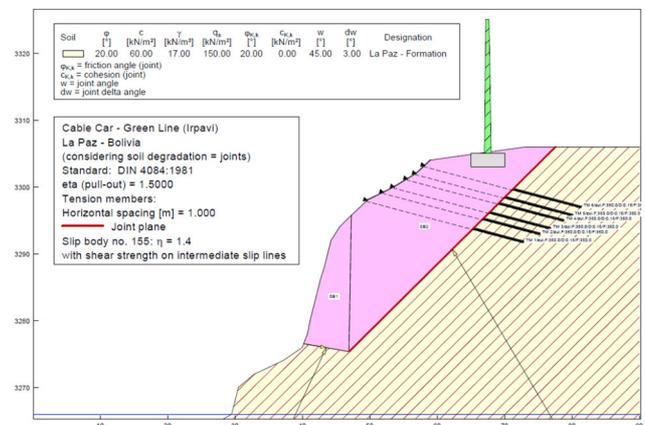
Figure 16. Reinforcement with soil nails. Critical slip body (No. 155): Joint inclination = 45° and correspondent safety factor $\eta = 1.4$

Figure 16 shows the slope reinforced with six (6) soil nails, set up with a center-to-center distance of 1m in both horizontal and vertical direction. The details are presented in Table 5.

Due to the abrupt topography on the site, the reinforcement was placed only on the more accessible areas at the top of the slope.
