# Debris flows that affected Mocoa city, Colombia on March 31, 2017

Gloria Ruiz <sup>1</sup>

(<sup>1</sup>Colombian Geological Survey, Colombia)

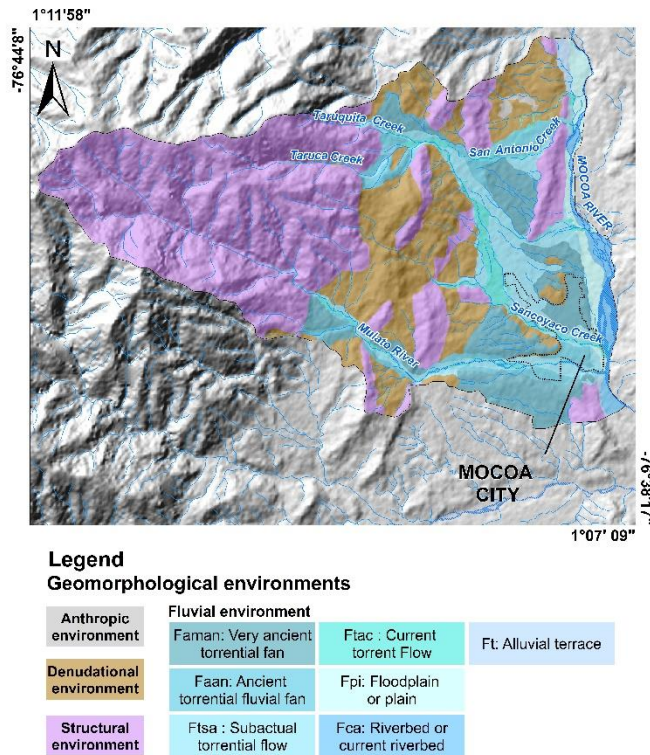
Figure 2. Geomorphology.

their distributaries (San Antonio and El Carmen creeks) form a fan spanning approximately 15 km<sup>2</sup>, as result of different debris flows events. At Mocoa city area four different deposits were identifying by their height to the riverbed, and the degree of weathering of boulders and state of conservation of matrix. Those deposits are classified as current fluvio-torrential flow (Ftac); undercurrent fluvio-torrential flow (Ftsa); old fluvio-torrential fan (Faan); and ancient fluvio-torrential fan (Faman) as shown in Figure 2.

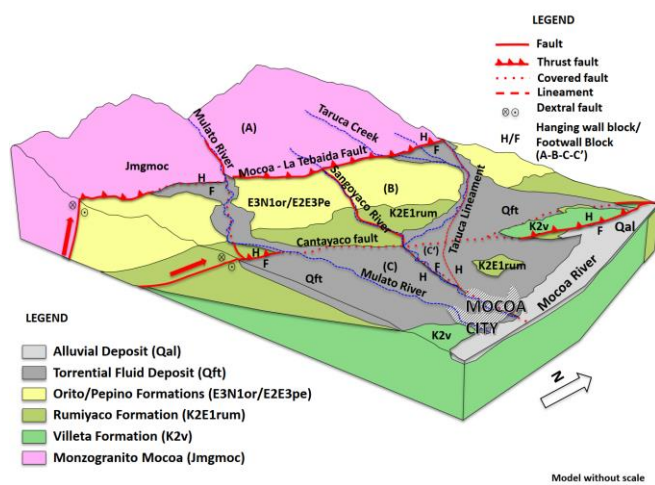
Figure 3. Regional and tectonic geology

Locally, the Mocoa-La Tebaida, Churumbelo, Cantayaco and Mulato Faults, along with La Taruca creek and Sangoyaco river paths, form a thrust faults system in N-S, NE-SW direction. According to stress field, this fault system has a regional compressive component likewise the regional tectonics of Cordillera Oriental foothills (SGC, 2017) (Figure 3).
