Altos de la Estancia: a Large Landslide Area in Bogota, Colombia- History and Remedial Measures

Alvaro J. Gonzalez G.

Abstract

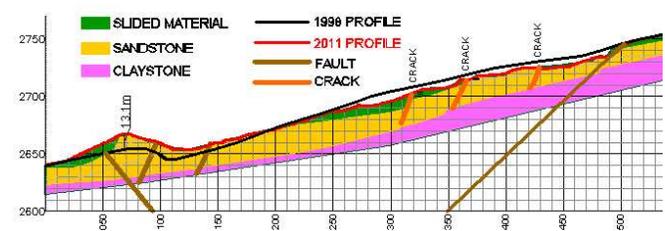
Figure 16. El Espino Landslide- Elevation of the floor

The topographic levels are presented in Figure 16, where the vertical displacement of 13.1m caused by the slide is presented

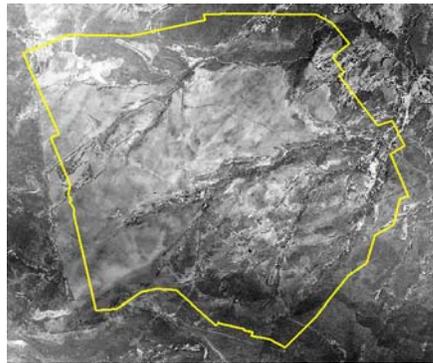
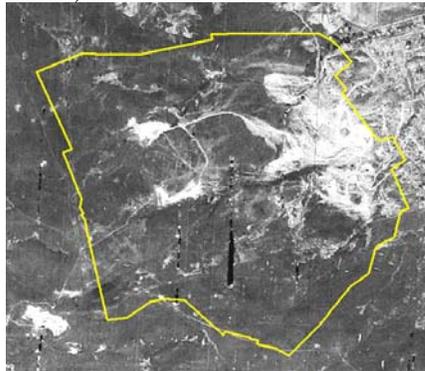
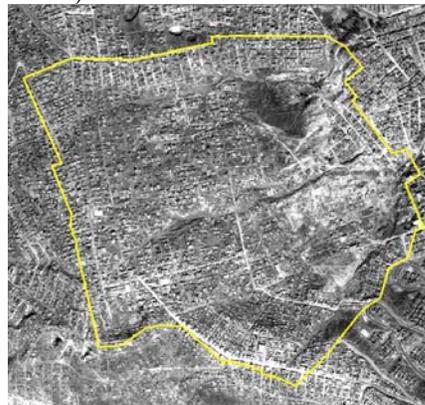
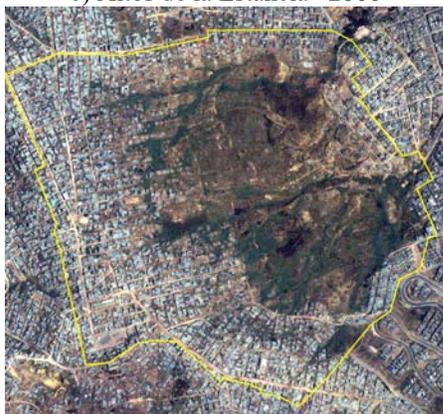
Figure 16. Altos de la Estancia- Historical Aerial Views

In this sequence of photographs, the evolution of the area is seen, with almost no dwellings in 1952, mining scars in 1987, almost full occupation in 2000 and abandoned areas in 2007

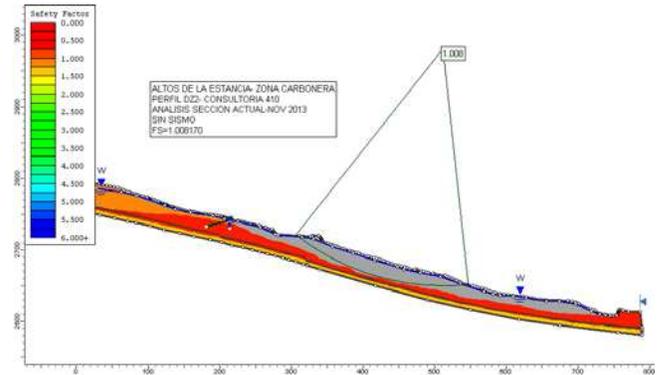
The inferred failure mechanism is with concave curvilinear surfaces (Figure 17)

Figure 17. La Carbonera Slide-Stability-Nov 2013- FS=1.01

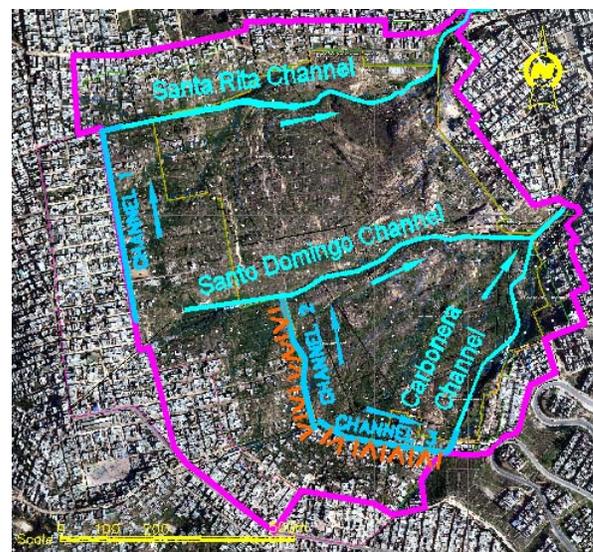
Figure 19- Altos de la Estancia- Surface Water Control

Since water, both surface and underground, was considered as the main trigger of La Carbonera landslide, and a contributing factor in El Espino landslide, works to control surface water were first considered and constructed (Figure 19)

To control the surface water that was coming from the upper inhabited part of the slide area, three small concrete rectangular channels were constructed; Channel 1 discharges in Santa Rita gabion channel., Channel 2 drains into Santo Domingo gabion channel. and Channel 3 goes to Carbonera gabion channel (Figure 19).

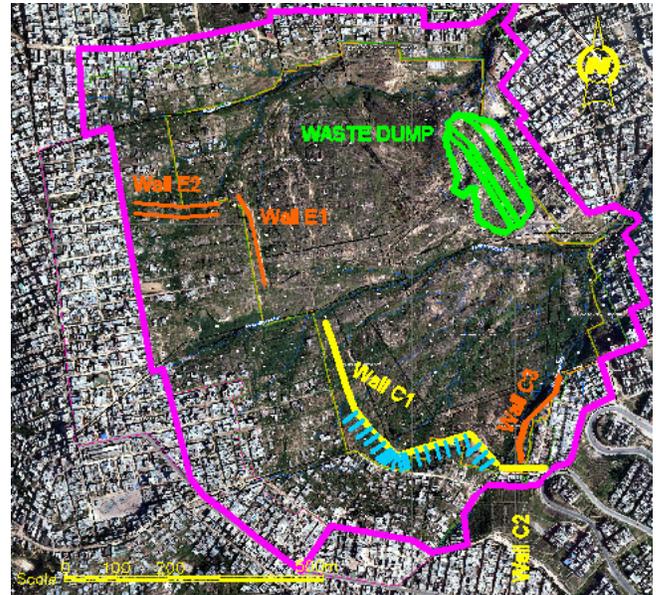
Figure 22- Altos de la Estancia- Retaining Structures

These measures were considered preventive rather the corrective and the main purpose was to prevent a remnant behavior of El Espino and La Carbonera slides

In El Espino a Waste Dump Fill was designed, but not built (Figure 22), that is supposed to act as a counterfort at the toe of El Espino Landslide

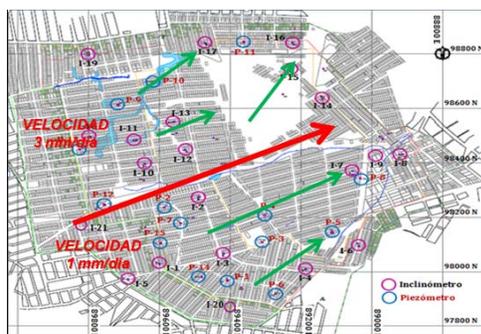
Figure 27- Altos de la Estancia- Surface Velocities in 2007

Although it not strictly a remedial measure, several monitoring campaigns have been done with surface points, inclinometers and piezometers. In Figure 27 an example of surface movement vectors in 2007 is presented.
