Earthquake-induced landslides: complicated mechanisms and outputs

Ikuo Towhata

Abstract

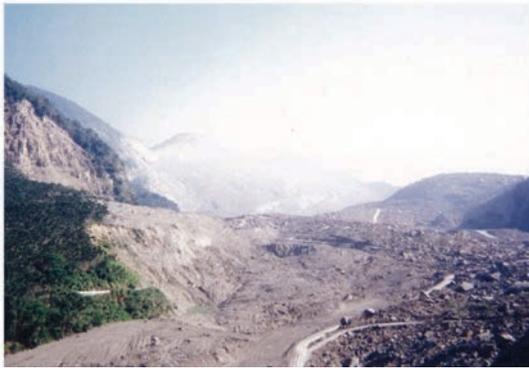
Figure 2 shows the slope failure at Tsaoling whose volume was 120 million m^3 (Hung, 2000). Noteworthy is that this slope consists of soft rock layers that are parallel to the slope surface (Hung, 2000). Accordingly, this slope failed several times during past earthquakes in 1862 and then in 1941 (Kawata, 1943) and rainfalls in 1942 and 1979. Because one rock block still remains at the top, one more disaster is likely in near future.

The slope failure in 1941 in Tsaoling with 150 million m^3 of volume produced a natural dam (Kawata, 1943) and the same was repeated in 1999. Because of the possibility of breaching and flooding, natural dam is now attracting serious concern. When the author made his second visit in

Figure 2. Failed slope at Tsaoling, Taiwan Island

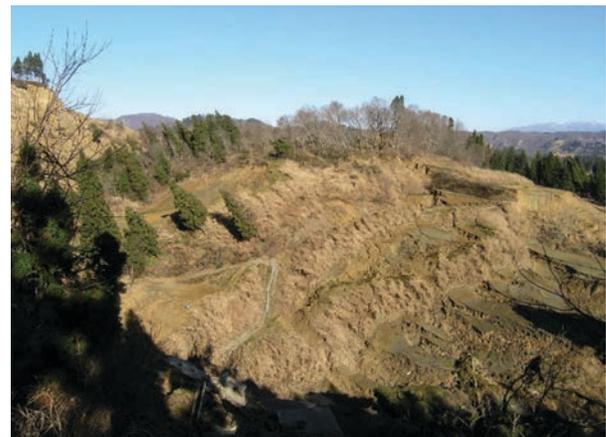
Figure 4. Dainichi-yama slope failure during the Niigata-Chuetsu earthquake, 2004

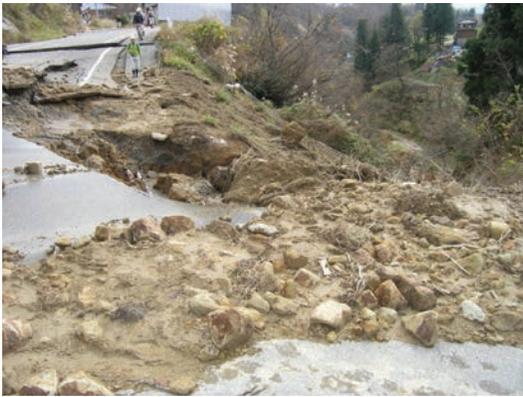
Figure 7. Failed road embankment that was made of crushed mud stone

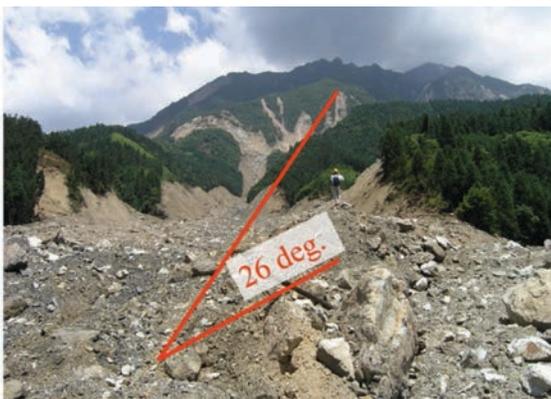
Figure 13 shows one of the big slope failures where debris flow claimed 60 lives under deposit.

Figure 13. Slope failure at Xiejiadian (謝家店) with grazing angle of 26 deg.

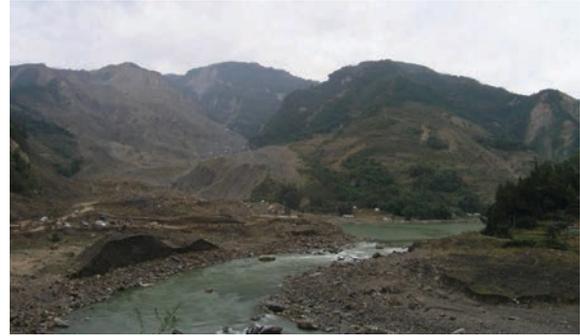
Figure 14. Slope failure at Donghekou (東河口) with 10 million m^3 volume and equivalent friction angle of 20 deg.

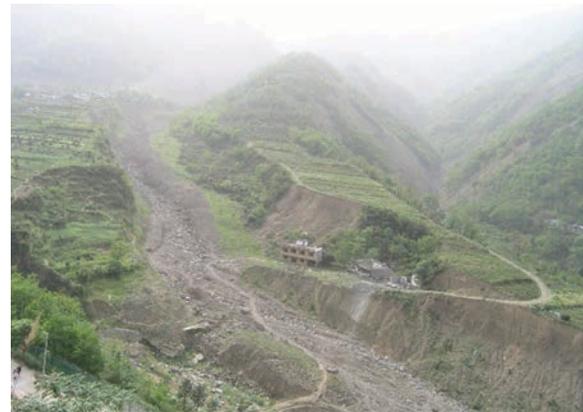
Beichuan was one of the centers of damage. Fig. 15 indicates a site of slope failure near this town. This slope is made of mud stone and, after the earthquake, it became unstable and many debris flows occurred during rainfall after the earthquake.

Figure 15. Slope failure near Beichuan (北川) where debris flows have been repeated after the earthquake

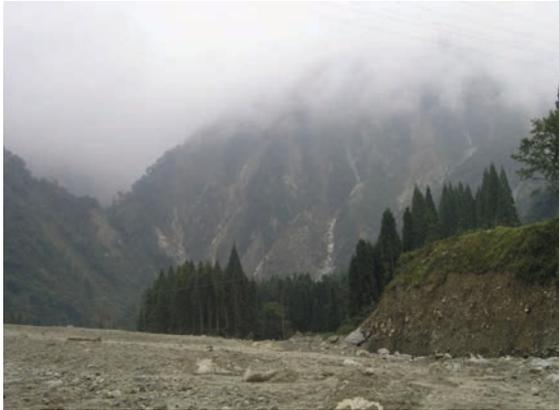
As was mentioned for Taiwan and Muzaffarabad, increase of slope disaster hazard during the aftermath deserves more attention. Fig. 16 demonstrates an example of affected mountain slopes where surface material fell down during heavy rains. Consequently, the valley at the bottom was filled with sediments and the former summer resort there was abandoned.

Figure 16. Mountain slope disturbed by earthquake shaking and valley filled with repeatedly induced debris flows (Yin chang gou 銀場溝)

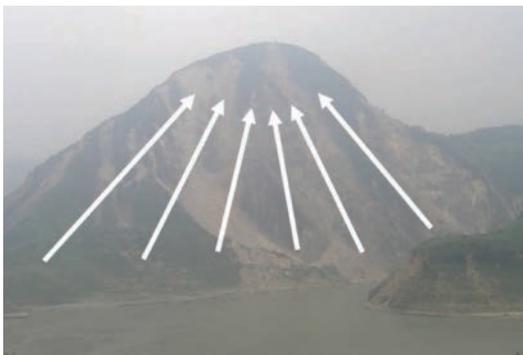
Figure 17 clearly indicates where the seismic slope failure starts during strong shaking. It started very near the top of a mountain, which is in a clear contrast with the behavior of rainfall-induced slope failures. The latter starts at a nick point at the middle height of a slope where the slope gradient changes from steep slope in the lower part to gentler slope towards the top. The reason

for the finding in Fig. 17 is the concentration of earthquake (shaking) energy towards the mountain top. Figure 18 shows that the earthquake occurred in the early stage of rainy season. Thus, it is possible that antecedent rain exerted only limited effect on slope instability but the post-earthquake rain likely aggravated the disaster.

Figure 17. Earthquake-induced slope failure starting from the top of mountain (near Zipingpu Dam reservoir)

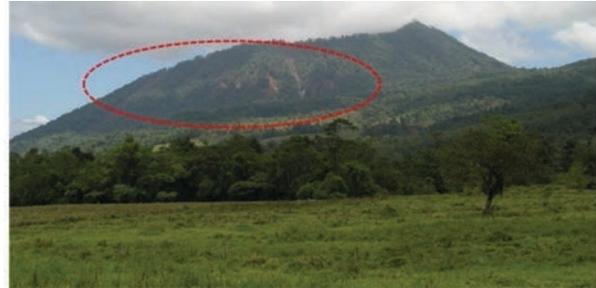
Figure 19. Failure of slope of Volcán Congo caused by the Cinchona earthquake in Costa Rica

Figure 19 shows the minor failures in a volcanic slope. Although their size looks small in this photograph, these failures in this mountain blocked a river (Rio Seco) and this natural dam breached by overtopping. The induced debris flow

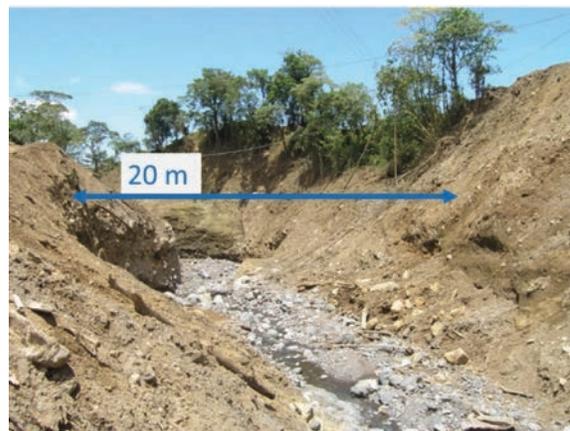
Figure 20. Appearance of Rio Seco in Costa Rica after debris flow

destroyed a bridge in the downstream area. Fig. 20 looks towards the downstream direction of this river whose width increased from 5 m to max. 20 m due to erosion. Similar to Fig. 17, the slope failure in Fig. 21 started from the ridge, not from the nick point. This was a substantial problem to local communities that were situated at the ridge.

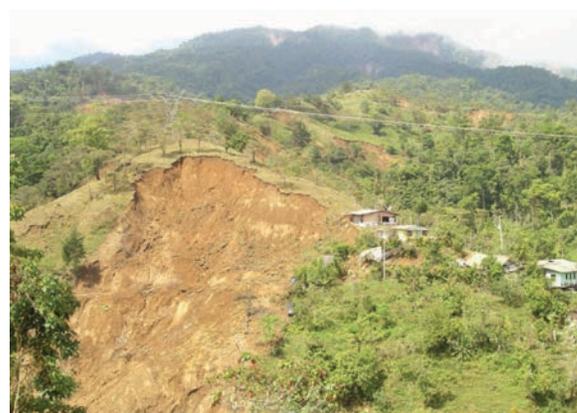
Figure 21. Slope failure starting from the top of ridge (Cinchona)

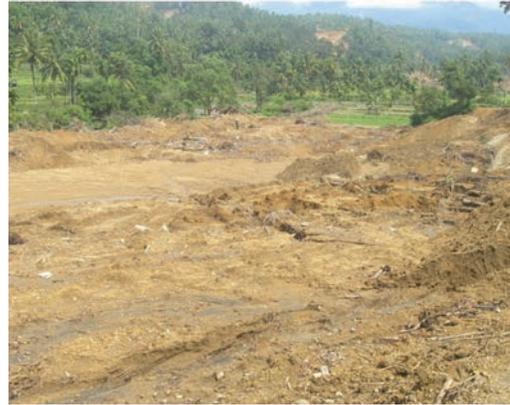
Near Padang, there are several volcanos such as Tandikat and slope surface in the affected area is covered by scoria that originated from those volcanos. Fig. 23 illustrates one of the slope failures in Palakoto locality where 41 residents were killed under the flow failure. This disaster is characterized by a long-distance run-out along nearly level ground surface. Fig. 24 shows the deposit of the failed soil mass that is composed of coarse brownish grains and was judged to be scoria. The volume of flow failure was assessed on the soil mass in Malakak community (Fig. 25) to be about 0.4 million m³.

Figure 23. Destroyed community of Palakoto, Indonesia

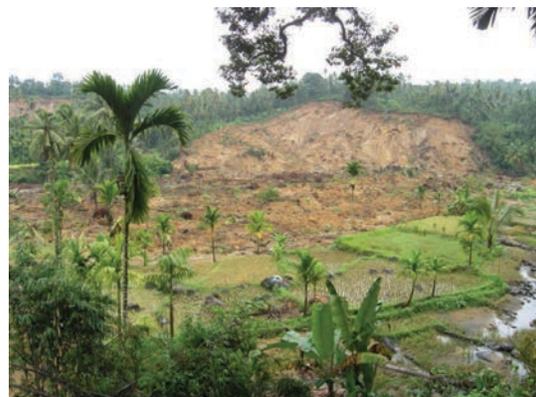
Figure 25. Flow failure at Malakak, Sumatra Barat, Indonesia

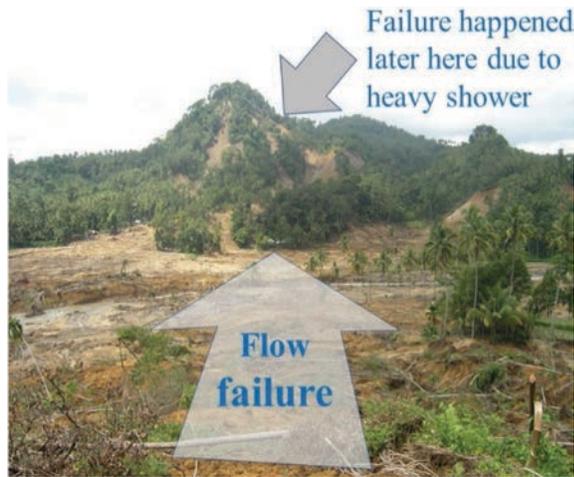
Figure 27. Small mountain near Cumanak where “viscous” flow occurred during heavy shower

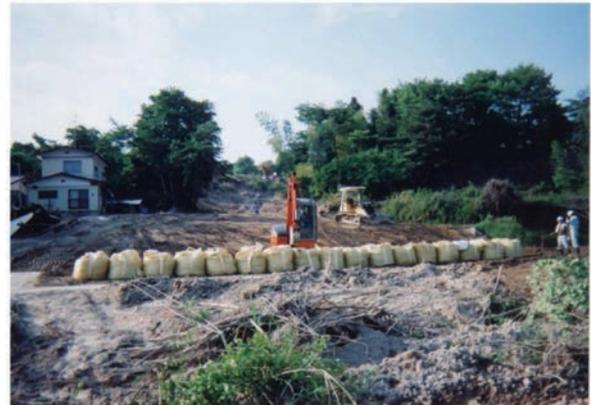
The 2003 Miyagiken-oki earthquake of $M_w=7.0$ in Japan triggered a slope failure in Tsukidate Town near Sendai City. Fig. 28 illustrates the view of the sliding mass seen from the bottom. This site used to be a small valley and was filled with locally available volcanic ash deposit. In spite of gentle sloping, the soil mass traveled over a long distance. One reason for this is the weakness of the soil as Kazama stated, while the other reason is that the soil mass was

Figure 28. Site of volcanic fill flow in Tsukidate, Japan, in 2003 (seen from the foot of slope)

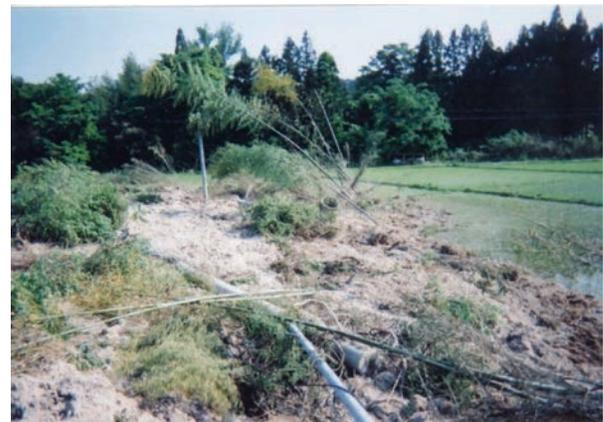
able to travel along rice paddy (Fig. 29) whose surface is covered by very soft mud and allows nearly free sliding in the horizontal direction. In countries of rice agriculture, the softness of rice paddy deserves attention.

Figure 29. Soil mass with bamboo on that traveled onto soft rice paddy (Tsukidate, 2003)

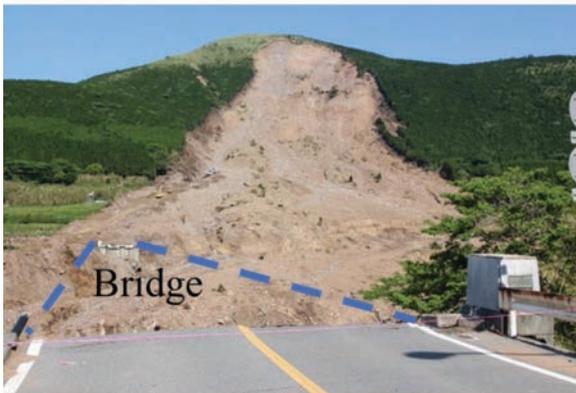
The 2016 Kumamoto earthquake triggered many landslides in the caldera of Aso Volcano. The caldera measures 25 km in North-South diameter and its population is 70,000 approximately. Fig. 30 indicates a big slope failure in the inner slope of the outer rim of the crater. This slope failure destroyed a big bridge at the bottom. Fig. 31 shows a failure of a gentle slope consisting of volcanic materials (Mukunoki et al., 2016). The author measured here the grazing angle to be 16 to 18 degrees.

Figure 30. Slope failure and destroyed bridge in outer rim of Aso Volcano

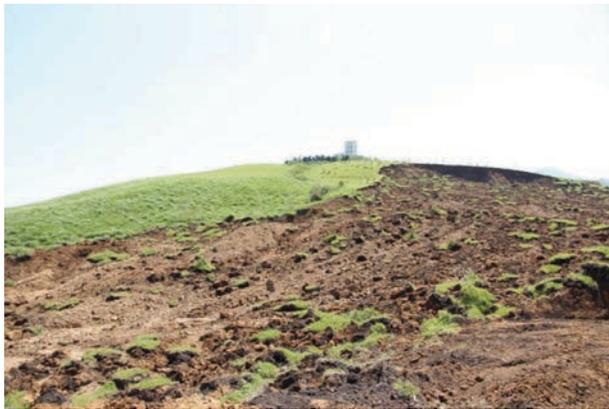
Figure 31. Failure of gentle slope made of volcanic materials in Aso

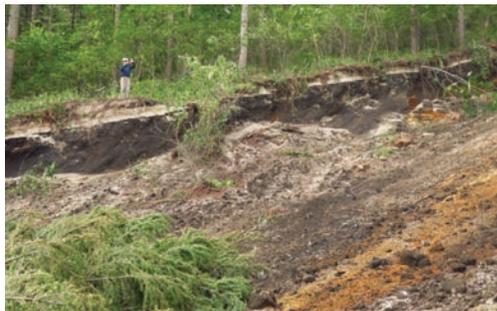
The side face of the failed slope in Fig. 36 shows that the slope consists of many layers of volcanic ash that came from eruption of different volcanos. Chuo Kaihatsu Corporation for which the author is a technical advisor made a brief measurement of the strength of ash layers during their reconnaissance and determined the location of slip plane. Fig. 37 indicates the rainfall record for 5 years. Although the rainfall in 2018 was not

Figure 36. Cross section of failed slope in Yoshino District

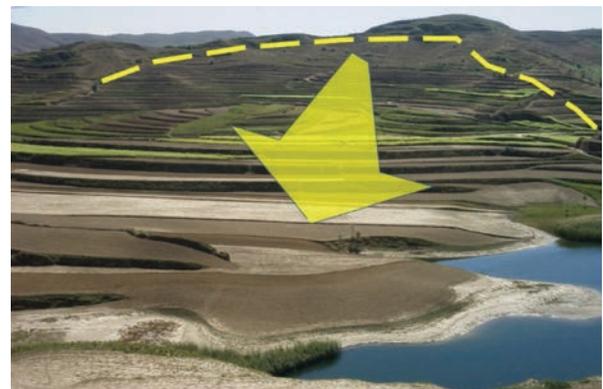
Figure 38 shows one of the places where a gentle loess slope flowed down during the Haiyuan earthquake and blocked river flow. Note that the topography after the disaster has been repaired afterwards. Zhang and Wang (2007) carried out ring shear tests on loess specimens to demonstrate that excess pore water pressure develops profoundly during undrained shear and reduces dramatically the shear strength of the material. Because of the dry climate, loess slope is subject to instability when wetted by, e.g., overirrigation (Zhang et al., 2009).

Figure 38. Site of loess landslide caused by Haiyuan earthquake (西吉 Xiji, Ningxia, China)

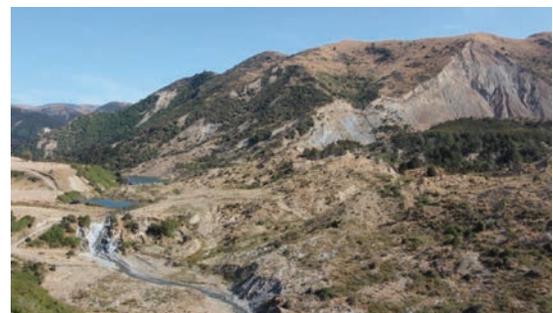
Figure 39 shows one of the major landslides at Leaders. This slope failure occurred in greywacke that is of many joints and cracks. Note that the soil mass stopped the river flow (bottom left of photo). This natural dam was still stable when the author visited the site in January, 2020, which was more than 3 years after the earthquake.

Figure 39. Leaders landslide in greywacke caused by the Kaikoura earthquake

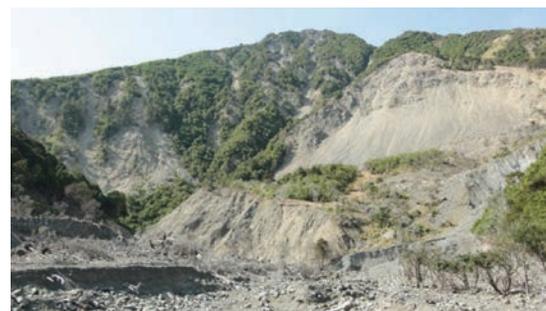
Figure 40. Linton landslide and breached natural dam

Figure 40 indicates the Linton landslide that is of 2 million m³ in volume and blocked river. This natural dam breached later. Fig. 41 depicts slope failure in limestone area near the sea shore. In the Kaikoura area, the monthly rainfall is similar around the year (Fig. 42).

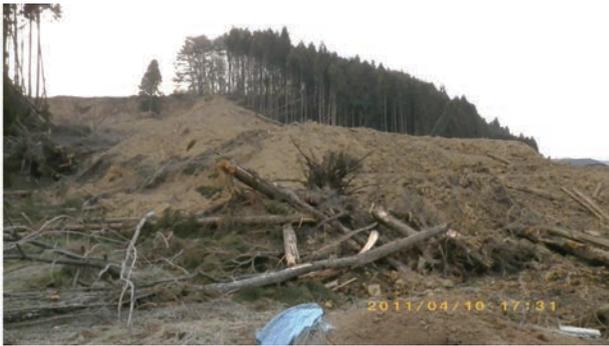
Figure 44. Slope failure at Hanoki-Daira during the 2011 Tohoku earthquake

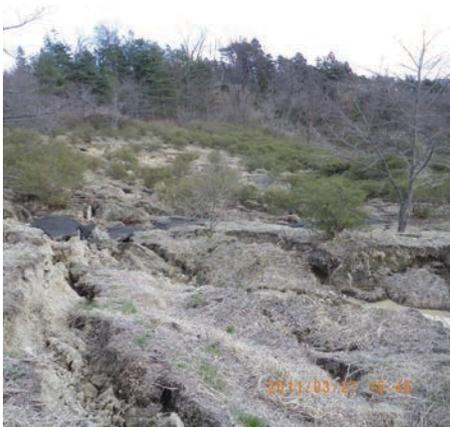
Figures 45 and 46 compare two slopes in Kotobuki-Yama area in Shiroishi, near Shirakawa. The 1978 Miyagiken-oki earthquake of $M_w=7.5$ triggered substantial slope failure here. This site was composed of volcanic fill materials and the size of the failure in 1978 was 70000 m³ with the grazing angle of 11 degrees (Kobayashi, 1980). After the disaster, the failed slope was restored by installing substantial drainage facilities. Accordingly, no failure happened in 2011 here; see vertical wells for drainage in Fig. 45. In contrast, another slope in its vicinity developed many cracks and displacement in 2011 (Fig. 46). The experiences in 2011 implies the risk involved in earth filling by volcanic materials.

Figure 46. Slope failure in Kotobuki-Yama during the 2011 Tohoku earthquake

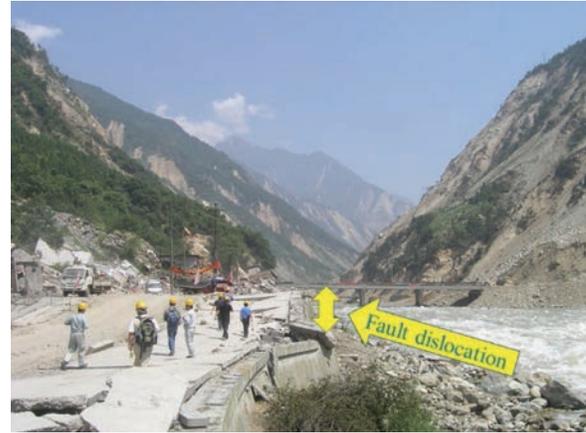
Figure 65. Total collapse of mountain slopes along the causative fault valley, Yingxiu 映秀, after the Wenchuan earthquake (photograph taken in June 2008)

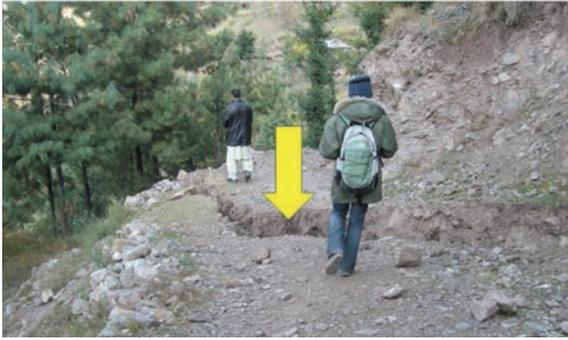
Figure 67. Surface crack in Northern Pakistan near the site of Hatian Landslide

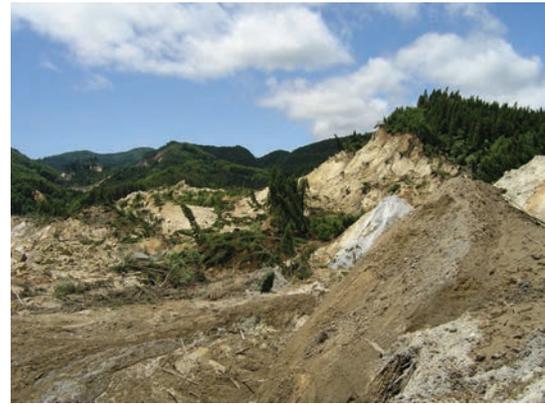
Figure 79. Aratozawa landslide caused by the 2008 Iwate-Miyagi Inland earthquake, Japan

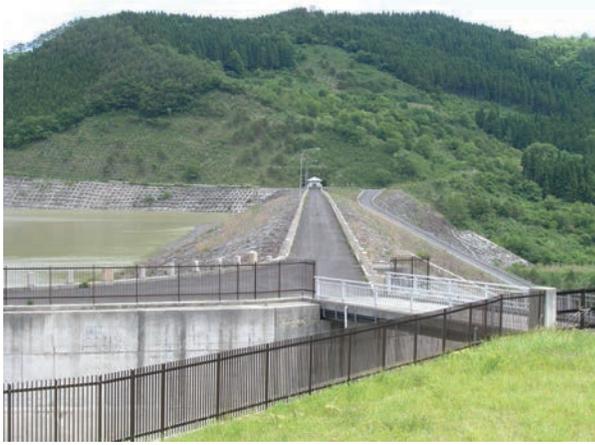
Figure 82. Aratozawa rockfill dam after the earthquake
