The paper was published in the proceedings of the 13th International Symposium on Landslides and was edited by Miguel Angel Cabrera, Luis Felipe Prada-Sarmiento and Juan Montero. The conference was originally scheduled to be held in Cartagena, Colombia in June 2020, but due to the SARS-CoV-2 pandemic, it was held online from February 22nd to February 26th 2021.

Solutions for the stabilization of the left bank slope in Salvajina hydroelectric power plant.

Isabel K. Cardona^b, Tatiana Betancur^a, Sebastián A. Valencia^a, Hernán E. Martínez^{a,c}

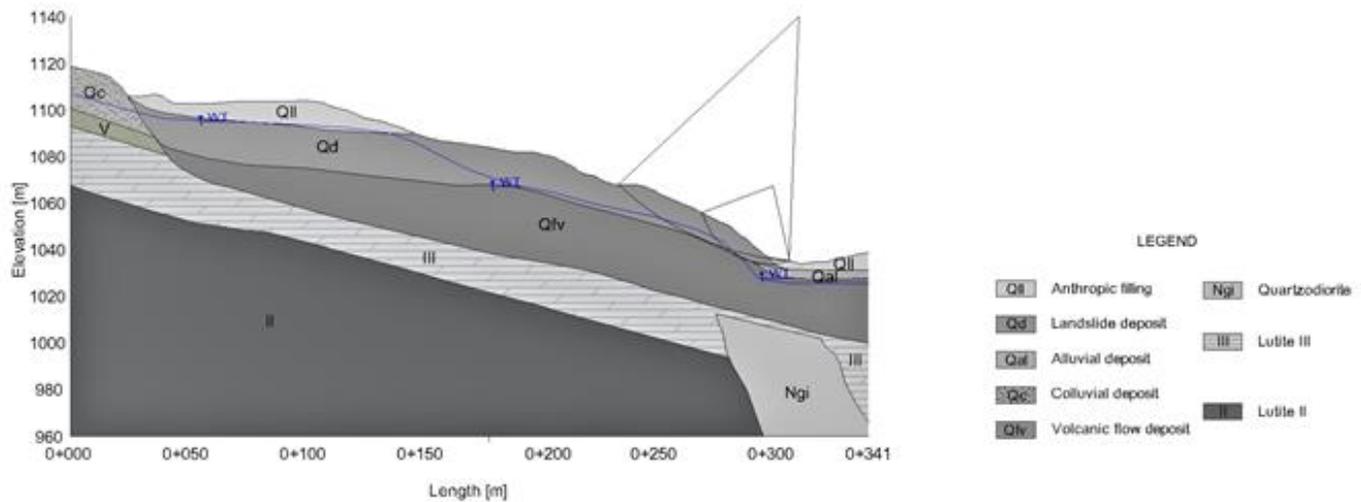
After performing a stability analysis which shows two potential failure surfaces with safety factors of 1.0 and 1.1, it is concluded that the static stability condition of the left bank slope is critical and then considered of likely to be reactivated. Figure 2 shows the stability analysis of the most representative section of the slope.

Figure 2. Slope stability analysis. Safety Factor 1,0 and 1,1.

The failure surfaces are found in the lower portion of the hillside where the slopes are steeper, and the water table is more superficial. These surfaces are located between the contact of the colluvium deposit (Qd) and the volcanic flow deposit (Qfv), where residual resistance parameters are considered due to the presence of a weakness zone.

For that reason, the imminent equilibrium condition can be affected by any modification that is made on the slope, and, thus, in order to rehabilitate the operation of the spillway discharge channel, stabilization works must be carried out.

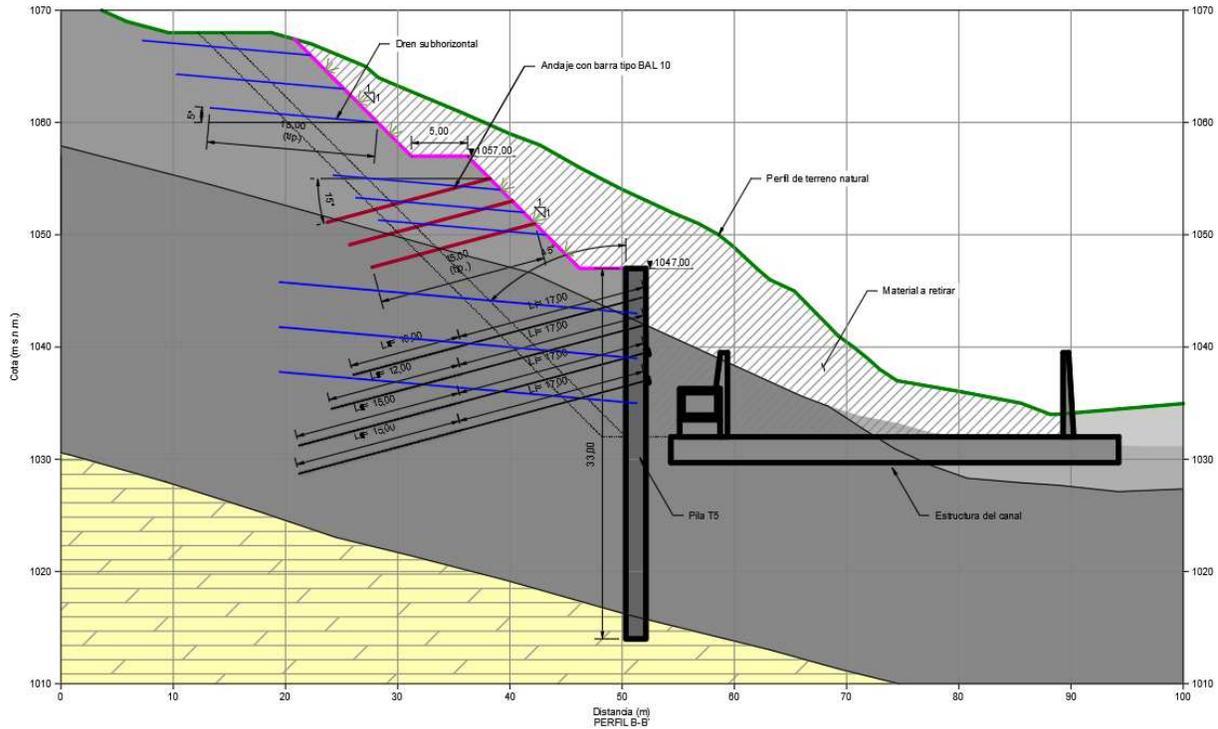
Figure 3. Alternatives implemented to stabilize the slope

The piles are 33.0 m long (mean value) and 1.8 m in diameter, joined by a head beam. The separation is 3.0 m between axes and the free space between piles is covered by a slab that prevents the passage of material between them. Anchor lines are added; the central piles will have a greater number of lines because they have to withstand greater thrusts. These piles will have four anchor lines with lengths of 27.0 m, 29.0 m, 30.0 m and 32.0 m, and loads in the range of 450 kN to 900 kN. The anchor lines are separated 2.5m vertically.

Finally, when implementing this alternative in the slope, safety factors of 1.5 in the static condition and 1.06 in the pseudo static condition are obtained, thus meeting the standard according Colombian codes.

For this alternative, it is first necessary to remove the landfill located at the top of the slope. Then, four 15.0 m high banks with variable inclination will be dug. The inclination of the two upper banks will be 2.0H: 1.0V and the last two will be 1.0H: 1.0V. In the middle, there will be 10.0m and 7.0m wide berms

For the complementary supports, active anchors of 60.0 m length were considered, with design load of 600 kN and inclination of 15 ° downwards. Also, sub horizontal drains are added, which allow the water table to be depleted.

Finally, the stability analysis was again calculated and a factor of 1.5 was obtained, which meets established factors according Colombian codes.
