The paper was published in the proceedings of the 13th International Symposium on Landslides and was edited by Miguel Angel Cabrera, Luis Felipe Prada-Sarmiento and Juan Montero. The conference was originally scheduled to be held in Cartagena, Colombia in June 2020, but due to the SARS-CoV-2 pandemic, it was held online from February 22nd to February 26th 2021.

Experience in the design and construction of slopes on mountain roads

Marcelo ZEBALLOS⁽¹⁾; Agustín BALBIS⁽²⁾; Joaquín RECHE⁽¹⁾, Juan Pablo CERUTTI⁽²⁾

(1) Universidad Nacional de Córdoba; (2) Abya Terra SRL

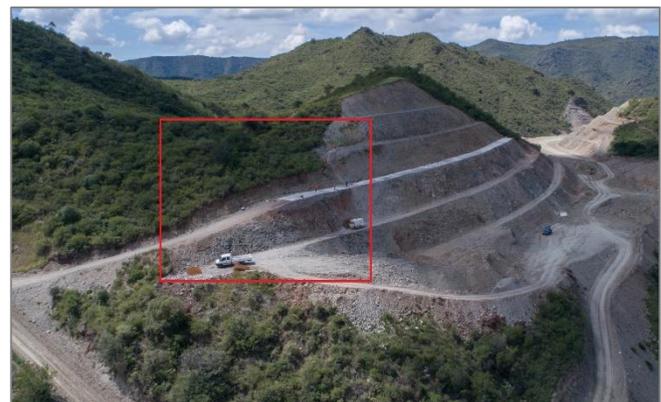
Figure 2 shows a view of the sector, in stages prior to its final conformation. The heterogeneity of the environment is appreciated.

Figure 2. General view of the slope (Pk. 6 + 200) with instability problems. Unstable sector is indicated in the box.

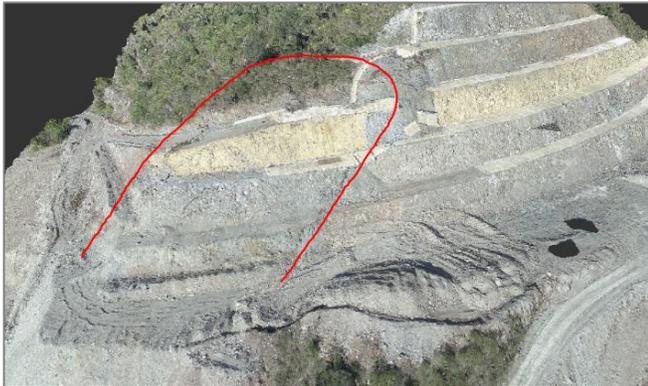
Figure 3 shows an aerial view of the area with instabilities. The variation in the disposition of the local material is appreciated, and this fact allows the construction of the originally planned profile, a few meters from the unstable area.

Figure 3. Aerial view of the unstable area. Continuous line delimits the area.

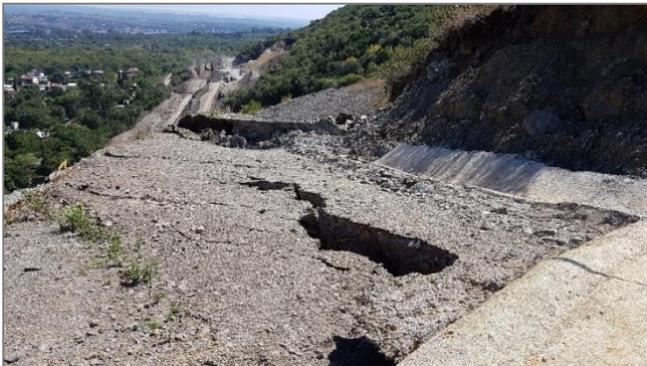
During the development of the construction, when the excavation was in its lowest sector, landslides of various sizes were observed. The failure mechanisms corresponded to a rotational kinematics. Characteristic elements of this type of movement were observed. Traction cracks were observed at the top. The settlements measured in the upper sector of the fault were several meters high. The settlements presented localized characteristics, which allowed for a retroanalysis. This allowed a review of the adopted geomechanical design parameters, and of the hypotheses applied. Table 1 shows a comparative between the design parameters adopted in the initial stage of design and those resulting from the retroanalysis. The observation of the slope, after the landslides, allowed us to conclude that part of the material initially considered as a low quality massif rock, should be considered as a deposit of clayed-silt soil, with the presence of gravel components.

Figure 4 shows a local view of the damage caused during construction.

Figure 4. View of fissures and settlements in the intermediate berm.

The sector where tensile cracks of several centimeters thick were developed, the surface material was removed, and compacted with the use of road equipment. The action carried out was intended to "seal" the fissures generated, in order to reduce potential water infiltration pathways. For this sector, a subsurface drainage system was projected. This consists of a mantle of draining material and perforated ducts separated every 10.0 m. The ducts act as collectors for local leaks. Finally, the coverage was made using fine soils, in order to act as a superior protection. A longitudinal slope towards the foot of the slope was formed, to allow efficient drainage.

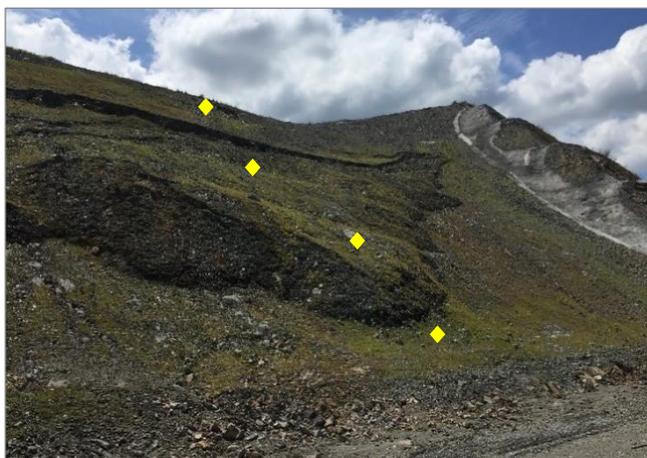
After the first landslide slope reconstruction, review of actions in the sector and topographic control points were arranged along the critical section of the slope (Figure 5).

Figure 5. Provisional topographic control points (yellow) placed to monitor the progress of instability.

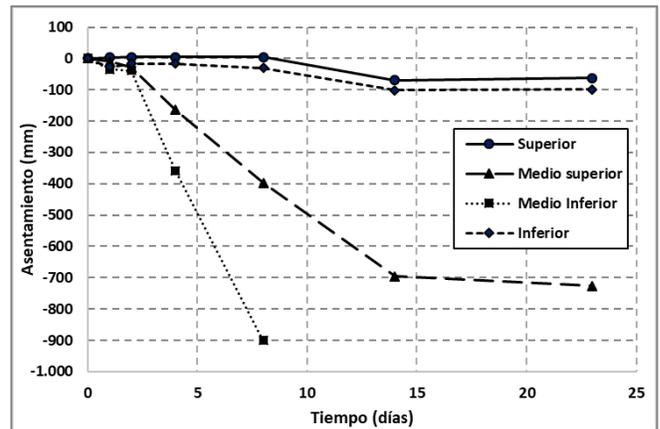
Those points allowed us to assess the magnitude and direction of the displacements, and their continuity over time (Figure 6).

Figure 6. Settlement of topographic control points.

Points located at the upper and lower ends of the fault zone were not affected by the movement of the whole mobilized mass. However, the middle points show significant displacements over time. The magnitude of settlement is around 700 to 900 mm.

In addition, the results of displacement monitoring were correlated with rainfall records, in order to verify its influence on the evolution of instability. A marked reduction in the rainfall regime towards the end of February has been noticed. The tendency to slip was significantly reduced after this.

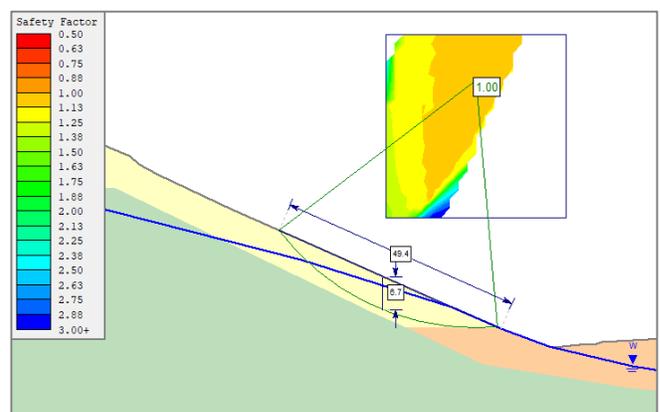
All this information has been very useful for the constitution of retro-analysis models based on the evolutionary behavior observed (Figure 7).

Figure 7. Retro-analysis model. Unitary safety factor under conditions of water table near the surface.

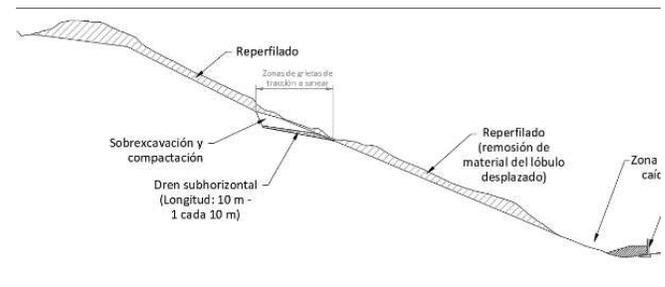
The modeled geometry consists of a uniform slope of around 25° (Figure 8). The geomechanical parameters used for the final design are those obtained from the retro-analysis model.

Table 2 shows the safety factors finally estimated for the analysis scenarios. In addition, Figure 8 shows a detail of the typical transverse profile applied.

Figure 8. Projected mitigation actions shown on the transverse profile

As can be seen, the solution adopted maintains the initial design criteria through the execution of a hillside reprofiling, which implies the reduction of the height and the modification of the slope. This contributes to the reduction of the weight forces that act as destabilizers in the upper part. In addition, the conditions of visual impact are improved.

In addition, the execution of a surface drainage control system was included. This is composed of ditches coated with shotcrete, which prevents the entry of runoff water into the treated slope.

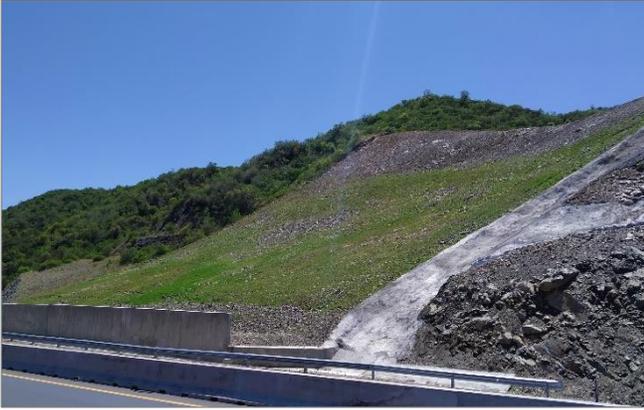
Figure 9. Final solution materialized. General view of the area with a homogeneous slope.

On the surface, vegetation was applied through hydroseeding techniques. This tends to minimize localized surface erosions and restore local flora.

The solution was completed with the construction of a support wall at the bottom of the slope. It has a double function, on one hand a control structure against possible mass movements located in the lower level of the slope (high percentage of soils), and on the other hand, as a barrier of block fall control. The final solution adopted is presented in Figures 9 and 10.

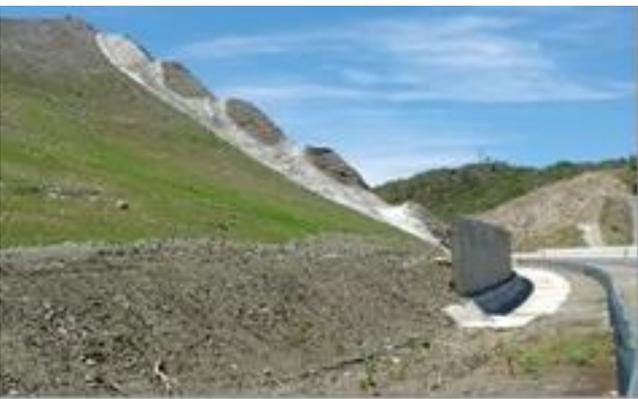
Figure 10. Final solution materialized. Wall detail for block fall control.
