A40 Brecon Bypass Landslide: investigation, remediation and asset management for climate resilience

Thomas ST JOHN¹, Hana OLIPHANT¹, Matt BUTLER¹

¹Mott MacDonald, Cardiff, United Kingdom

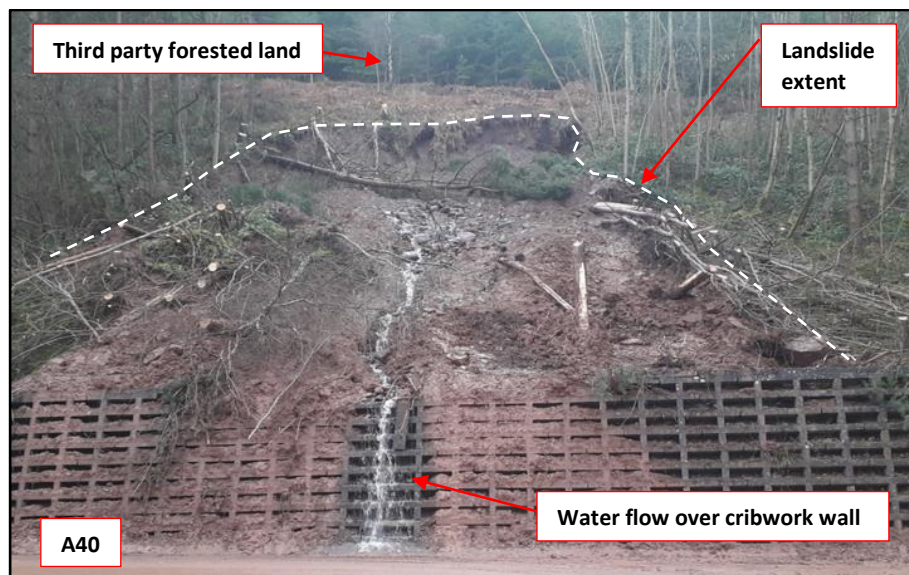
Immediate risk mitigation following the landslide involved closure of all four lanes of the bypass, with one eastbound lane re-opened on the afternoon of 17/02/2020 and lane two of the westbound carriageway re-opened on 18/02/2020, following a phase of inspection and clearance of 300 tonnes of debris. Lane one of the westbound carriageway remained closed as water continued to flow from the landslide backscar and over the cribwork wall (Figure 2) and further adverse weather (Storm Jorge) was forecast for late February 2020.

A 15m long, up to 3m high 30-50° backscar was left by the failure, below which a bowl was present in the mid slope (Figures 2 and 3). Water was issuing from the bowl and saturated debris had accumulated in the mid slope. A green plastic-coated mesh was identified on the slope, damaged by the landslide. At the crest of the cutting, a fence forms the highway boundary, parallel to which is a gravel drain. The drain was obscured by soil and vegetation and surface water flows from third party land were seen to flow over the drain and onto the cutting.

Figure 2: The landslide site following initial clearance of debris from the A40.

The cribwork wall repairs comprised replacement of missing elements that had been entrained in the landslide and repairs to damaged elements. Damaged elements were deconstructed to ascertain the reinforcement details and the additional elements were cast for potential future works. To avoid deconstruction of the wall to replace damaged elements in the lower part of the wall, the elements were broken back to fresh concrete, reinforcement added and formwork used to cast the repair. Where damage was extensive, no-fines concrete with weep pipes was used as infill to ensure continued drainage.

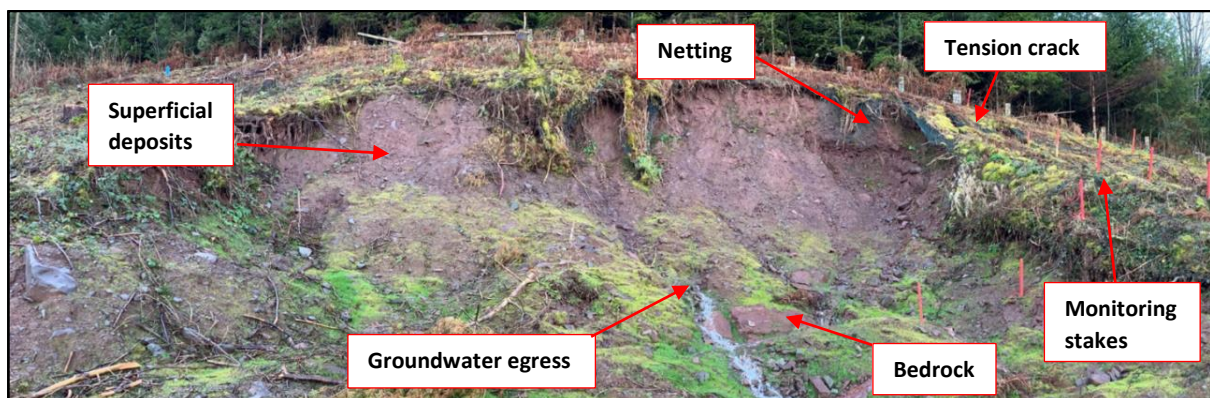
At least 3m of superficial deposits was exposed in the backscar, comprising red-brown clayey gravelly sand or silt. Within the central area of the bowl, exposures of red-brown weak siltstone and medium strong micaceous sandstone were identified, interpreted as the St Maughans Formation. At the interface of the superficial deposits and bedrock, a dominant groundwater egress was observed, with further egresses from the backscar (Figure 3).

Figure 3: Detail of the landslide backscar, showing groundwater egress and monitoring stakes.

Ground investigation was undertaken by Geotechnical Engineering Ltd as subcontractor to Alun Griffiths Ltd in October 2020. Interim risk mitigation included monthly and reactive inspections triggered when thresholds were exceeded, namely 70% of the 7-day and 24hr rainfall pre-landslide, equivalent to 100mm and 50mm, respectively. On clearance of vegetation, tension cracks were identified at the backscar extents and a series of stakes were installed and their relative offset and tilt monitored to identify any further movement (Figure 3).

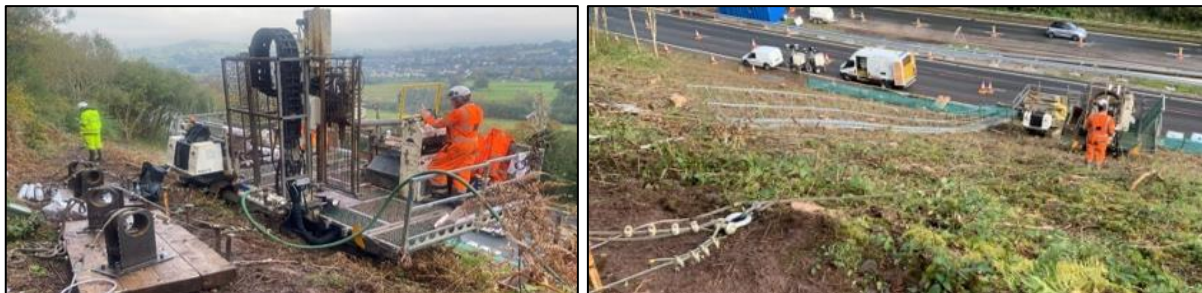
An investigation options appraisal was undertaken as part of the CD622 Ground Investigation Scoping Report. To understand the slope ground conditions, nine dynamic sampling with rotary coring follow-on boreholes were sunk using a ‘slope-climbing’ rig (Figure 4) which was lifted over the cribwork wall and onto the slope during a night road closure. Ground anchors were used to support the rig in the event of loss of ground contact. Dual-depth standpipe piezometers with dataloggers were installed within the boreholes to understand the groundwater regime. A ‘flashy’ response to rainfall events was observed for installations within the coarse superficial deposits and fractured bedrock. Deeper installations showed a less pronounced response. As exposed on site, a cover of superficial deposits was encountered and is interpreted as hill-wash (Figure 5). The ground model (Figure 6) and material parameters were documented within the CD622 Ground Investigation Report.

Figure 4: On-slope ground investigation, showing crest anchor system.

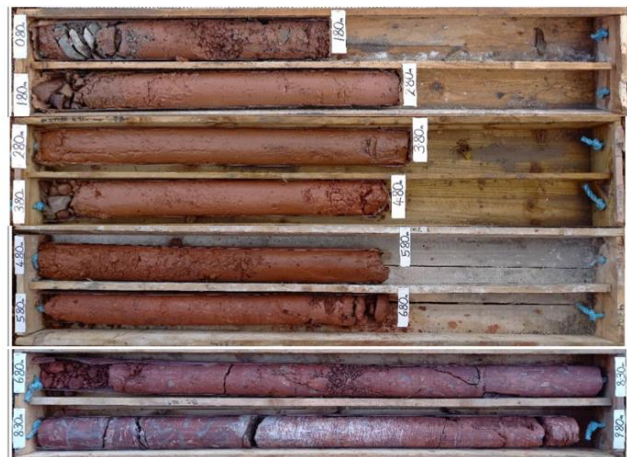
Figure 5: Summary ground model (below the crest of the backscar) and borehole core sequence.

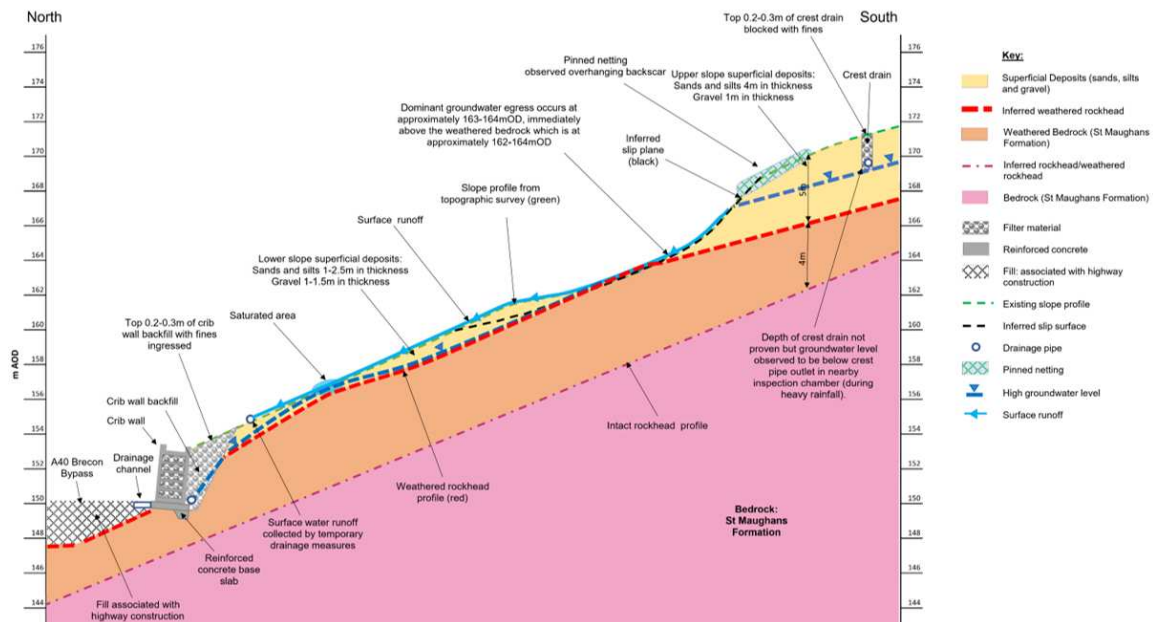
Daily rainfall data from the NRW raingauge 1km west of site spans from 1961 through the 2020 landslide. Between 15th-17th February 2020, during Storm Dennis, 99mm of rain fell, compared to the whole-February average of 111mm. Storm Dennis represents the second highest daily rainfall recorded since construction of the bypass, with Storm Callum (October 2018) representing the highest, at 106mm. 199mm rain fell over a nine-day period up to the end of Storm Dennis, compared to 151mm over the equivalent period to the end of Storm Callum. Higher magnitudes of rainfall had been experienced at the site prior to the failure event, however it is interpreted that the cumulative antecedent conditions led to the landslide. The prolonged heavy rainfall, large

catchment, inefficient crest drainage and presence of the spring are interpreted to have contributed to progressive saturation of the slope and initiation of a groundwater 'burst' type failure.

Figure 6: Conceptual ground model cross section.

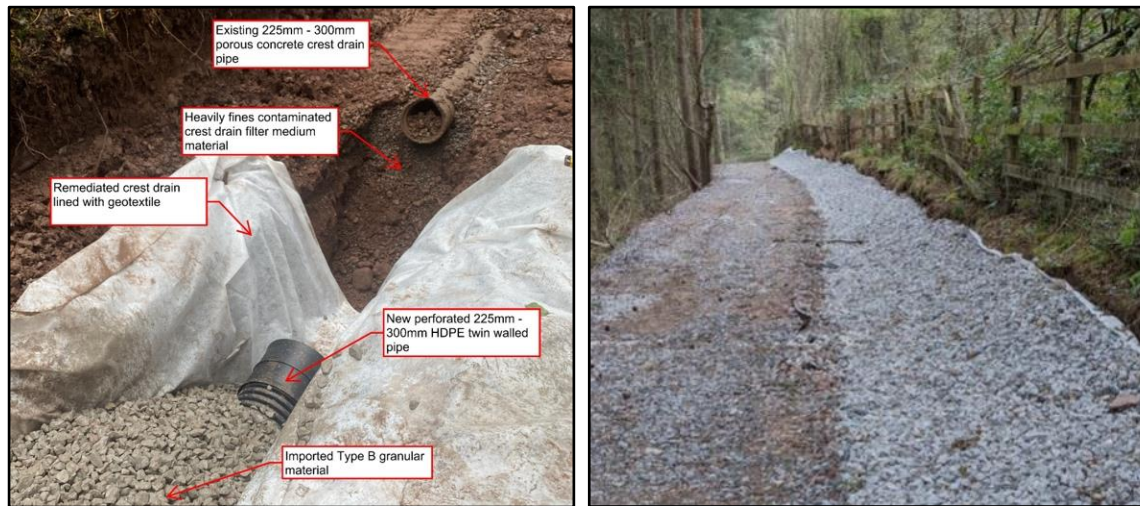
Figure 7: Renewal of the crest drain. Left: replacement of pipework and filter media. Right: completed works.

roads to the crest in addition to a fill platform within the closed lane. Renewal of the crest drain was commenced first (Figure 7). Due to fines presence throughout the filter media, clean stone backfill was imported for the new pipework. The undermined brick headwall at the Nant-y-Ceiliog outfall was replaced with a gabion solution. A 130m length of crest drain was found to have no outfall into a downslope drain where expected from the as-built drawings so modifications were made to help capture surface water and reduce infiltration.

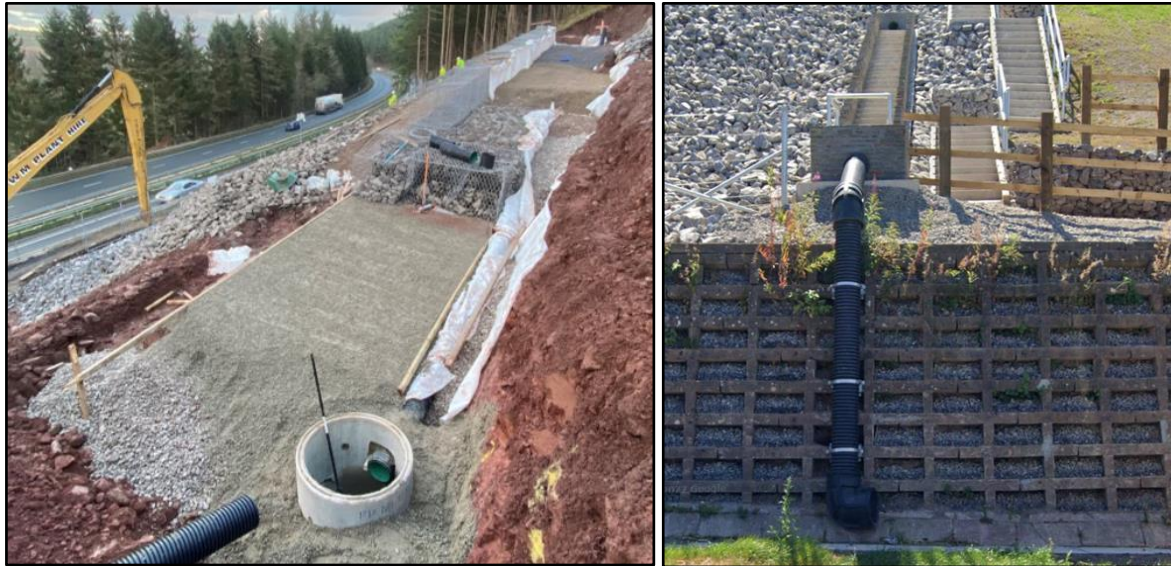
Figure 8: Left: gabion wall and associated drainage construction, right: cascade and over-wall drainage pipe.

Excavations for the gabion wall were formed in bays to manage temporary slope stability. Baskets were braced externally and hand-filled to minimise voiding and post-construction distortion. A backfall on the blinding was constructed to aid wall stability and direct water into the back of wall drainage. The drainage comprised a perforated twin-wall pipe with Type B filter media wrapped in a separator geotextile to minimise fines ingress (Figure 8). Rodding eye accesses were used in place of chambers where possible to aid constructability.

The gabion drainage discharges into a cascade via a headwall (Figure 8). A concrete apron was formed upstream of the headwall and weepholes were installed into the headwall to direct and discharge, respectively, flows in the pipe bedding from groundwater seepage. The cascade is a proprietary segmental concrete stairs product, reducing the need for formwork. The step treads were infilled with concrete and natural stone side walls were formed. The adjacent steps comprise the same product as the cascade. For additional sliding resistance, min. 1m length 25mm diameter high yield strength bars were driven into the slope and embedded within the concrete of the step treads. The cascade discharges into a PVC pipe which passes over the cribwork wall and into a channel which was enlarged to manage the increased flows (Figure 8). After a very dry early-mid 2022, water flow was observed in the drainage measures in November 2022 after heavy rainfall.

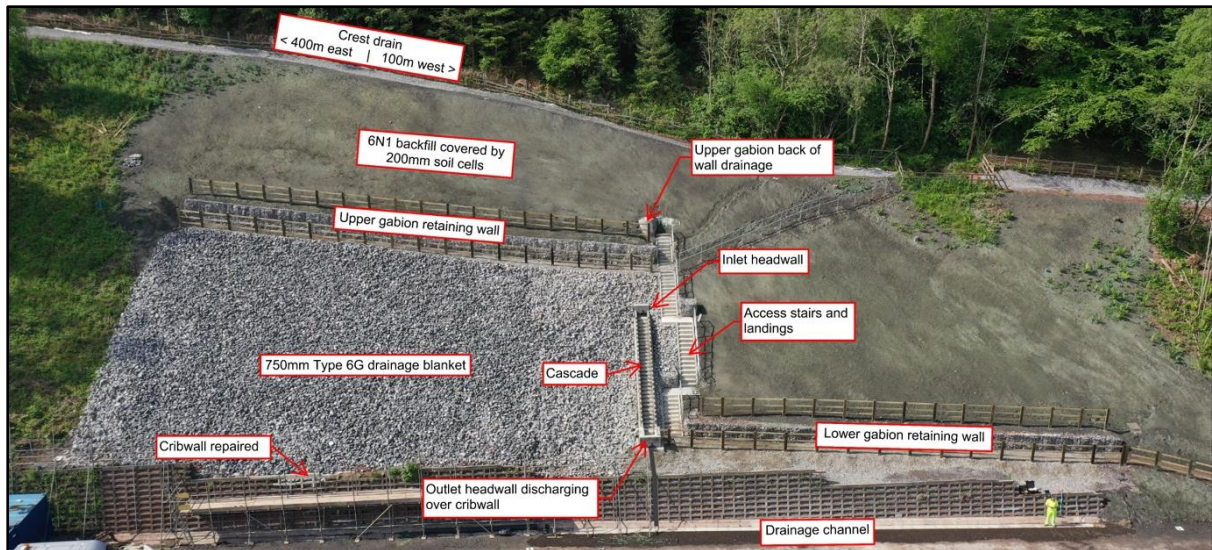
Figure 9: Drone photograph of landslide remedial works at the end of the construction phase.

The scheme was designed to be as simple and easy to maintain as possible since residual risk requires inspection and maintenance of the measures (Figure 9). Recommendations for maintenance were made within the CD622 Geotechnical Feedback Report. Key objectives are ensuring free-flow of drainage and visibility and serviceability of retention measures. A risk-based approach to inspections was recommended, with the frequency decreasing over time to the baseline DMRB CS641 requirements as the performance of the remedial measures is observed and response to weather events understood in the context of the expected behaviour. The open cascade and discharge of water into the verge channel permits immediate visual confirmation of the drainage effectiveness. Shallow gradient dedicated paths and inclusion of steps with guard rails allows safe and robust access for long-term inspection and maintenance of the retention measures, chambers and crest drain.
