## **Hugo Reservoir Embankment Depression Study**

James B. Nevels, Jr.<sup>1</sup>

The cause of unusual depressions in the embankment slopes is examined of the causeway crossing over Lake Hugo in Southeastern Oklahoma. The design of the embankment slope consisted of a rip rap armor underlain by a filter fabric and 1.22m thick sand. The failure patterns observed from the lake were oblong depressions in the riprap varying in distance from the lake pool elevation up to and near the highway shoulder. The average depression dimensions (length, width, and depth) were 7.5, 2.1, and 1.5 m respectively clay plate. The embankment interior was constructed from an unclassified borrow source consisting of predominantly silty clay but lensed with layers of clayey silt, clayey sand, and silty sand. Twelve borings originally were made to evaluate the engineering properties of the clay plate and underlying embankment material. Extensive laboratory testing in supplementary investigations, documented through the crumb, double hydrometer, pinhole, soil chemistry, and x-ray diffraction tests, confirm that the A-6 clay plate material used was highly dispersive. The original design had specified an A-7

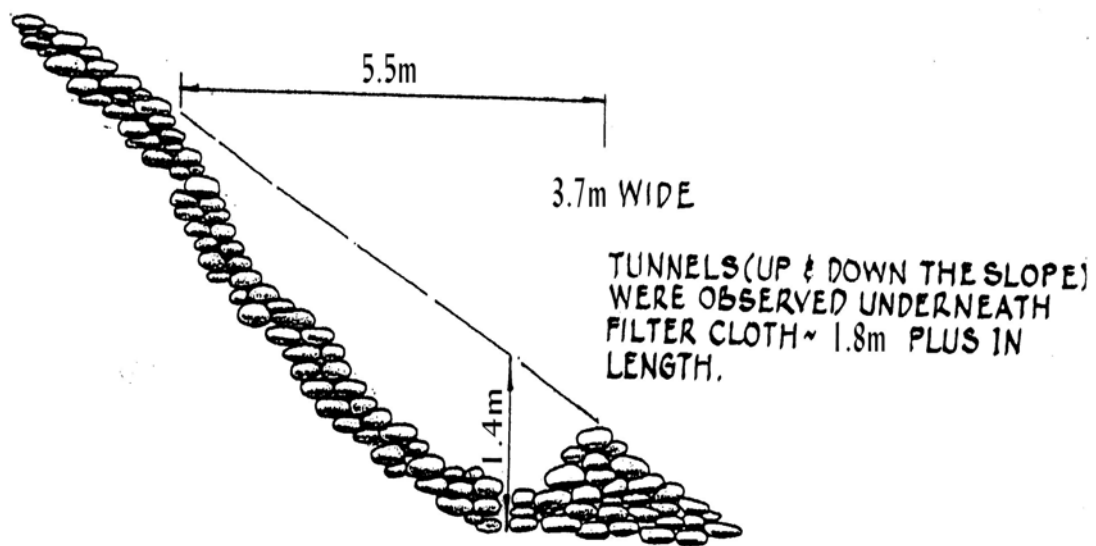
Figure 2 - Two Dimensional View of Typical Depressions

A detailed survey was first made of the 126 depressions by a field party in which the location of the depression in reference to the centerline of survey, length, width, and depth were recorded. Riprap was removed from slope in order to measure the depressions in the clay plate. The failure patterns observed from the lake as well as by physical measurement had the appearance of oblong depressions. The mean depression length, width, and depth measured were 7.5, 2.1, and 1.5 m respectively. Figure 2 presents a two dimensional view of the typical depression shape. It was observed that once the riprap and filter fabric had been removed, several depressions showed erosion tunnels and rills running up the slope. The clay plate material was observed to highly fissured. An unusual feature found in the clay plate construction was an approximately 0.5 m thick sand with gravel layer found in both cross sections slightly above the lake pool elevation, see Figure 3. No explanation was ever given by the Division 2 construction engineer.

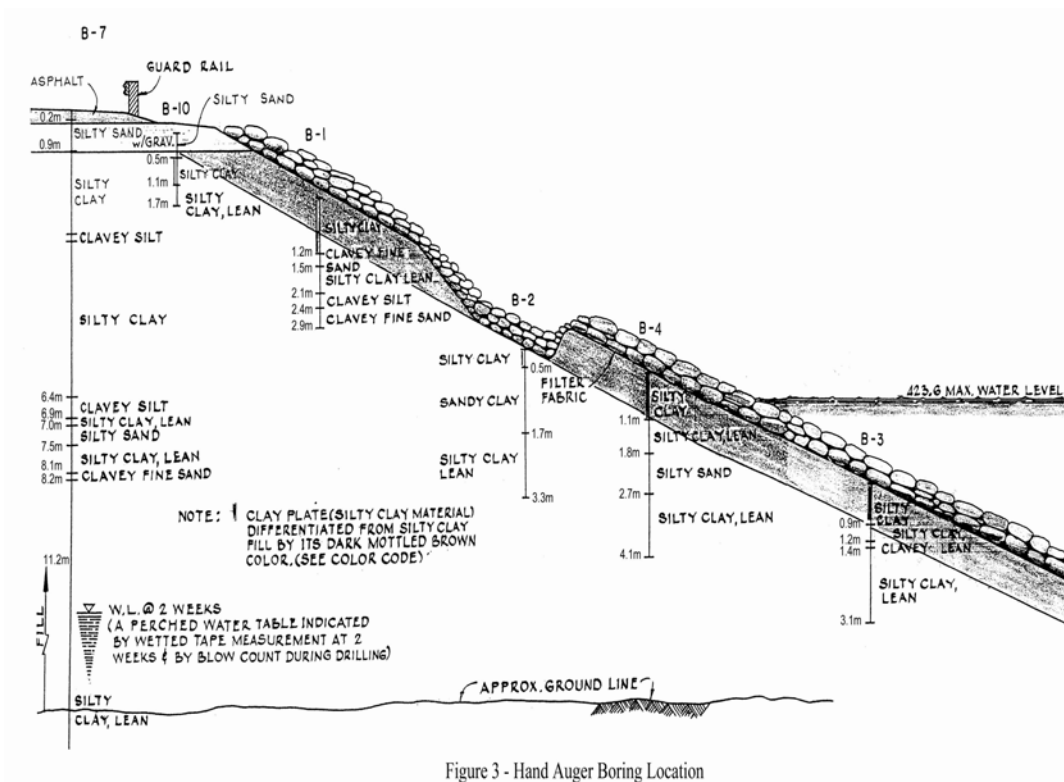
Figure 3 - Hand Auger Boring Location

hand auger borings 1 through 4 at station 500+30 were duplicated, see Figure 3. These borings were sampled at 100-mm intervals to a depth of 1.22 m.

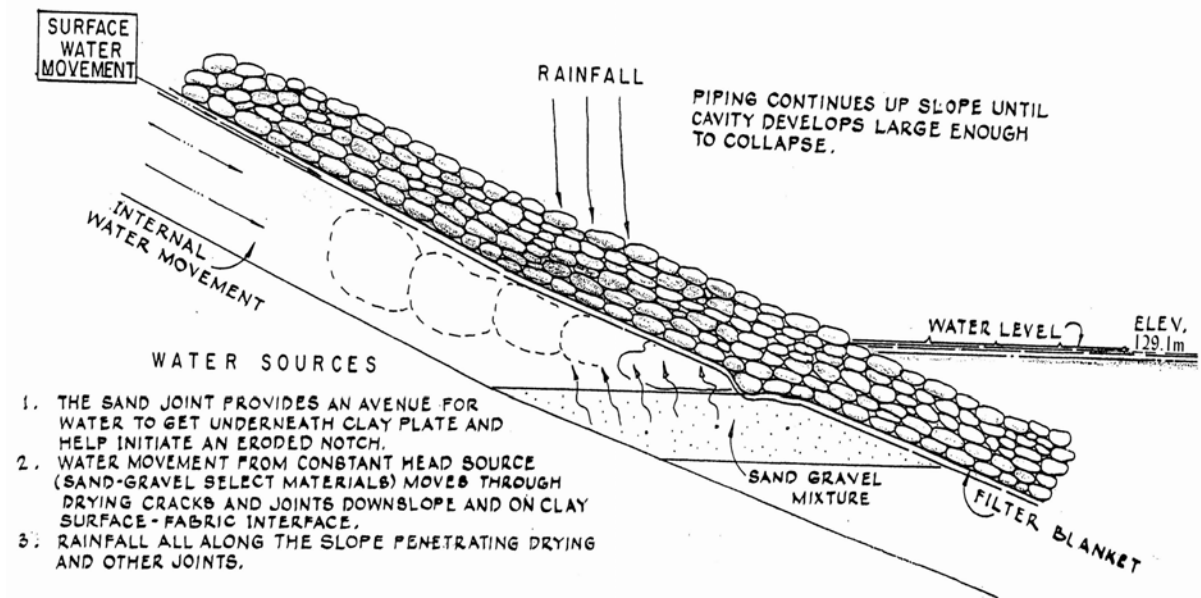
Figure 4 - Sources of Water

The sources of water that promote the formation of the depressions are presented graphically in Figure 4. It appears that the significant source of water was the sand and gravel layer discovered near the midpoint of the clay plate slope, providing an avenue for lake water to enter into the embankment. Other sources of water are rainfall on the slope and parallel internal seepage. The latter two sources of water would be dependent upon cracks and fissures in the clay plate soil, which were documented in the field investigation.

It can generally be concluded from the battery of tests performed that the depressions are the result of dispersive soil behavior. Also there is the likelihood that an unexplained construction deviation from the plans in the form of a sand and gravel layer near mid height of the clay plate layer facilitated the formation of some of the depressions.

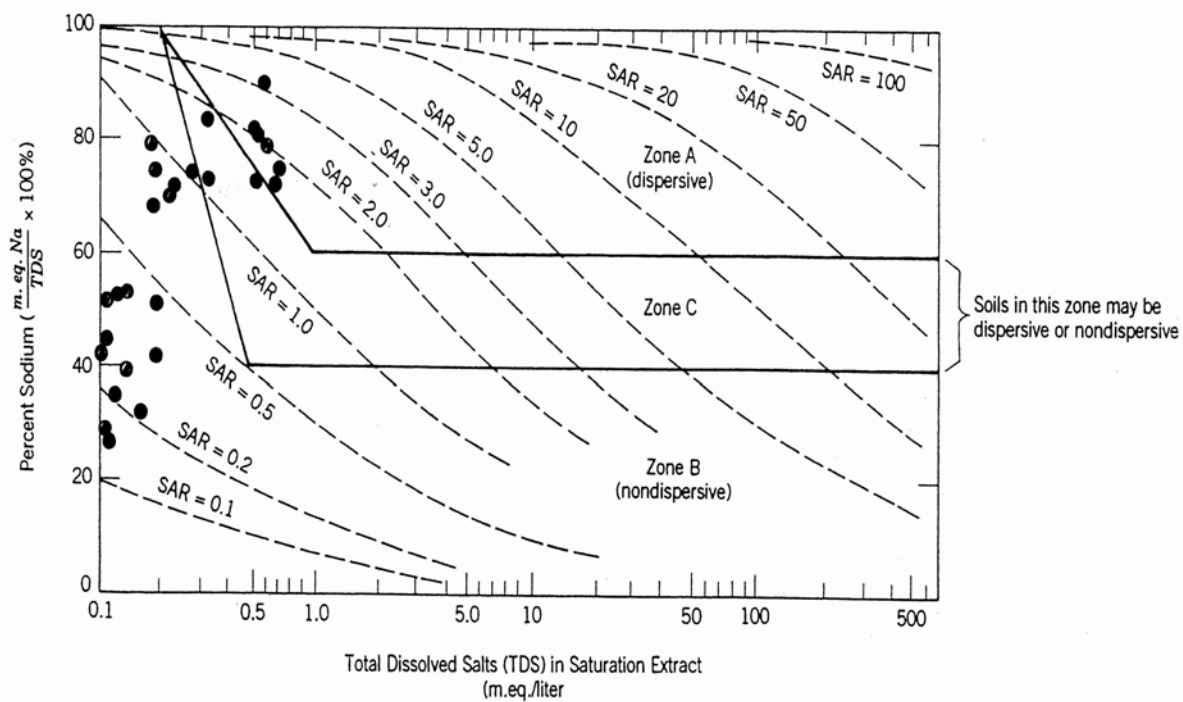
Figure 5 - Relationship Between Dispersive Soil Classes and Total Dissolved Salts

In the chemical analysis test results from Table 3, a sample of the pore water is extracted from saturated slurry and analyzed for cations. A total of 55.2 percent of the samples was found to have more than 60 percent of their total salts being sodium, which indicates dispersive soils. A review of the relationship between dispersive soil classes and total dissolved pore water salts (Sherard et al., 1976) can be seen in Figure 5. Results indicate only 17.2 percent of the samples can be classified into Zone A for dispersive soils with the vast majority, 72.4 percent ranked in the nondispersive Zone B and the remainder in transition Zone C. The estimate for this result is at very low total salt concentrations, higher percentages of sodium may occur in samples and the samples still not have dispersive field behavior. Because so few salts occur in these soils, the influence on the soil behavior is minimal. Also from Table 3, the SAR and ESP provide a good indication of the stability of clay soil structure to breakdown and particle dispersion. A SAR between 4 and 12 (Carter et al., 2000) provides a good indication of soil dispersion and results show that 67.9 percent of the samples tested are potentially dispersive. Soils with an ESP greater than 2 percent may be susceptible to spontaneous dispersion (Mitchell, 1993). Results from Table 3 indicate that 84.4 percent of the samples are dispersive.
