*The paper was published in the proceedings of the 1<sup>st</sup> International Conference on Scour of Foundations and was edited by Hamn-Ching Chen and Jean-Louis Briaud. The conference was held in Texas, USA, on November 17-20 2002.*

## **Scour of Railway Embankment Foundation Located on Sea-Cliff in Japan**

Hiroto Suzuki <sup>1</sup>, Makoto Shimmura<sup>2</sup>

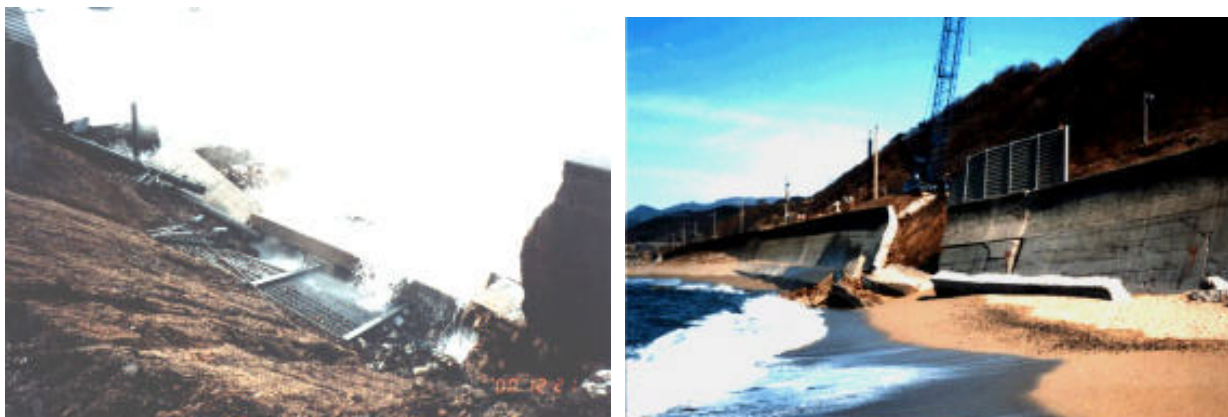
Photo 1 The collapse site of the wave protection work and the embankment

Photo 1 is photographs of the collapse site. Figure 2 shows the section and plane diagram of the collapse site of outbound line. The basement rock in and around the collapse site is granite formed from the latter term of Cretaceous period to Paleogene period. Upper layer of it is decomposed granite. The embankment made of silt was constructed on it. This site has 137 m long and from 5 m to 7 m high wave protection work of the railway embankment. The masonry protection work was constructed in 1924, when the present outbound line was laid. In 1954 the front of the masonry protection work was reinforced by concrete and the concrete parapet was constructed, and moreover in 1955 the concrete consolidation of foundation was constructed at the foundation of the wave protection work. In 1997 the splash protection fence was built at the top of the wave protection work, because splash can easily go over the top of the wave protection work, when it was high waves.

The wave protection work and the embankment with 21.7 m width and 6.5 m height collapsed due to scour of the wave protection work foundation. The slope failure reached up to the track ballast layer. The volume of the soil collapsed was about 450 m<sup>3</sup>. Moreover about 30 m section each of both sides of the wave protection work collapse was out of the perpendicular.

apart, Thereafter urgent repair work of the collapse site was completed on February 5, 2001, train operation to use outbound line and inbound line was recommenced. In the present repair work is under construction, and it will be completed on December 2003.

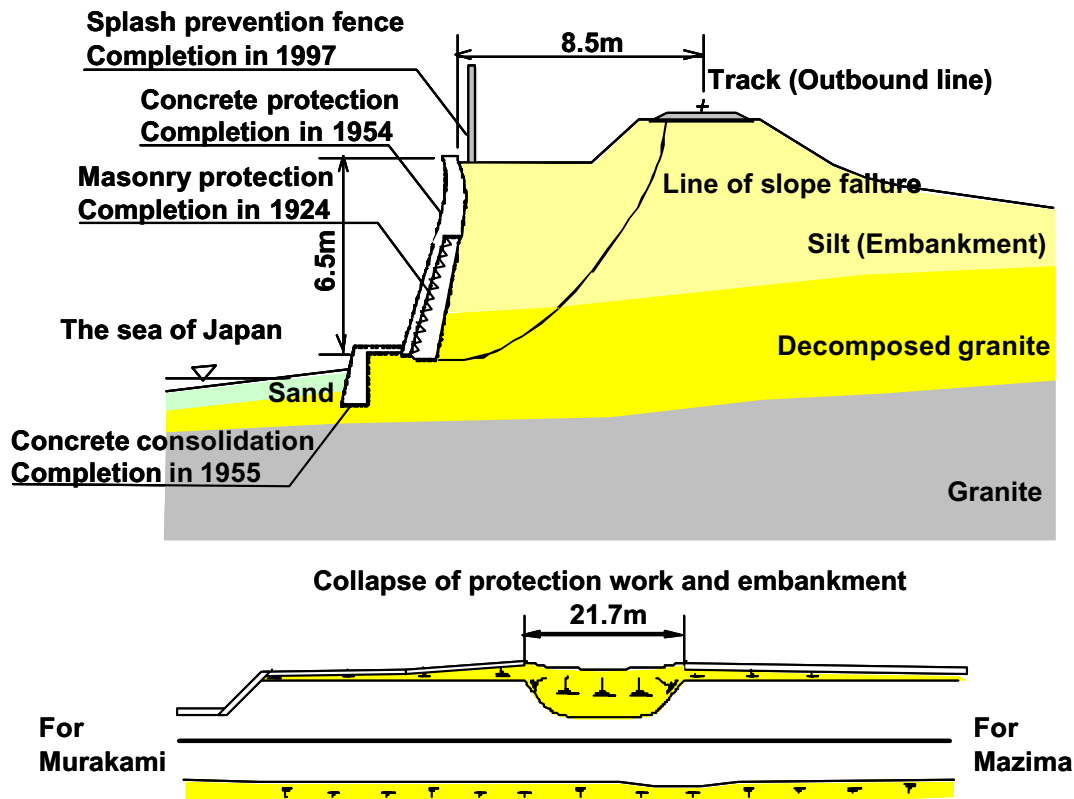
Figure 2 The section and plane diagram of the collapse site

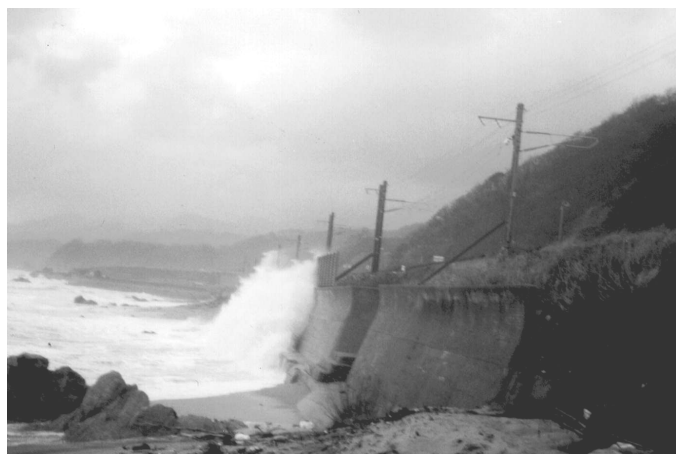
Photo 2 shows the waves condition of the collapse site before 2 hours of the collapse occurrence, at about 17 o'clock on December 19. The sea was rough and splash covered on the railway track. These high waves seem to be the immediate cause of the wave protection work collapse.

Photo 2 The waves condition of the collapse site before 2 hours of the collapse occurrence

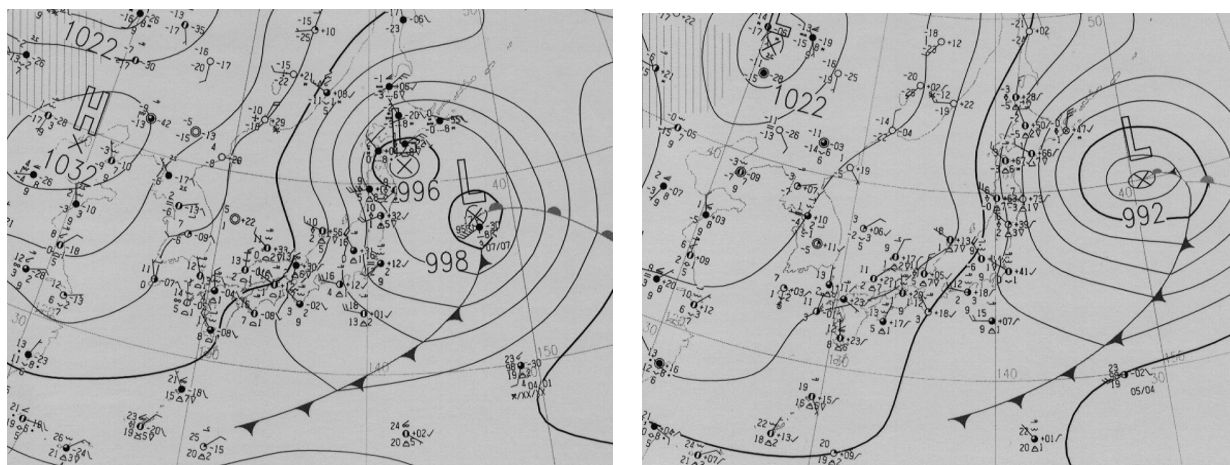
Figure 3 Weather maps at 15 o'clock(left) and 21 o'clock (right) on December 19, 2000. At 15 o'clock there were two deepening lows in the Pacific Ocean which traveled toward the northeast. At 21 o'clock two lows became one and the pressure of low was lower. In the Eastern and Northern Japan it blew strong wind under influence of these lows.

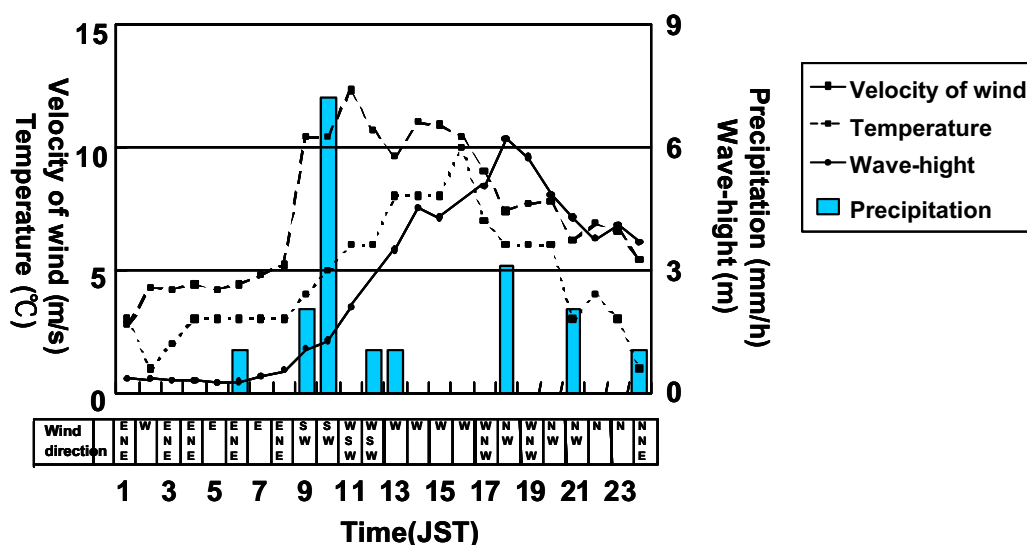
Figure 4 shows time history of wind velocity, precipitation, and temperature at Murakami(Figure 1), where is the nearest meteorological observation site of Japan Meteorological Agency(JMA) from the collapse site. The wind direction changed from east-north-east to south-west, and temperature rose at about 9 o'clock. At that time the low passed over near Murakami. After this the wind velocity grew gradually strong, and

Figure 4 Time history of wind velocity, precipitation, and temperature at Murakami, and significant wave height at Atsumi on December 19, 2000

the maximum wind velocity which is 10 m/s was recorded at 16 o'clock. 0 to 12 mm hourly rainfall was observed, but it was not a heavy rain to cause of the wave protection work collapse.

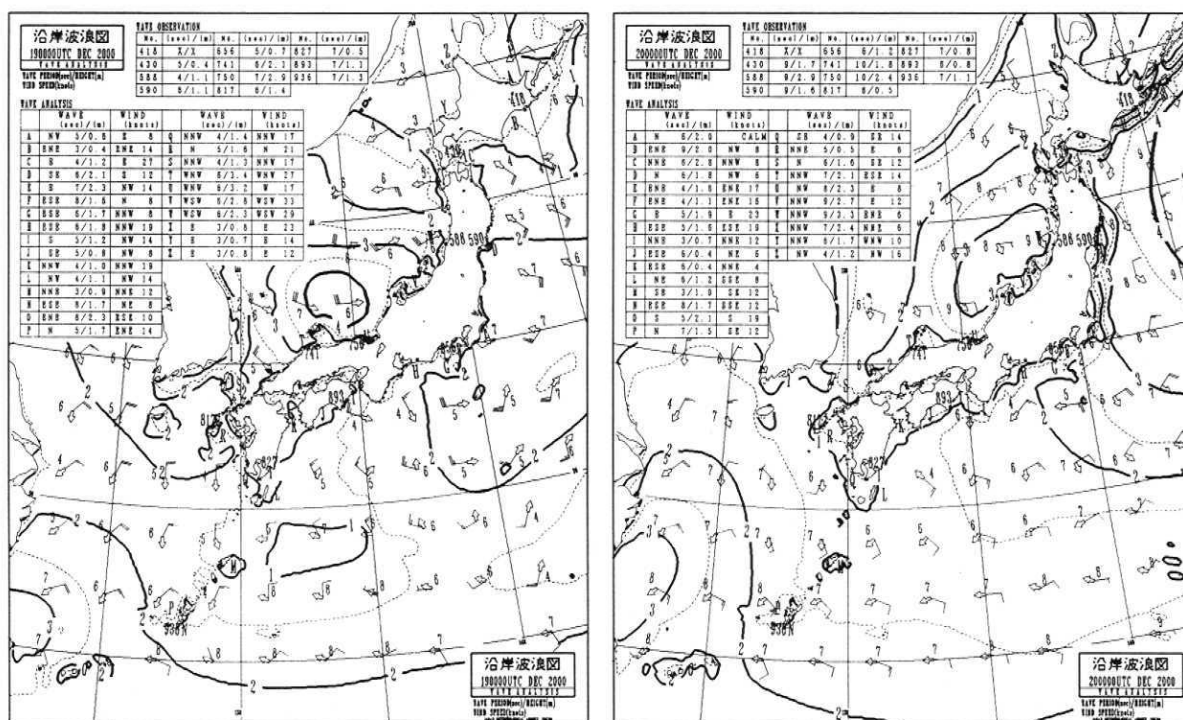
Figure 5 is wave maps at 9 o'clock on December 19 and 20, 2000. In the eastern area of the Sea of Japan waves were high. Figure 3 also shows time history of significant wave height at Atsumi (Figure 1), where is the nearest wave observation site of JMA from the collapse site. The significant wave height grew gradually high from 9 o'clock. The maximum significant wave height and wave height, which were 6.19 m and 11.8 m, were recorded at 18 o'clock when almost accords with the time of the wave protection work collapse. Table 3 shows returns period of them, it is below 2 years.

Figure 5 Wave maps at 9 on December 19 and 20, 2000

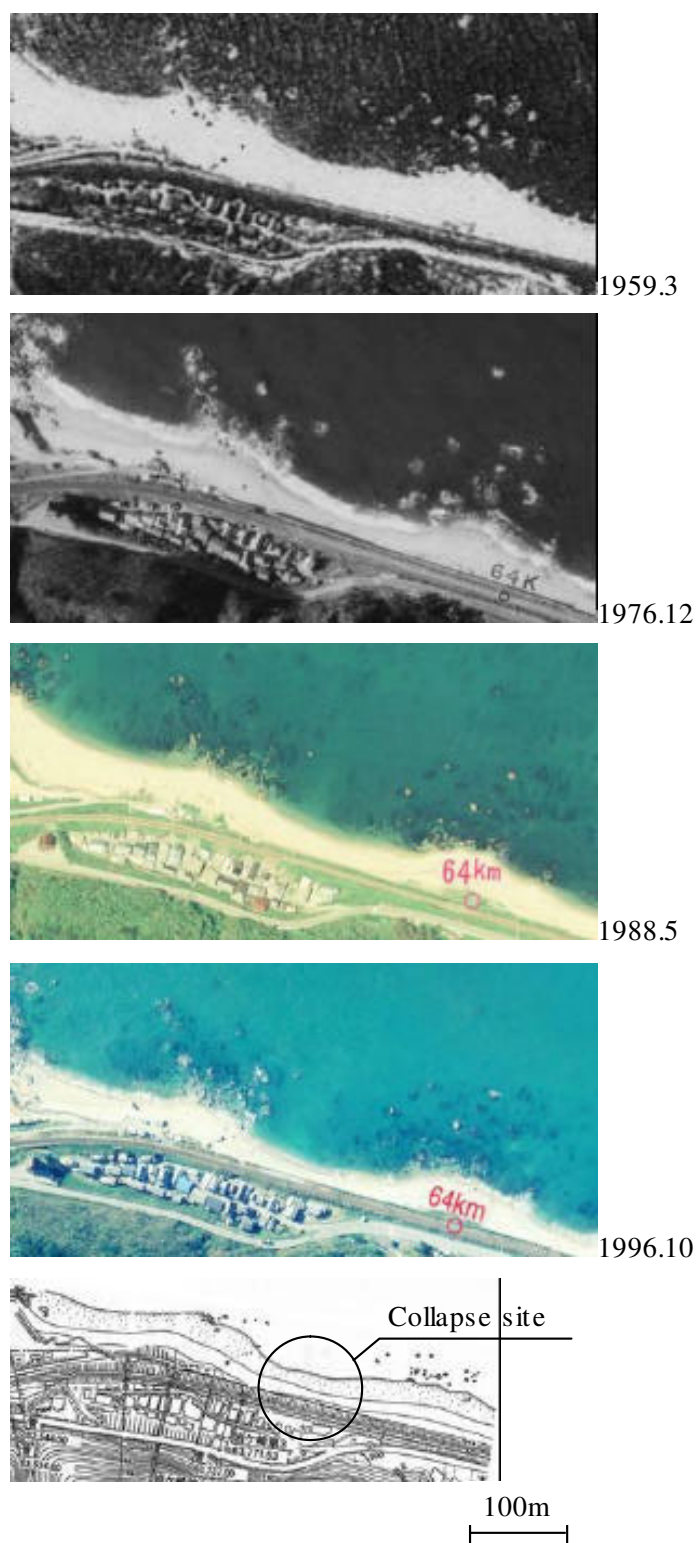
Figure 6 is aerial photographs and plane diagram in and around the collapse site. In some place of seashore there are outcrops of granite. But there is no outcrop in front of the collapse site. The length of sandy beach of no outcrop site is shorter than one of outcrop sites. According to photograph decipher, the length from the wave protection work to beach line was 40 m in 1959. However, it gradually decreased, in 1976 it was 20 m, and in 1988 it was 18 m, and in 1996 it became 13 m.

The cause of the seashore retreat seems to be the decrease in sand supply from Miomote river. There is the mouth of this river at a distance of 1 km from the collapse site. At the upper reach of this river, Miomote dam and Saruta dam were built in 1953 and 1957. It is most probable that the decreases in supply of sand from rivers were

Figure 6 The aerial photographs and plane diagram in and around the collapse site.

Wave energy hitting the wave protection work gradually increased with the progress of the seashore retreat. From about 1996 splash became to easily go over the top of the wave protection works, when it was high waves, as a result, in 1997 the splash prevention fence was built at the top of the wave protection work. Therefore the seashore retreat seems to work as the indirect cause of the scour and collapse of the wave protection work.

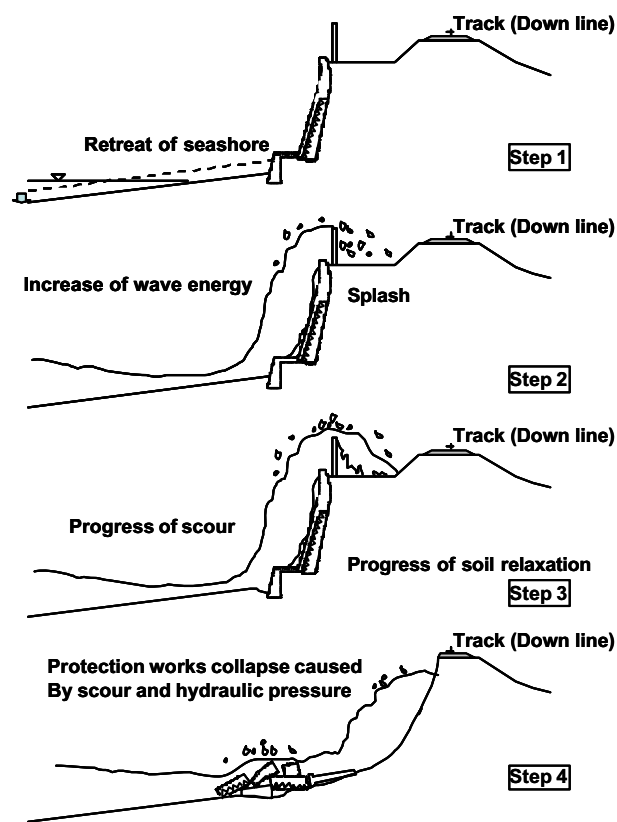
According to the meteorological data analysis and aerial photograph decipher, the immediate cause of the collapse is the attack of high waves reduced by strong wind, and the indirect cause is the seashore retreat at the collapse site. The presumption mechanism of the damage process is as follows (Figure 7):

1. The seashore in the front of the collapse site gradually retreated by decrease in sand supply.
2. Wave energy hitting the wave protection work increased by the seashore retreat. Moreover splash became to easily go over the top of the wave protection work.
3. The foundation of the wave protection work was gradually scoured by high waves. Moreover soil relaxation progressed with sea water by splash.
4. The wave protection work and embankment collapsed by the scour of the wave protection work foundation reduced by high waves attack on December 19, 2000. Moreover the increase of hydraulic pressure in embankment with sea water supplied by high waves is presumed to affect the slope failure.

Figure 7 The process of the wave protection work collapse
