The paper was published in the proceedings of the 11th International Conference on Scour and Erosion and was edited by Thor Ugelvig Petersen and Shinji Sassa. The conference was held in Copenhagen, Denmark from September 17th to September 21st 2023.

The role of gravel shoals on scour and erosion in the Yellowstone River during the 2022 flood event - initial observations

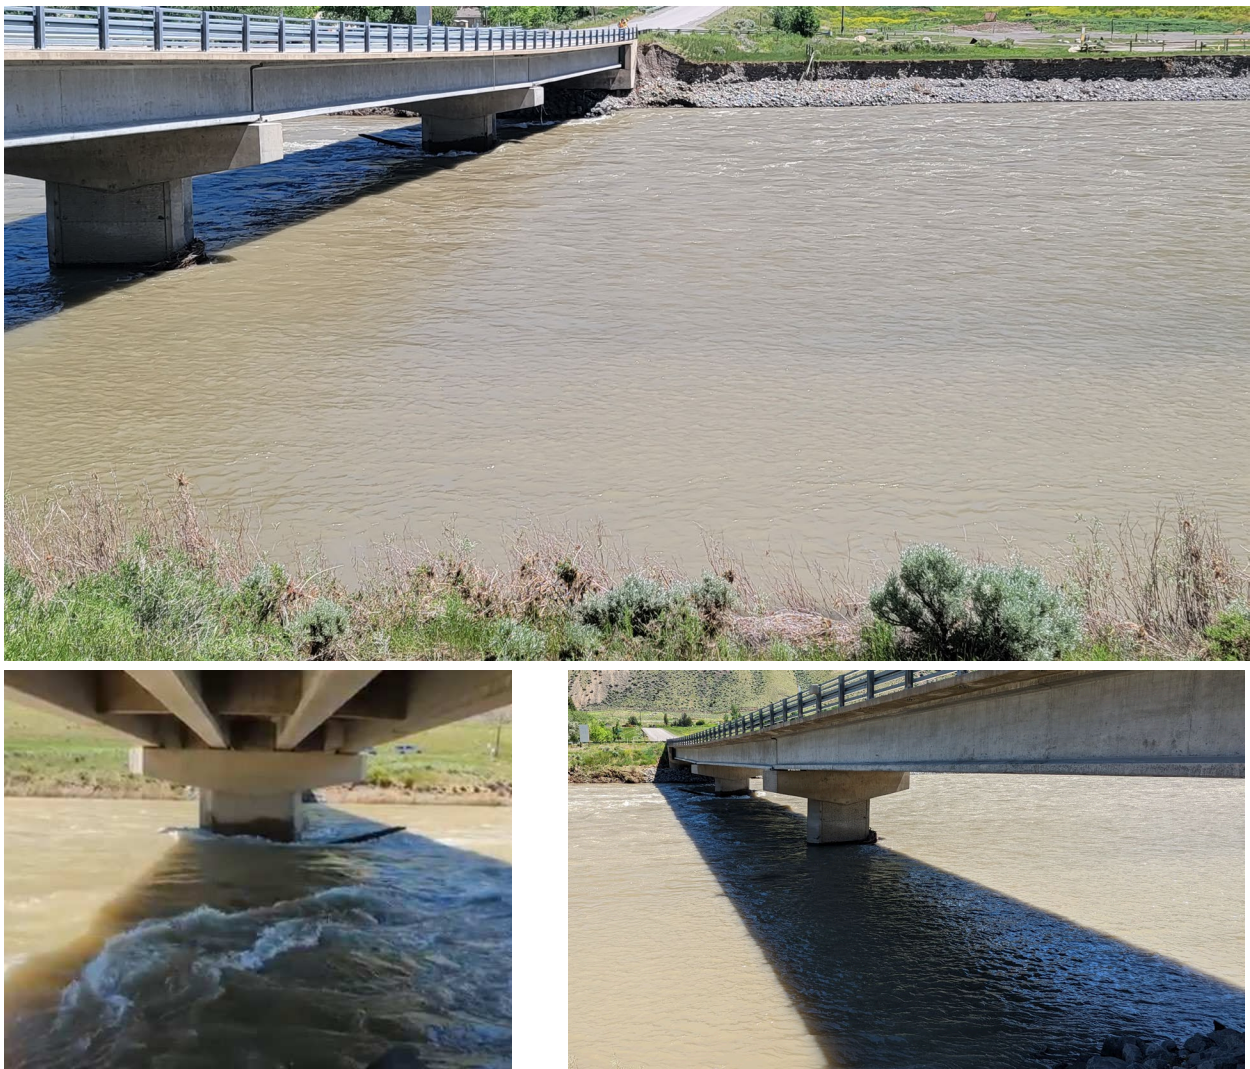
The bridge was in good condition during the GEER reconnaissance mission and fully functional. However, asymmetric flow seemed to apply to the northeastern versus southwestern bridge sides, and diagonal erosional and depositional sediment relocation patterns were visible. Figure 3 (top) shows the upstream side of the bridge looking from the southwestern side to the northeastern river bank. Comparison of qualitative flow appearance at the two bridge piers suggested no visible turbulence at the southwestern bridge pier but significant turbulence as well as debris wrapped around the bridge pier at the northeastern pier. Looking from the downstream side, whitewater in the shape of a horseshoe wrapped around the front and sides to the lee of the northeastern pier (Fig.

Figure 3. Photographs of the Cinnabar Basin Rd bridge from June 30, 2022: Top: from upstream southwestern bank; bottom left: from northeastern abutment; bottom right: from downstream southwestern bank.

3 bottom right), and a view from the northeastern abutment shows also significant turbulence between the northeastern abutment and bridge pier (Fig. 3 bottom left).

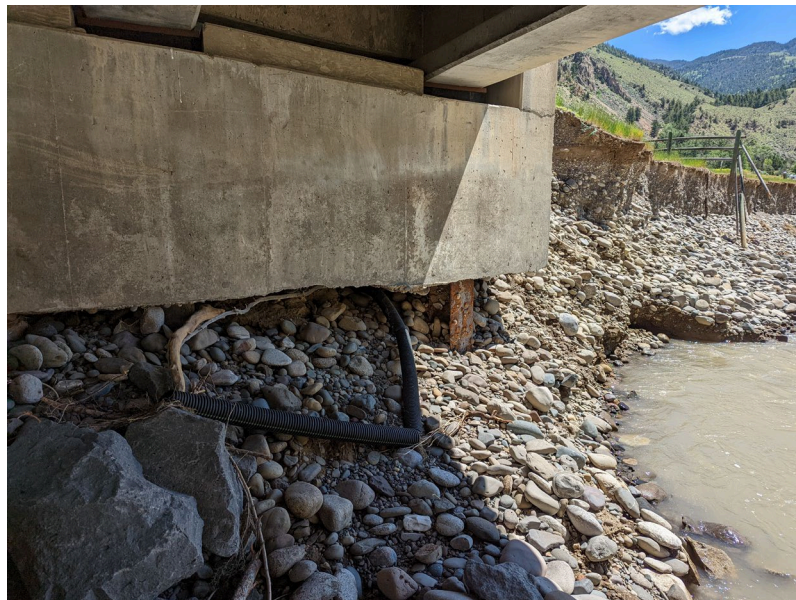
Significant erosion on the order of meters from the pre-flood location of the riverbank was visible on the upstream northeastern riverbank with significant erosion at the upstream side of the northeastern bridge abutment (Fig. 3 top), leading to undermining of the concrete structure and exposure of the metal piles (Fig. 4). The erosion of the riverbank exposed a gravelly sand top layer, underlain by sandy gravel, and a gravel bottom and toe. Even coarse gravel and cobbles seemed to be removed within a scour hole that developed in front of the upstream abutment corner (Fig. 4). On the other hand, the upstream southwestern river bank featured sandy deposits with multiple deposit terraces and ripple development with sand ripple wave length on the order of 10 cm (Fig. 5).

Figure 4. Photograph of upstream corner of northeastern bridge abutment and riverbank.

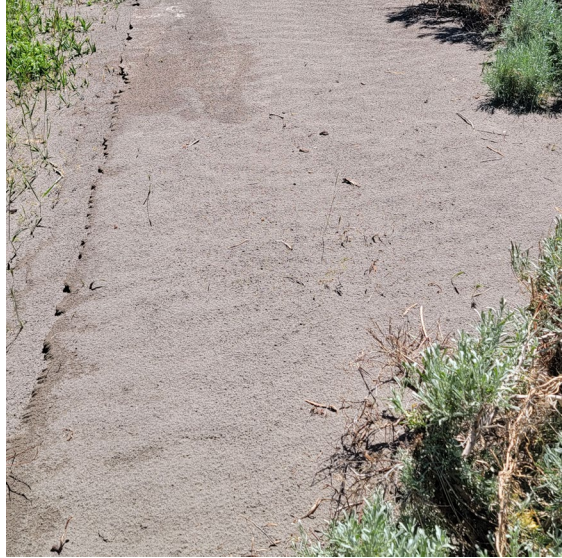
Figure 5. Photograph of sand deposits upstream of the southwestern bridge abutment. Sand ripple wave length was approximately 10 cm.

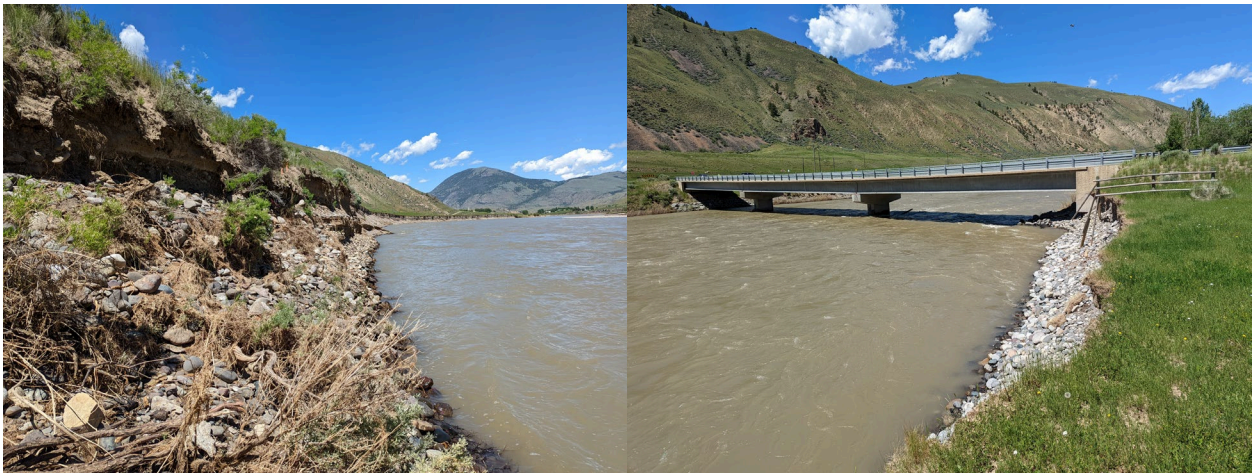
Vice versa, downstream of the bridge, erosion was prominent at the southwestern riverbank (Fig. 6). Reports from residents and high water marks confirmed significant inundation of the noticeably flatter downstream northeastern riverbank, but neither significant deposits nor significant erosion was obvious to the reconnaissance team

Figure 6. Erosion at the southwestern riverbank downstream of the bridge.

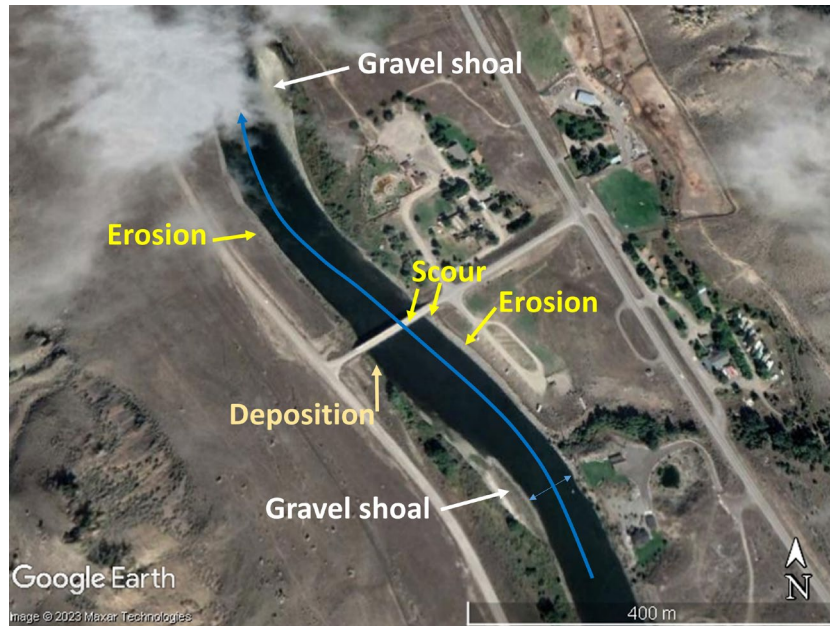
In summary, a diagonal pattern of erosion and deposition was observed from upstream to downstream of the bridge with strongest flows being directed at the northeastern bridge abutment and pier (Fig. 7). It is apparent that this results from slight meandering of the river that seemed to have increased over time with the bridge being located where the river meandering switches from a left-bend meander to a right-bend meander (looking downstream), and it may be hypothesized that this effect is exacerbated by inner meander deposition shoals being composed of coarse gravel and cobbles while riverbanks feature upper layers of sand and sand-gravel mixtures that are significantly more erodible.

Figure 7. Annotated Google Earth image highlighting erosion and scour hotspots in the context of the river meander and gravel shoals.
