A retrospective view on liquefaction-induced flowslide and lessons learned - an example of Petobo failure incident during 2018 Palu-Donggala Indonesia earthquake

M. Chang¹, T.C. Upomo², R. Kusumawardani³, G.A. Prayitno⁴, N.M. Ermansyah⁵, and C.J. Yang⁵

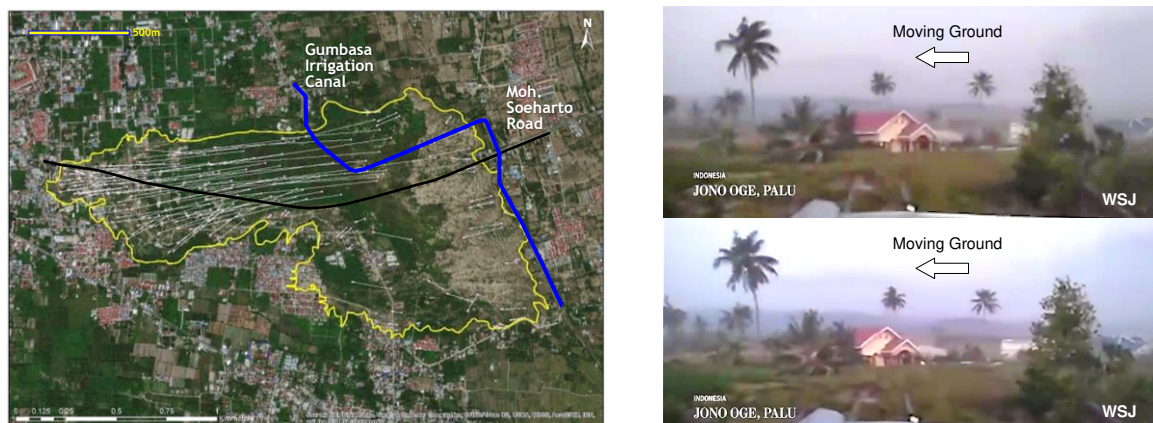
Four major landslides occurred in the areas of Balaroa, Petobo, Jono Oge, and South Sibalaya of Palu valley, with distances approximately 3~30Km south of the bay, or 65~90Km from the epicenter of the earthquake. All of these landslides were triggered by soil liquefaction during the shaking and resulted in long-distance sliding of ground of several hundreds of meters. The Petobo sliding, as shown in Figure 1(a), was the most severe one in terms of its casualty, damage and sliding distance (>1,000m). Figure 1(b) illustrates the moving ground during the course of sliding in Jono Oge area, as indicated by relative movements of the houses and the nearby trees.

Figure 1. (a) Displacement vectors of the 2018 Petobo slide (left; Kusumawardani et al., 2021). (b) Snapshots of moving ground from the videos taken at Jono Oge (right; WSJ, 2018).

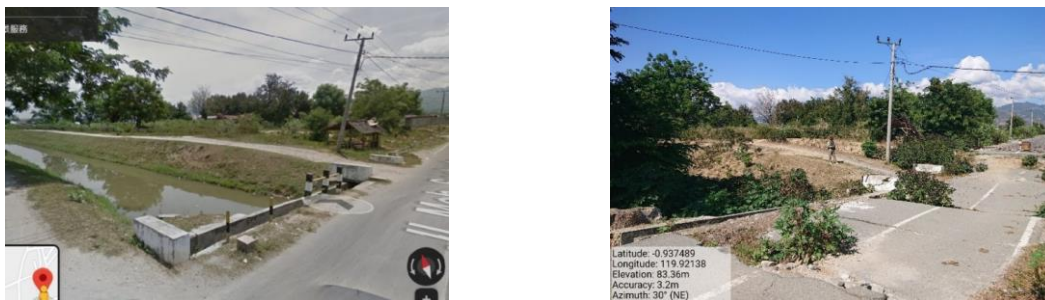
Reconnaissance of the landslide failures were conducted shortly after the earthquake by several parties worldwide (PuSGeN, 2018; Cummins, 2019; Bradley et al., 2019; Watkinson & Hall, 2019; GEER, 2019; Kiyota et al., 2020; Okamura et al., 2020). Preliminary findings generally agreed the liquefaction-induced sliding with the observed sand boils and ponds at or near the landslide sites. All of the landslide areas were situated on the sloping flanks of Palu valley with minor reliefs of less than 5% ($<3^\circ$); facing eastwards (Balaroa) and westwards (Petobo, Jono Oge, South Sibalaya) to Palu river running south to north through the valley. Except Balaroa site, all of the landslide areas bordered their crests to the Gumbasa canal, a major irrigation channel constructed during 1910s by Dutch that extended more than 30km from south to north along eastern flank of the valley. The Gumbasa canal was mostly unlined and constantly

filled with water throughout the years based on witness accounts. It was also observed that widespread wet paddy fields existed on the downslope side of Gumbasa canal prior to the earthquake.

Figure 2. Gumbasa canal at the crest of Petobo slide footprint, before (left) and after (right) the 2018 earthquake (Kusumawardani et al., 2021).

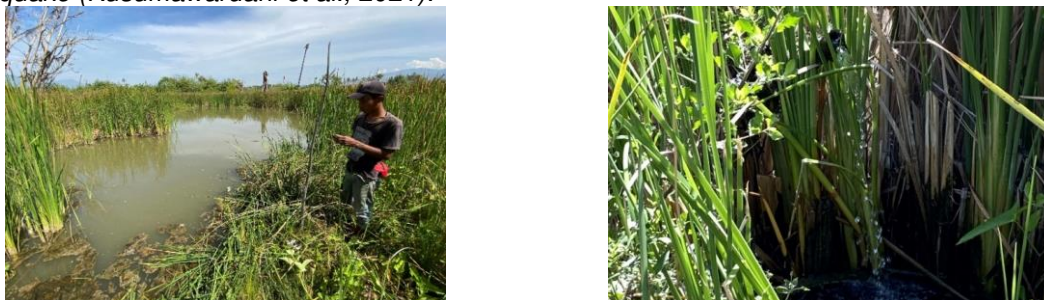
Ample evidences had revealed ponds, springs and sand boils were extensive near the toe and crest of sliding area soon after the failure (GEER, 2019; Kiyota et al., 2020). Based on our site reconnaissance and witness interviews in 02/2020, victims reported water with sands erupted from the ground during the sliding, and then ponded the softened surface after the slide (Kusumawardani et al., 2021). The phenomena might have been due to the originally high groundwater levels of the area and the pore water being squeezed out of the liquefied ground. Local victims also indicated the constantly-full unlined Gumbasa canal and its irrigation system, as well as the extensive wet-paddy fields that were filled with irrigation water, during Feb-May and Aug-Nov of the year (Kusumawardani et al., 2021); suggesting the groundwater levels prior to the 2018 slide should have been very close to the ground surface.

Figure 3. Surface ponding (left) and artesian waters (right) in the middle of Petobo slide footprint during 02/2020 site reconnaissance (Kusumawardani et al., 2021).

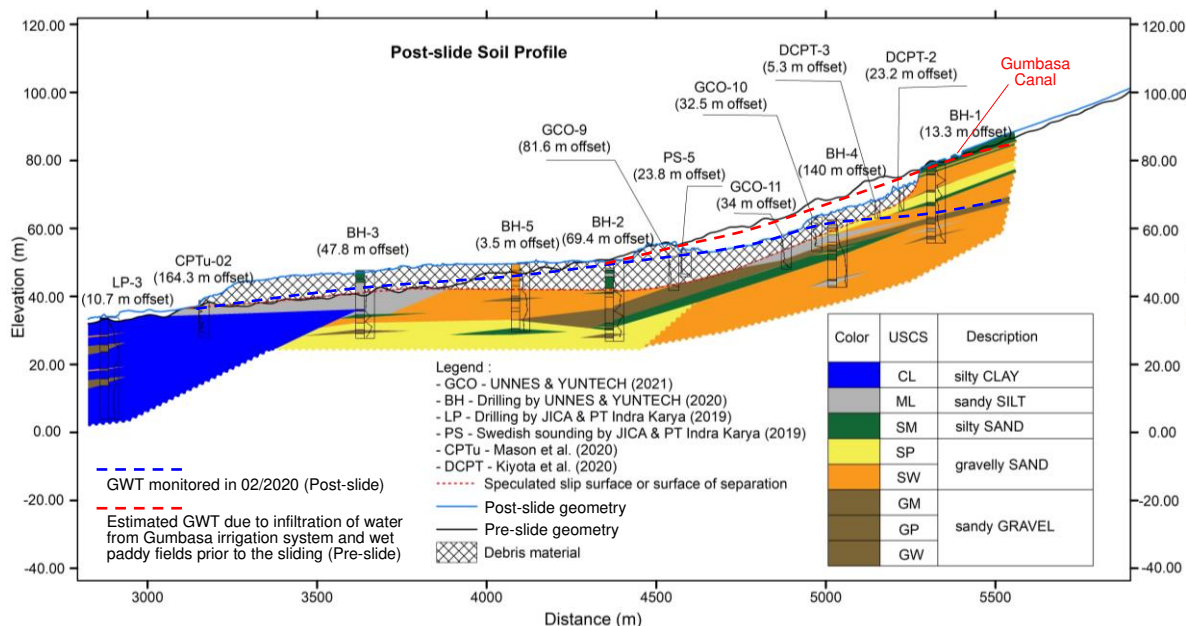
We also carried out subsurface exploration, geo-resistivity surveying, and groundwater monitoring along the EW main road (Moh. Soeharto Rd.; location shown in Figure 1) of the Petobo area, and results are summarized in Figure 4. The post-slide investigations indicated the groundwater level in the upper portion near the sliding crest had substantially dropped by 10~15m, as compared with its pre-slide situation. In the mid-upper portion, the groundwater level was close to its post-slide surface; while in the mid-lower portion, the groundwater level was approximately parallel to the pre-slide geometry.

Figure 4. Post-slide material profile along EW cross-section (Moh. Soeharto Rd.) of Petobo area with monitored / estimated groundwater tables (GWTs), respectively, after / before the 2018 earthquake.

In accordance, the evidences observed soon after the failure by other parties, as well as the additional information obtained during our investigation of 02/2022 suggest the original groundwater table in the upper portion of slide footprint had been substantially raised prior to the earthquake shaking, as shown by “Blue” and “Red” dashed lines in Figure 4, which appeared to be the results of constant infiltration of water by Gumbasa irrigation system and wet paddy fields of the area.

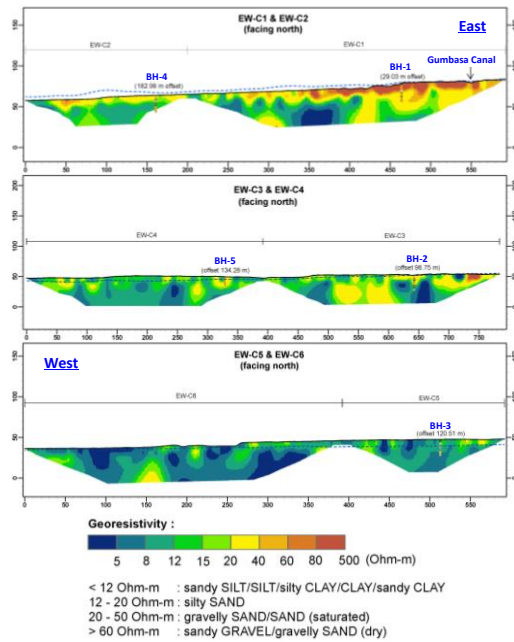
Figure 6. Results of geo-resistivity surveying along EW cross-section (Moh. Soeharto Rd.) of Petobo area during 02/2020; (up) E-segments, (middle) mid-segments, (down) W-segments.

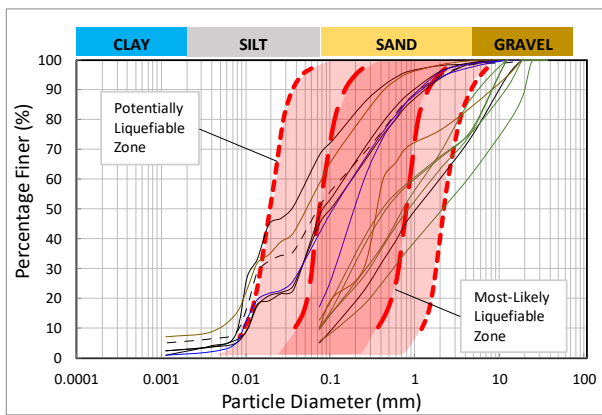
Figure 7. Grain-size distributions of SPT soil samples within Petobo sliding area.

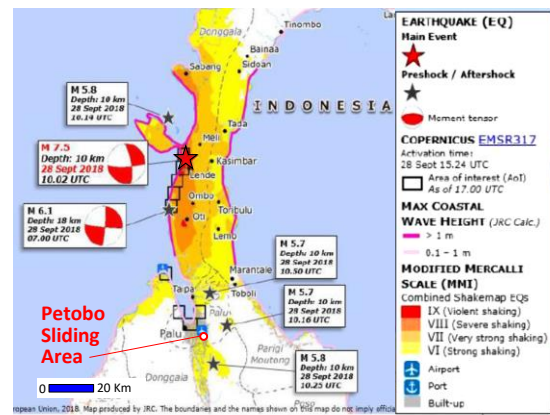
It is noticed that one large foreshock and several aftershocks were involved in this failure incident. As indicated in Figure 8, a foreshock ($M_w6.1$) occurred approximately 3-hr before the main shock, some

60Km north of Palu city, did terrify the local residents with severe shaking. However, no serious damages or casualties were apparent, based on available reports or witness testimonies (PuSGeN, 2018; Kusumawardani et al., 2021).

Figure 8. Foreshock, mainshock, aftershocks of 2018 Palu-Donggala EQ (GEER, 2019).

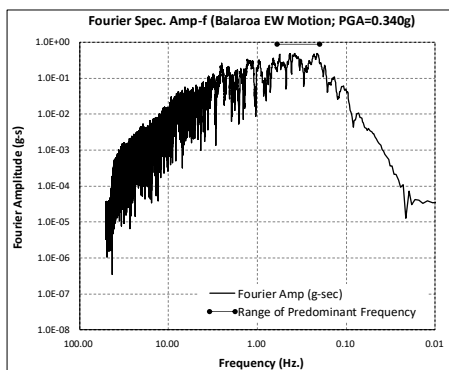
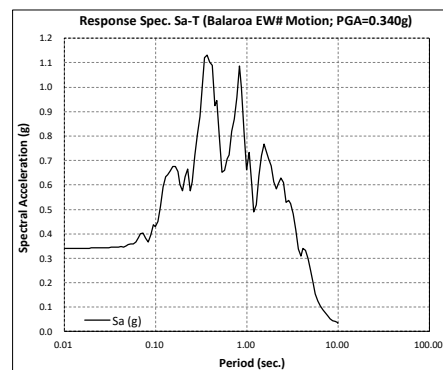
Figure 9. Fourier spectrum and response spectrum of 2018.9.28 Palu-Donggala mainshock motion (EW component amplified to a PGA of 0.340g) recorded at Balaroa station.

Figure 9 shows the Fourier spectrum and the acceleration response spectrum of this input motion. As seen, Fourier spectrum indicates the predominant frequency of this motion is around 0.2~0.6Hz, or a predominant period of 1.6~5s. The acceleration response spectrum indicates a maximum spectra acceleration of more than 1.1g and the corresponding natural period of 0.35~0.85s. In view of average thickness and shear wave velocity of soil deposit, the estimated site period in Petobo area would be approximately 0.4~0.5s. In accordance, this earthquake motion would have been very severe and destructive to the Petobo site and the Palu valley as well.

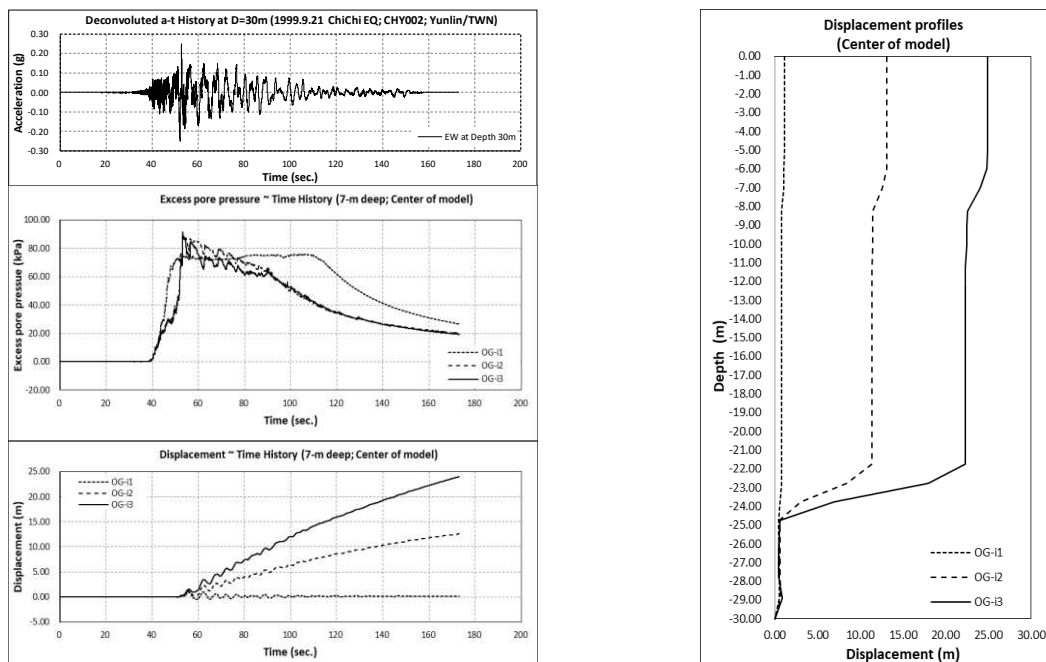
Figure 10. Verifications of liquefaction-induced flowslide behavior with different ground inclinations by OpenSeesPL (Ground surface inclination: $i_1=0$ / level ground, $i_2=3\text{deg.}$, and $i_3=6\text{deg.}$).

The soil deposit adopted in this exercise is 30m in depth, where the top 24.75m consists of very-loose to medium sands and the bottom 5.25m is loose to medium silt and clay. For the very-loose to medium sands, the assigned material data includes: $\phi' = 29^\circ \sim 33^\circ$, $c' = 0.2 \sim 0.4 \text{ kPa}$, $G_{max} = 55 \sim 75 \text{ MPa}$, $B_{max} = 150 \sim 200 \text{ MPa}$, and $K_h = 6.6 \times 10^{-5} \text{ m/s}$. For the loose to medium silts, the assigned material data includes: $\phi' = 29^\circ \sim 33^\circ$, $c' = 0.35 \text{ kPa}$, $G_{max} = 55 \sim 75 \text{ MPa}$, $B_{max} = 150 \sim 200 \text{ MPa}$, and $K_h = 1 \times 10^{-7} \text{ m/s}$. For the medium clay, the assigned material data includes: $\phi' = 0$, $c' = 43 \text{ kPa}$, $G_{max} = 60 \text{ MPa}$, $B_{max} = 300 \text{ MPa}$, and $K_h = 1 \times 10^{-9} \text{ m/s}$. The groundwater table is 3.84m below the ground. The input motion is based on the 1999 Chi-Chi earthquake of Taiwan recorded at Station CHY002, with $a_{max} = 0.250g$ as illustrated in the upper left of Figure 10. Results of time histories in excess pore pressure generation as well as lateral displacement at a depth of 7m are shown in the two lower left graphs. The displacement profile of entire deposit at the end of shaking is shown on the right of this figure.

It's obvious that a slight inclination of the ground would be sufficient to trigger significant lateral displacements once the ground is agitated with excess pore pressure and liquefied. The displacement would appear to last for a period of time even if the excess pore pressure has substantially reduced. The slip surface of this exercise coincides with the boundary between liquefied and non-liquefied zones of the deposit, signifying the sliding triggered by gravitational shear on the liquefied soils. Finally, a slight inclination of ground of 3° could considerably displace the deposit by about 13m at the end of computation ($\sim 175s$). If the ground is inclined further (6°), the lateral displacement of deposit would appear to increase proportionally (25m), indicating static shears of the inclined ground would be critical in triggering the long-distance sliding of liquefied ground.

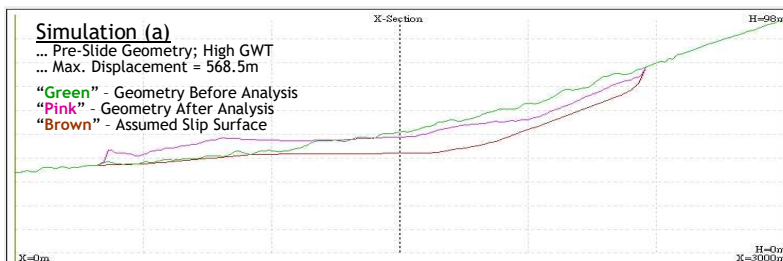
Figure 11 indicates the results of Simulation (a) for the conditions of Petobo slope at the time of 2018 earthquake. The slope was in its pre-slide geometry and the groundwater table was high as due to a constant infiltration of water from Gumbasa irrigation system and wet paddies on upper portion of the slope. As illustrated by the "Red" dashed line of Figure 4, the high groundwater table was expected to be close to the pre-slide surface of the slope. As shown in Figure 11, results of the simulation clearly demonstrate a significant slide by the 2018 shaking, with a total displacement of the slope up to 569m; which is in resemblance to the post-slide slope geometry of the EW cross-section.

As for the details of sliding process of the simulation, the slide initiates at approximately 3 seconds after the shaking start, and then keeps sliding for around 223 seconds (3.72 minutes) before ceasing. Maximum speed during the course of sliding is 18.3 m/s and the average sliding speed is around 7 m/s (25 Km/h). This simulation validates the Petobo slope would be failing and sliding for distance when all of the conditions are met, including liquefiable soils, high groundwater levels, strong shaking, and the inclined ground that provides sufficient driving forces.

Figure 11. Verification of Petobo sliding subjected to 2018.9.28 Palu-Donggala earthquake shaking; Simulation (a) - EW cross-section (Moh. Soeharto Rd.), pre-slide geometry, high groundwater table.

- Numerical simulation on the Petobo slope during the 2018.9.28 earthquake ([Simulation \(a\)](#); pre-slide geometry & high groundwater table) confirms the significant slide by the 2018 shaking, with its final configuration resembles the post-slide geometry of the in-situ slope. It also validates the liquefaction and long-distance of Petobo slope when all of four conditions are met.

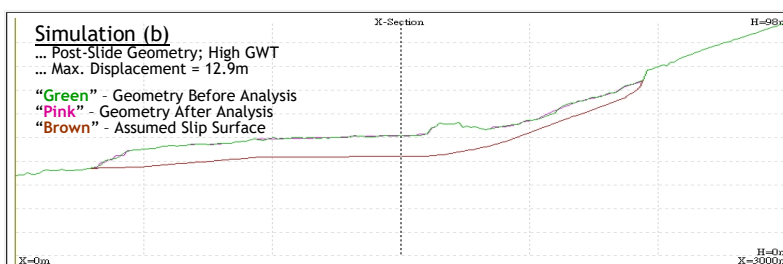
Figure 12 shows the results of Simulation (b), for the case of post-slide geometry of the Petobo slope right after sliding, and then subjected to a second strike of the same earthquake. It would be of interest to know if the post-slide slope geometry, which has become much flatter than its pre-slide one, would still be able to provide sufficient static/driving shears and re-trigger a slide in the slope. The simulation is performed under a condition of high groundwater table since the timing considered is for the “right after pre-slide”, where the groundwater level is close to the post-slide surface.

Results of the simulation apparently show the much flatter post-slide geometry would not be able to restart a significant flowsliding in the slope, even if the groundwater table remains high, the slope mass is still liquefied, and the same earthquake is striking at the slope. Details of the simulation also show a slight movement of the slope is noticed at about 3 seconds after the shaking start. The movements last for 56 seconds (<1 minute) then cease, ending up a total displacement of around 13m, which is very small as compared with the length of slope of more than 2000m.

Although the entire slope appears to be “stable”, a small amount of the computed displacement within one minute indicates the post-slide slope right after the first strike of earthquake would still be in a quasi-state, given the facts that the groundwater table remains high and the slope mass is still liquefied. The reason why the slide in slope is not re-triggered would probably be due to the geometry of the post-slide surface which is much less inclined than the pre-slide slope. If the slope surface becomes steeper, a significant flowsliding would then be anticipated. This simulation demonstrates the importance of ground inclination, which provides static/driving shears, in triggering a long-distance slide of liquefied slopes.

Figure 12. Verification on the potential of re-initiation of sliding in the failed (flatten) slope subjected to the second striking of the same earthquake; Simulation (b) - EW cross-section (Moh. Soeharto Rd.), post-slide geometry, high groundwater table.

- Numerical simulation on the post-slide geometry of Petobo slope, with high groundwater table right after slide and then subjected to a second strike of the same earthquake, i.e., [Simulation \(b\)](#), shows insignificant movement of the slope. The simulation demonstrates a much flatter geometry of the post-slide slope would not be able to restart a significant slide.

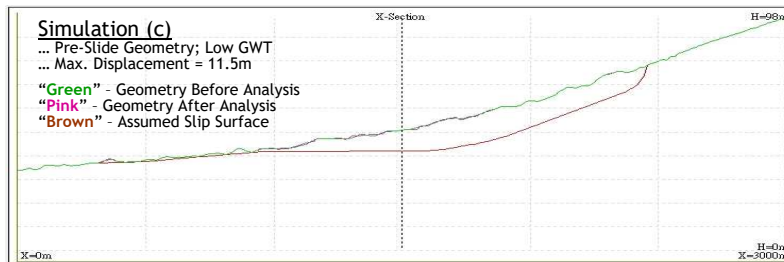
Figure 13 illustrates the results of Simulation (c), an assumed case of low groundwater table prior to the 2018 shaking, as a result of no water infiltration by Gumbasa irrigation system and wet-paddy fields. This simulation would like to focus on the influence of localized-raised groundwater level due to human activities on the potential of soil liquefaction and flowsliding of the slope. As seen in Figure 4, the groundwater table is expected to have raised by 0~15m in the upper portion of the slope, as a result of the irrigation system and wet paddies, prior to the 2018 earthquake. It would be of interest to see If without

The simulation is conducted with a low groundwater condition as observed in the 02/2020 investigation and a pre-slide slope geometry of EW cross-section of Petobo area. The Balaraa EW record of the 2018 earthquake, as mentioned previously, is adopted as the input motion for the simulation. As shown in Figure 13, results of the simulation indicate no major liquefaction or flowsliding in the slope is likely. The computed overall displacement of the slope is around 12m, very small as compared with the slope length. The slope movement occurs within the beginning 20 seconds of the shaking and then no further deformation is noticed. This simulation, associated with [Simulation \(a\)](#), clearly demonstrate the importance of the localized-raised groundwater table, as a result of human activities, would have a detrimental effect on the stability of slopes.

Figure 13. Verification on the potential of sliding of Petobo slope if no infiltration of water from Gumbasa irrigation system and wet paddy fields; Simulation (c) - EW cross-section (Moh. Soeharto Rd.), pre-slide geometry, low groundwater table.

- Numerical simulation on the pre-slide geometry of Petobo slope with an assumed low groundwater table, i.e., [Simulation \(c\)](#), as expected for the case of no influence of water infiltration by the Gumbasa irrigation system and wet-paddy fields on the upper portion of the slope, shows insignificant movement of the slope and no major liquefaction or flowsliding in the slope is likely.

- The primary lesson that we could learn from the 2018 incidents of liquefaction-induced flowsliding in Palu, Indonesia, would probably the avoidance of human activities in raising the local groundwater table, in areas that are prone to strong seismic shaking, covered with large extent of liquefiable soils, and inclined on the ground surface.
