Forensic Geotechnical, Hydrological and Hydrogeological Analysis of Instability Phenomena Occurred at a Waste Management Centre

ABSTRACT

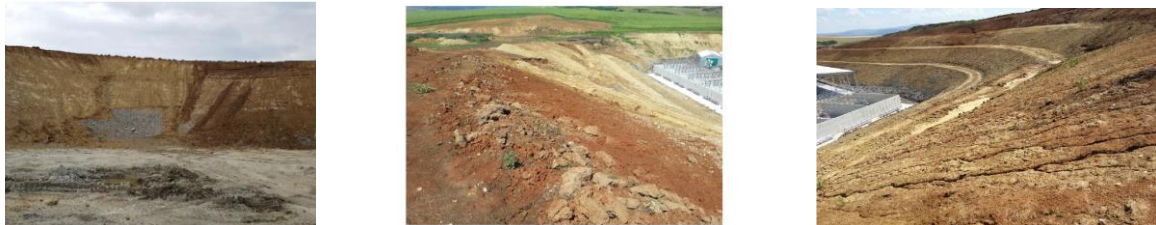
Figure 1. Local instability phenomena and (at right) initial remediation (berms)

From a technical point of view, the forensic analysis showed that the landslides occurred have been produced due to a cumulative effect of natural and anthropogenic aspects:

Site lithology: an upper layer (deluvium) composed of swelling clays, laying over the bedrock composed of marls; this lithology is leading to upper layer slipping over the one below, at their contact, when water infiltrates to the area, softening the interface in between.

Groundwater presence: this is influencing both by increasing the water pressure in the fissures and by reducing shear strength of the clays. The water infiltrated in the soil is drained very slowly due to low hydraulic conductivity and to slow-dynamics hydro-structure.

Excavations: the earthworks performed on site created a drainage path for the water accumulated in the ground, which outflowed and ran off and through the slope;

Swelling clays: these led to contraction fissures in the ground, through which rainwater could infiltrate;

Slope inclination: designed slopes were too steep with regard to above mentioned soil and water conditions.

Once the instability phenomena occurred, several consolidation measures were taken, based on reports of several experts and all these seems to be a kind of “trial-and-error” approach. Among the consolidation measures were included: Stage 1: less steep slope (1:2.5) including also berms (2 berms on the slope of max. 26 m height), drainage works in one corner of the site where water sources were identified, collection of runoff water on each berm, surface protection against erosion; Stage 2: sub-horizontal drainages and drainage trenches; discontinue, reinforced concrete, retaining walls founded on micropiles and anchored, with a “saw teeth” disposal (one section of the wall on one of the berm, the following section on the other berm at higher or lower level); monitoring; Stage 3: new interventions on the retaining walls as new instability phenomena occurred, new drainage works.

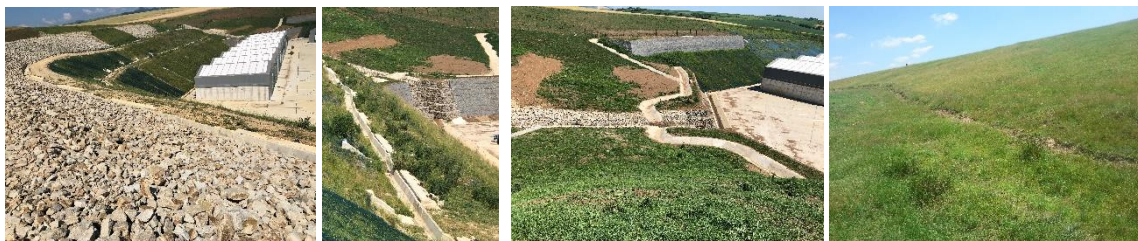
Figure 2. Final works, including drainage, mechanical consolidation works, hydrological measures; at right signs of ongoing instability

The remodelling intervention of the slope (berms and partially less steep slopes) was not sufficient as the stability analyses show it and also what happened further on site. Therefore, were required more interventions, consisting of: 39 sub-horizontal drains for collecting groundwater infiltrations, 46 segments of reinforced concrete retaining walls each supported by 5 – 6 micro-piles and 3 – 4 pre-tensioned ground anchors, disposed in zigzag on the berms (at the lower and middle section of the slope). Despite these extensive consolidation measures the swelling characteristic of the soil has still not been considered and no detailed stability analyses performed. When analysing the consolidation measures through the stability analyses presented here-above it was concluded that in some sections the retaining walls were not properly disposed for intercepting the slip surfaces, leaving many areas of the upper part of the slope not covered. This has been confirmed by the monitoring of ground displacements showing that the movement is still active and that signs of continuing instability phenomena have been identified. The consolidation measures proved to be insufficient as the retaining walls were not continuous, they were not able to intercept in all sections the slipping surfaces and their effect was not checked using stability analyses, in fact their design being made as for a normal retaining structure, not for one supposed to stop a landslide. Drainage works have been poorly designed in absence of a proper hydrogeological investigation.

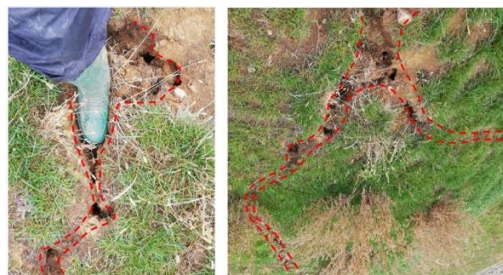
Figure 4. Drying cracks (left in the plateau area upstream of the site)

At the surface, the clay material is affected by drying cracks oriented approximately parallel to the contour lines, with millimetric and centimetric openings. It has been observed that after periods of precipitation, these cracks close due to clay swelling as it becomes saturated.

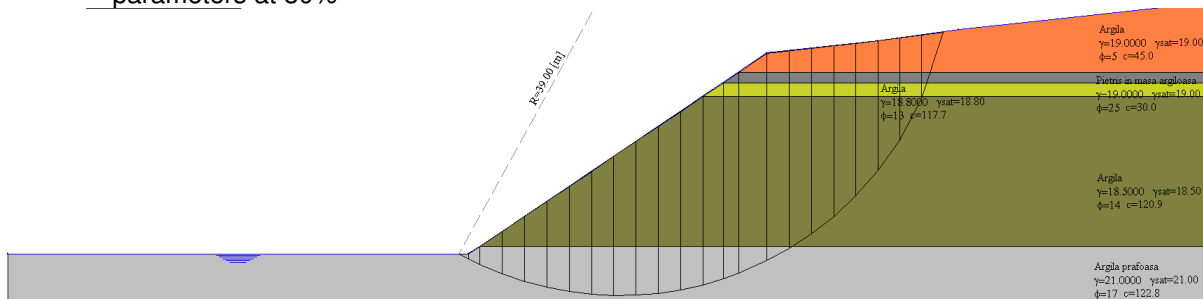
The results of the stability analyses performed for the man-made slopes (initial inclination 1:1.5) are shown Table 2. The initial design is not ensuring stable slopes and an inclination of 1:4 would have been required or to provide mechanical consolidation and drainage measures. More stability analyses have been performed for the situation after geometrical remodelling of the slopes (part of the slope with inclination 1:2.5), some of the results being also shown in Table 2.

Based on these results was concluded that even though the groundwater was the primarily cause of the instability phenomena and the design should have consider it, this has been superposed over basic design errors, as slopes were designed too steep and didn't consider the presence of swelling clays and that water can infiltrate through the contraction fissures, reducing drastically the shear strength parameters.

Figure 10. Results of stability analyses for the initially designed cut slope 1:1.5, no berms, GWL at GL, static conditions, parameters as determined in the initial geotechnical report.

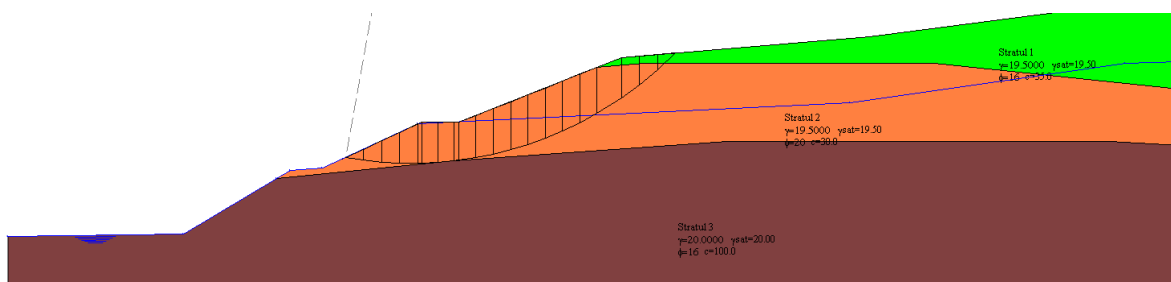
Figure 11. Results of stability analyses for the remodelled cut slope, GWL as measured, static conditions, parameters as determined in the final geotechnical report.
