## Underground Church of Saint-Emilion : Geotechnical challenges in light of heritage issues

### ABSTRACT

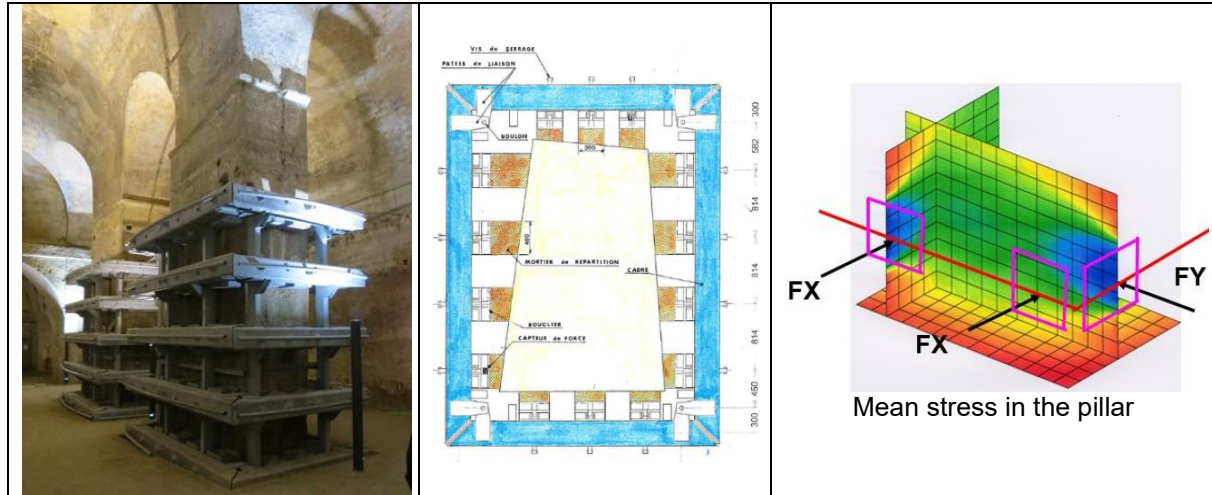
Due to the rigidity of the system and the pillars' geometry, it was difficult to apply a uniform force using mechanical jacks, so the nominal force was limited to **50%** of the initially targeted value.

**Figure 6.** Photograph of the banding system (left), plan view of a metal frame (center) and 3D numerical model (right)

Today, the instrumentation of the banding system is no longer operational (only 20% of the sensors are still in order), preventing assessment of the actual stresses in the pads and therefore of the system's efficiency (residual stress estimated less than 30% of initial stress after 15 years).

The metallic banding works, through the application of lateral confinement, was implemented in 2000, allowing the removal of the unaesthetic temporary props (Figure 6). The system consisted of metal frames encircling the pillars, fitted with mechanical screw jacks exerting calculated pressure on distribution plates. To prevent surface damage, a layer of lime mortar was inserted between each plate and the pillar. Each pillar had five frames spaced one meter apart, with 12 to 14 jacks per level, depending on pillar cross-section.

The applied stress on the plates ( $0.4 \times 0.4 \text{ m}^2$ ) ranged between 0.8 and 1 MPa. Force sensors on the adjustment screws allowed verification of the applied load. 3D modeling has been done to assess the behaviour of the pillar.

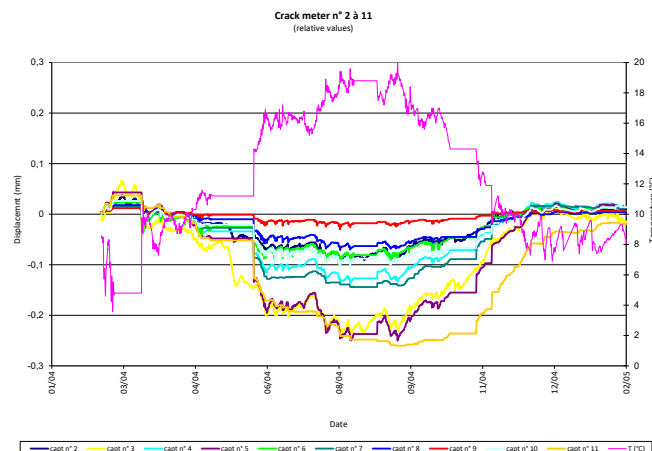
As part of the consolidation and restoration works, a monitoring system was installed, including 10 crack gauges fixed on the identified vault cracks. Monitoring showed small variations (less than 0.3 mm) correlated with temperature (pink line) changes (cf. figure 7):

- Cracks narrowing with higher temperatures,
- Cracks widening with lower temperatures.

Residual displacements over a yearly cycle were negligible (a natural “breathing” phenomenon of the rock mass), and no abnormal movement was observed. Therefore, the system was removed after two years of monitoring.

**Figure 7.** Cracks monitoring on one year (2002)

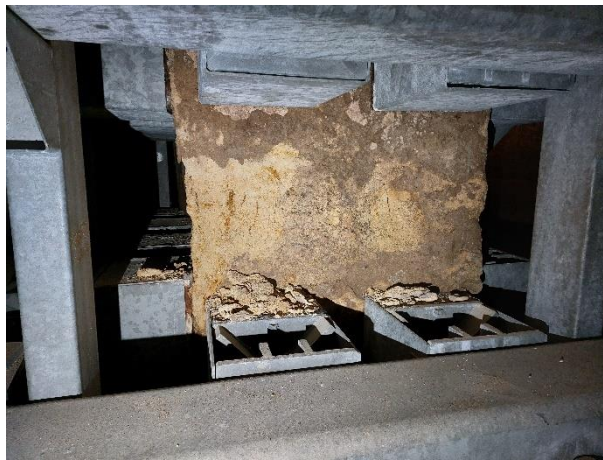
Given the slow and continuous deterioration at the base of the pillars (see figure 8), partly due to capillary rise, and the reduction of banding stress, Antea Group explored new methods to improve the mechanical properties of limestone in depth. In this context, the Biocalcis process, developed by Soletanche Bachy, appeared as a potentially suitable solution.

**Figure 8.** Pillars alteration at the base, between the metal frames (Carpentier, 2024)

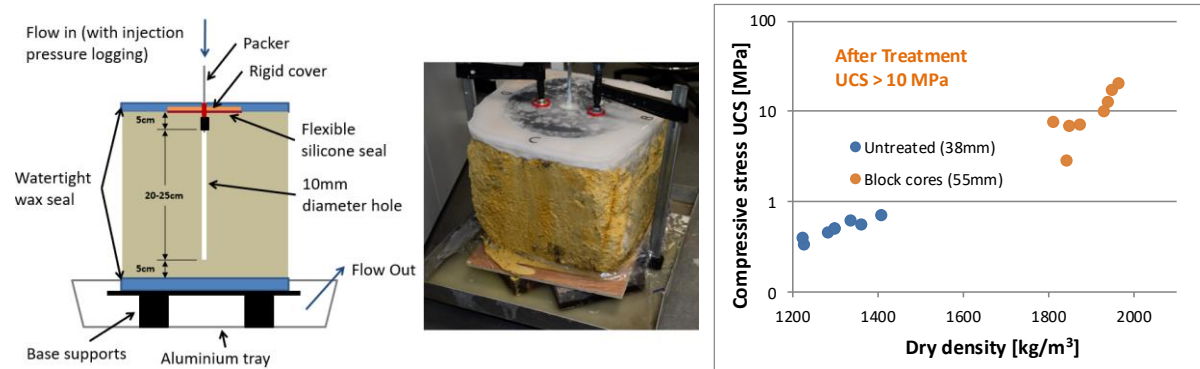
After injection, a significant increase in mechanical strength was observed: between 2 and 5 times that of untreated limestone. The resulting mechanical strengths are remarkable, ranging from approximately 2.8 to >10 MPa to compare with values # 1 MPa before treatment (see Figure 10).

**Figure 10.** Injection device in the block and obtained mechanical strengths (Soletanche Bachy, 2015)
