# A Multidisciplinary Approach to the Restoration of the Pyli Arch Bridge: Integrating Seismic, Geotechnical, and Hydraulic Analyses

## ABSTRACT

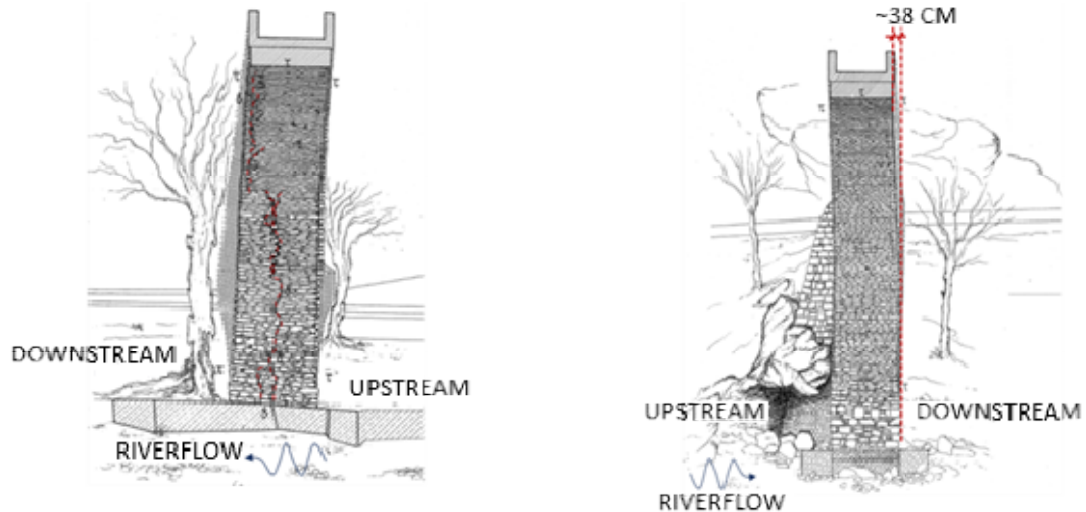
Pyli arch bridge, despite its long-term use and constant exposure to natural factors, currently presents limited structural pathology, mainly in the southern pier, where the most serious problems are identified. From the on-site inspection and the comparative evaluation of data dated back to 2004 (Karaveziroglou, 2004), it is established that the main damages of the previous period have not reappeared. In particular, the significant vertical crack in the inner part of the southern step (Figure 2), which had been observed previously, is not recorded today.

Additionally, at the crown of the arch (near the keystone region), a pronounced transverse deflection of approximately 35 cm is observed toward the upstream direction (Figure 2). This deformation, however, appears to correspond to the original geometric configuration of the bridge rather than a product of recent structural movement.

**Figure 2.** Transverse deflection – deformation of the arch. View of the Southern Abutment (Left). View of the (Northern Abutment (Right). Figures adapted from Karaveziroglou, 2004.

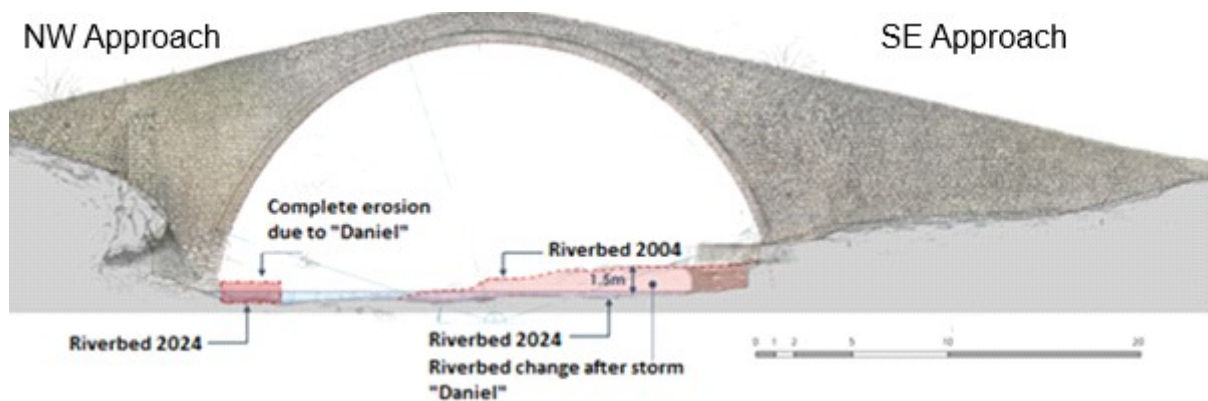
However, scour phenomena have been identified at the base of the southern abutment (Figure 3), posing a critical threat to the bearing capacity and overall stability of the monument. At the northern abutment, an ongoing process of localized detachment of the external stonework is observed, accompanied by vegetation growth, while the foundation rests on *hard rock outcrop* offering better resistance to erosion.

**Figure 3.** Overview (upstream view) of the scour zone on the southern abutment, following the Daniel (2023). Figure adapted from Structural Study (GEO.PER. S.A., storm 2024).

The extreme flood event of Storm “Daniel” (September 2023) caused river overflow and extensive scouring at the base of both abutments, accompanied by erosion of the surrounding slope material. At the southern abutment, substantial loss of soil mass and partial exposure of the foundation were recorded. The northern abutment, though founded on rock, experienced loss of fill material and partial detachment from the natural slope.

These hydraulic phenomena were identified as the primary cause of structural deterioration at the southern abutment. The absence of prior anti-scour protection measures allowed for progressive erosion of the foundation soils over time. The observed hydraulic impacts were integrated into the geotechnical and structural analyses, informing the design of targeted protective interventions aimed at ensuring the long-term stability and resilience of the monument.

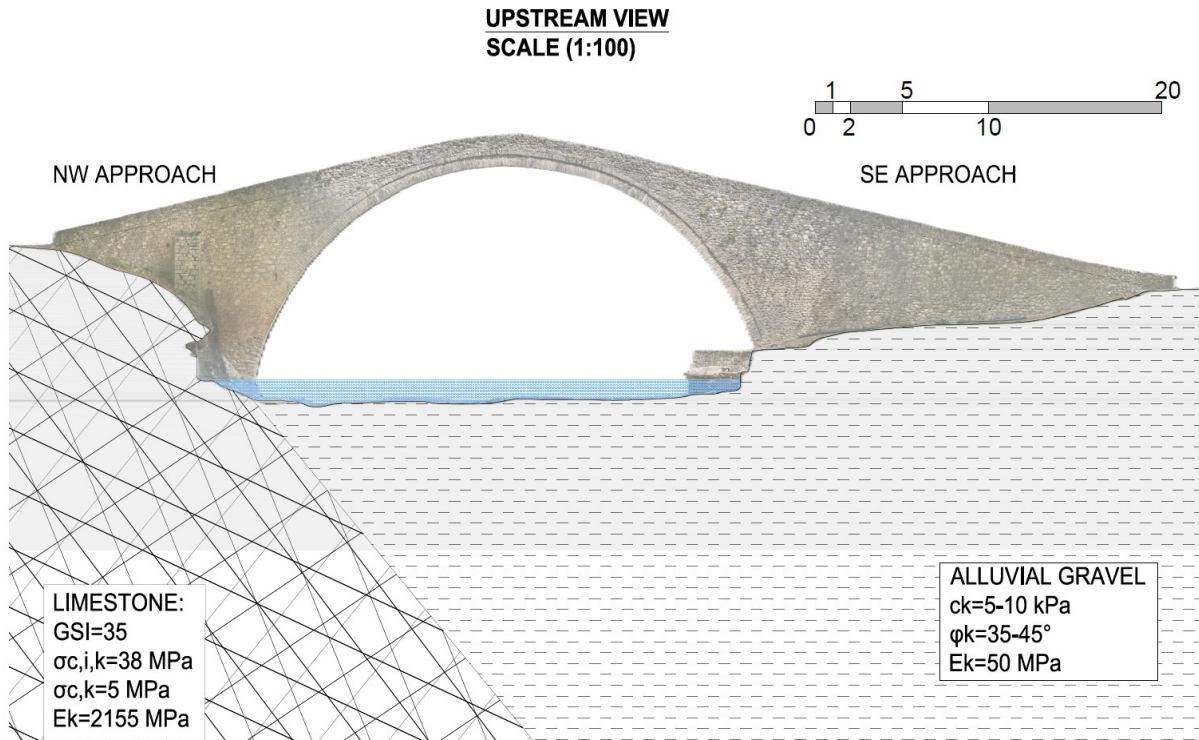
A characteristic longitudinal geotechnical section of the bridge foundation area is shown in Figure 4, while Table 1 presents the derived geotechnical parameters and soil spring constants used in the geotechnical and structural analyses supporting the bridge assessment.

**Figure 4.** Characteristic (longitudinal) geotechnical section in the area of Pyli Bridge (downstream view). Figure adapted from the drawings of Structural and Geotechnical Studies (GEO.PER. S.A., 2024; Egglezos, 2024).

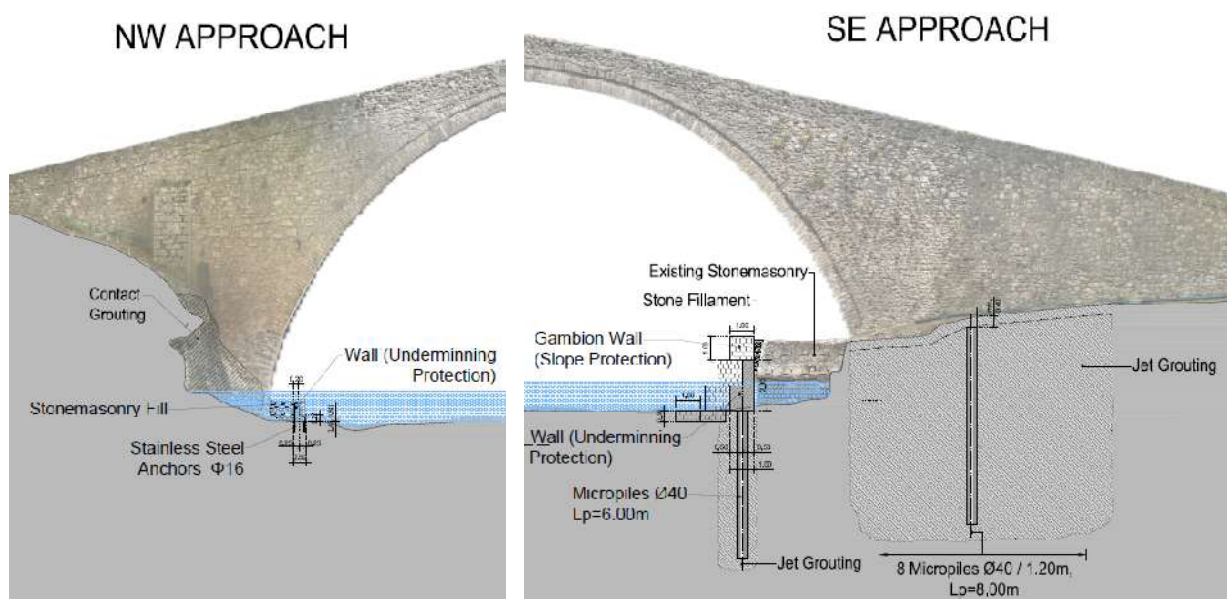
**Figure 10.** Upstream view of the proposed geotechnical measures. Left: at the northeast abutment. Right: at the southwest of the Pyli Bridge.

The proposed interventions to strengthen the foundation area (*Figures 9 and 10*) concern: cleaning of the foundation soil; deep jet grouting in the subsoil of the southern pedestal; contact grouting in the northern pedestal; micropiles around the perimeter of the southern pedestal; construction of walls/walls to protect against undermining; and shaping and strengthening the bank with gabions. These measures are reversible, minimally invasive, and designed to mitigate future scour phenomena while maintaining the visual and structural authenticity of the monument.
