Restoration and Rehabilitation of Old Pagara Masonry Dam by Grouting Technique (A Case - Study)

M. Bidasaria

ABSTRACT: Pagara Masonry Dam was constructed about 98 years back from now, during the period 1911-1917 in the erstwhile princely state of Gwalior, INDIA. After construction, it had breached and was rehabilitated three times. The masonry dam rests on Sandstone formation which had open joints. As the dam was designed and constructed in the early part of twentieth century, it was deprived of the present design concepts and was left with many deficiencies, which resulted in considerable problems that required rehabilitation three times since its construction. The third rehabilitation was done in the present time, which called for a rational approach of dam safety, including thorough geological investigations, treatment of foundation and body of dam, using grouting and guniting technique, stability analysis, hydraulic studies, etc. It is essential to provide inclined pressure release holes, in the masonry portion from d/s face of the dam to release the pore pressure, as there was no foundation gallery in the old dam. The drill holes for grouting, were done from top of dam, thro

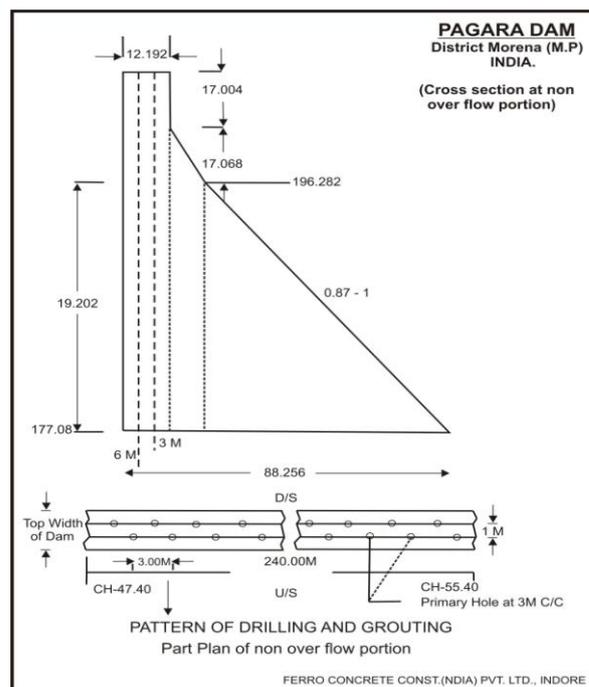
Fig. 1 Section of non-over flow, Pagara Dam. Showing drilling & Grouting pattern in plan.

The test grout pattern is proposed in two rows one meter apart and holes being spaced at 3 m. c/c staggered. The first row of grout holes were one meter from the u/s. face of dam. After test section, different reaches of masonry dam was proposed to be grouted accordingly. Layout of grout holes is shown in Fig. 1.

4.2.3 Grouting the body of the dam and upper layers of the foundation to fill in all the voids created by leaching etc. using cement grout.

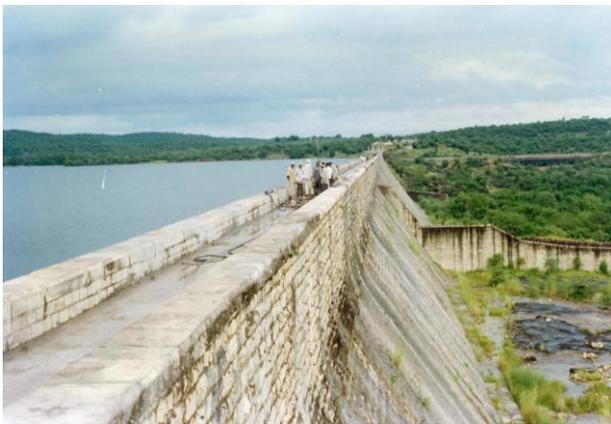
Fig. 2 Pagara Dam before treatment

3.4 Distress (Fig. 2) was due to ageing, which comprises of deterioration of construction materials (i.e. cracking, erosion and weathering etc.) and foundation failure. The failure may occur even under usual operating conditions due to increase in normal loads (i.e. silting, uplift and decrease in resistance i.e. by leakages crack propagation, weathering, erosion etc.) leading to complete failure of structure.

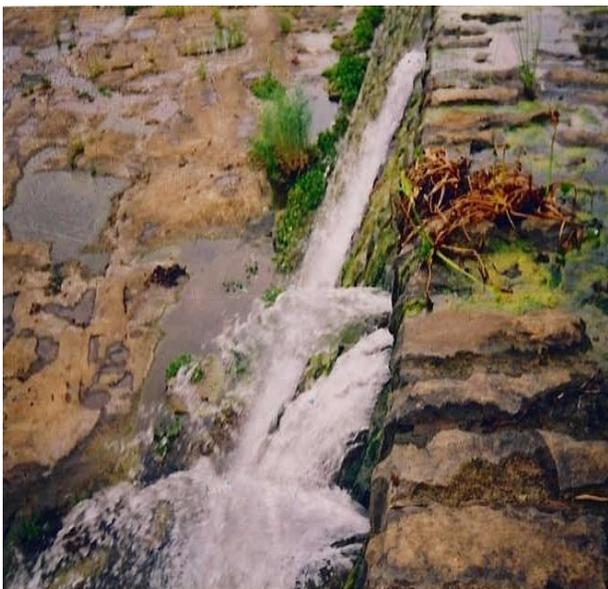
3.5 On the downstream face of masonry, very heavy spouts of water (Fig. 3) were coming out. The entire downstream face was wet and most of the masonry joints were leaking. This further confirms that mortar from the joints has been eroded and lot of voids has been created in the body of the masonry. The body of the masonry dam was porous and safety of this structure was under danger zone.

Fig. 3 Leakage through the Dam before treatment

When water is gushing out from the various joints, seepage water is localized through 20 mm G.I. pipe embedded in the masonry joint so that water from the nearby surface starts coming through the pipe and later on, when pointing is done in surrounding area, this pipe can be closed and seepage water brought under control.

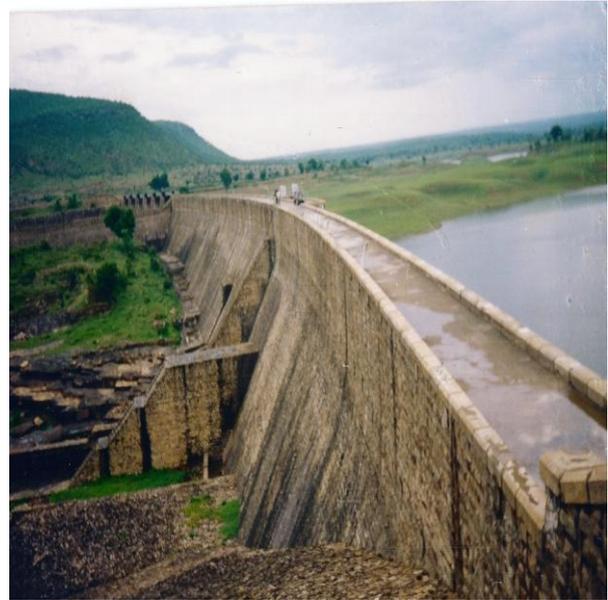
6.14 It was found that good core recovery up to 97 % has been achieved and water test shows the result of less than 2 to 5 lugeons. Following Photographs shows condition of Pagara Dam before grouting (Figs. 2 & 3) and after grouting treatment (Fig. 4).

Fig. 4 Pagara Dam after treatment
