# Site Investigation of Sinkhole Damage in the Armala Area, Pokhara, Nepal

R. M. Pokhrel, T. Kiyota, R. Kuwano, G. Chiaro and T. Katagiri

*Institute of Industrial Science, University of Tokyo, Japan*

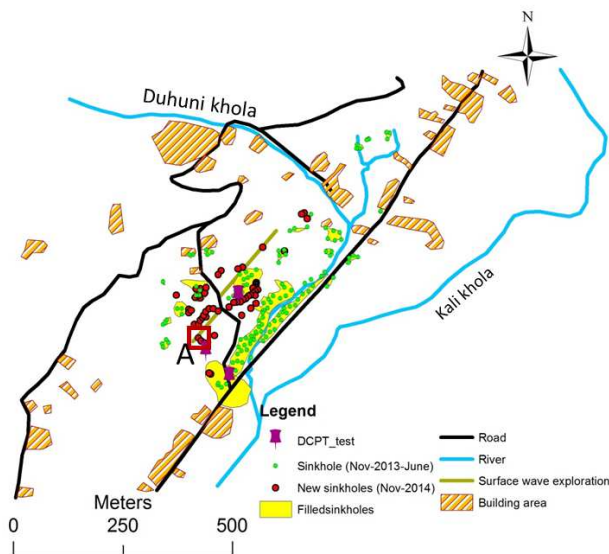
During the June 2014 survey, the trace of a number of sinkholes previously formed in November 2013 could typically be observed in the east side of the field survey area (Fig. 2). In Fig. 2, the sinkholes (light dots) as well as filled areas around these dots are concentrated along the Duhuni Khola, a stream of the Kali Khola River.

Fig. 2 Detailed map of sinkhole damage area

During the November 2014 survey, a number of sinkholes of recent formation, understood to be developed in August 2014, were mostly observed in the west side of field survey area. In Fig. 2, new sinkholes (dark dots) are mostly concentrated in the western side of the damaged area. These new sinkholes are quite far away from the Duhuni Khola River, towards uphill side of the investigated area. From the sinkholes pattern it can be understood that the new sinkholes are extending towards the recharge area.

Among many, sinkholes N1, N2 and N3 were found of particular interests. These sinkholes are within the square area 'A' in Fig. 2. They were developed in a delimited area of approximately  $10 \times 20$  m, as shown in the schematic map reported in Fig. 4. They have a circular pattern and a diame-

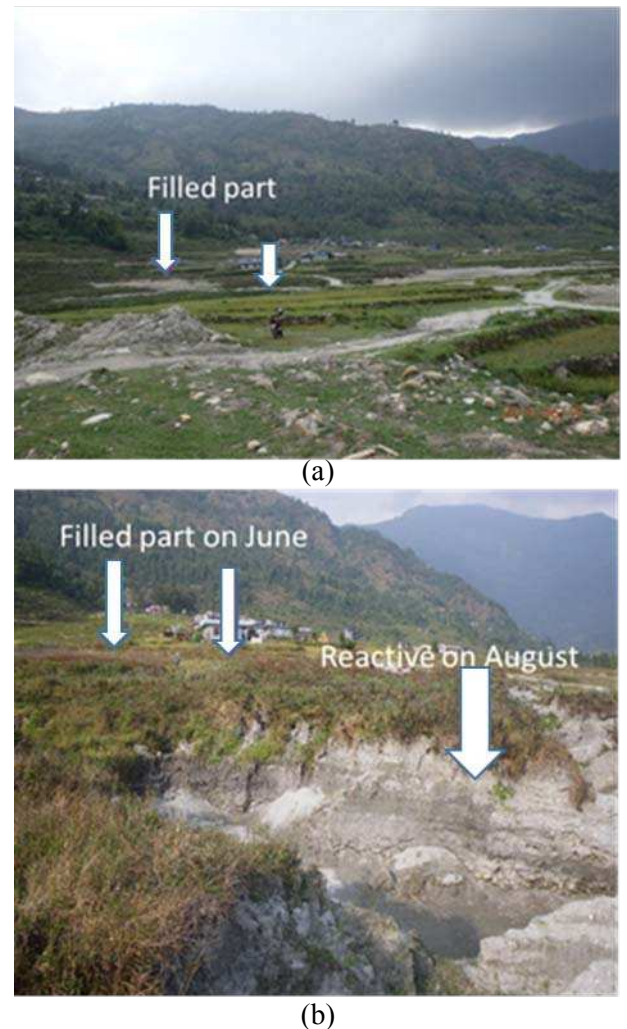
Immediately after the occurrence of sinkhole formation, a wide area affected by the cave-in was backfilled government agency by using gravelly soil retrieved from nearby quarries. At the time of our first damage survey in June 2014, most of those sinkholes gave the impression to be essentially fully backfilled (Fig. 3a). However, photos taken in November 2014 clearly show that the backfilling was not an adequate solution as most of former sinkholes re-activated (Fig. 3b), likely in August 2014 during the rainy season.

Moreover, in November many recently-formed sinkholes were observed, due probably to a change

in underground water flow conditions resulting from previous sinkhole formation/filling.

Fig. 3 Re-activated sinkholes: (a) backfilled sinkholes as seen in June 2014, and (b) reactive sinkholes as observed in November 2014

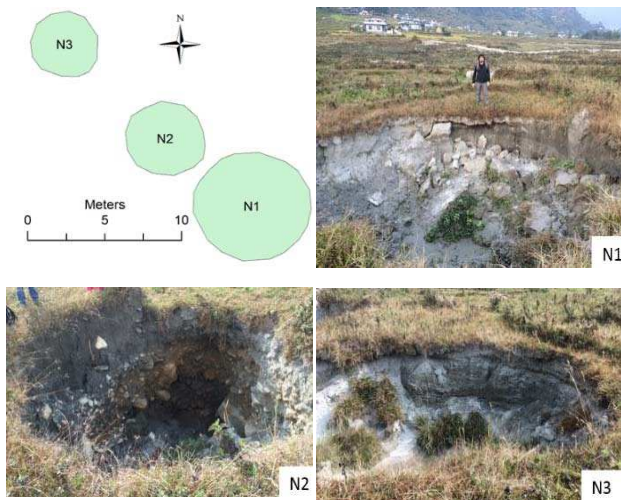
ter ranging from 4.6 m (N3) up to 6.8 m (N1). Their depth measured at the top of collapsed soil varied from 2.2 m (N1, N3) to a maximum of 3.5 m (N2). According to local residents, N1 was the first sinkhole to be formed. Few days later, N2 was caved-in and finally N3 was developed.

The progressive formation of these three sinkholes along a straight line (moving along upstream direction from N1 to N3) may suggest that the collapse of N1 caused the complete disruption of underground water flow. Consequently, water started to erode the soil just adjacent N1 until a new cave-in (N2) was formed. In similar way, N3 was later developed.

Fig. 4 Three sinkhole appeared in the area A in Fig.2

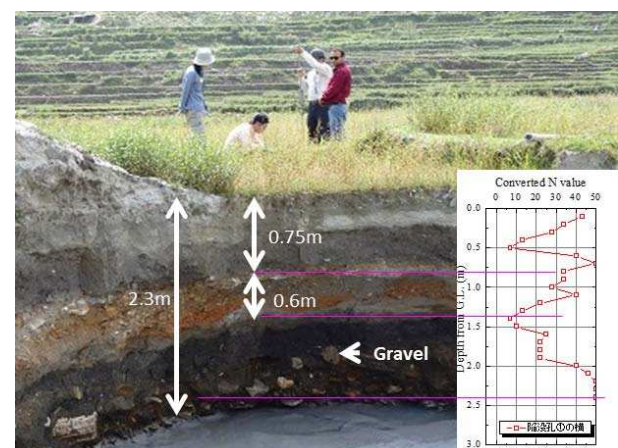
In the case of DCPT No. 2, the converted DCPT- $N$  values are plotted in Fig.5. The upper layers of surface soil could be penetrated until reaching the gravel layer, where even by hitting more than 150 times the penetration process stopped.

From the third DCPT, it is concluded that the used filling material is also gravelly soil. However, the compaction at the surface is not good enough because the  $N$ -value measure is very low.

From these test results, it is assumed that likely the cave-in started just below the gravelly layer. Then progressively the cavity size increased and finally the loose upper layer collapsed.

Fig. 5 Soil profile and DCPT result in the location 2 observed in Sinkhole on June 2014 (Kuwano, et al., 2014)

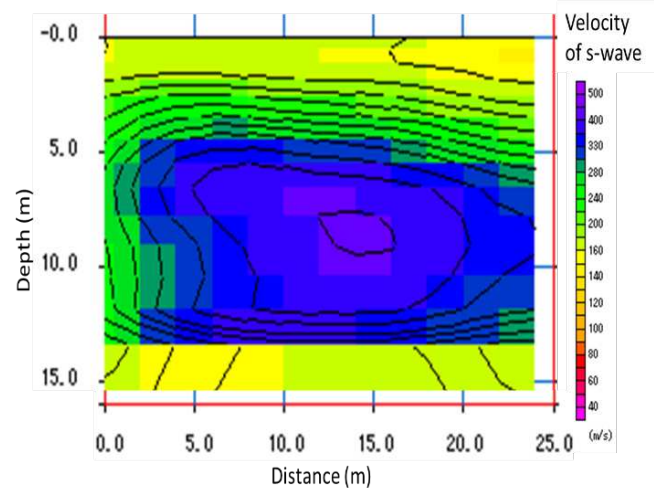
Typical results of surface wave exploration are shown in Fig.7. In fig.7 a 25 m distance is taken as one section. One can see that the shear wave velocity at the surface layer is in the range of 150-180 m/s is very loose layer. The thickness of this loose layer is 1.5 m. The gravel has higher velocity than surface layer about 240 m/s. The stiff soil below 4 m depth has a shear wave velocity greater than 350 m/s. Note that, the results obtained below 15 m depth are not reliable because the properties of the surface wave measurement.

Fig.7 Result of surface wave exploration method
