Use of Sub-Excavation Method for Foundation Remediation; A Case Study

ABSTRACT: The sub-excavation method has been used to remediate a number of historical monuments that suffered large differential settlements. Among the most well-known structures are Italy's *Leaning Tower of Pisa* and Mexico City's *Metropolitan Cathedral*. In general, sub-excavation (also known as soil extraction or under-excavation) involves removal of soil from underneath the building foundation. This paper describes a case study involving the application of the sub-excavation method to a seven story structure that suffered severe differential settlement following the 1985 earthquake in Mexico City, Mexico. The differential settlements increased throughout the years due to Mexico City's regional settlement creating inclinations ranging from 241mm to 310mm to the north and 69mm to 98mm to the east. Due to these movements, the building was declared to be in an unserviceable conditions by Mexico City's authorities. This structure was selected to be rehabilitated by using the sub-excavation method combined with horizontal micro-excavations. This paper describes the details and results of the sub-excavation proce

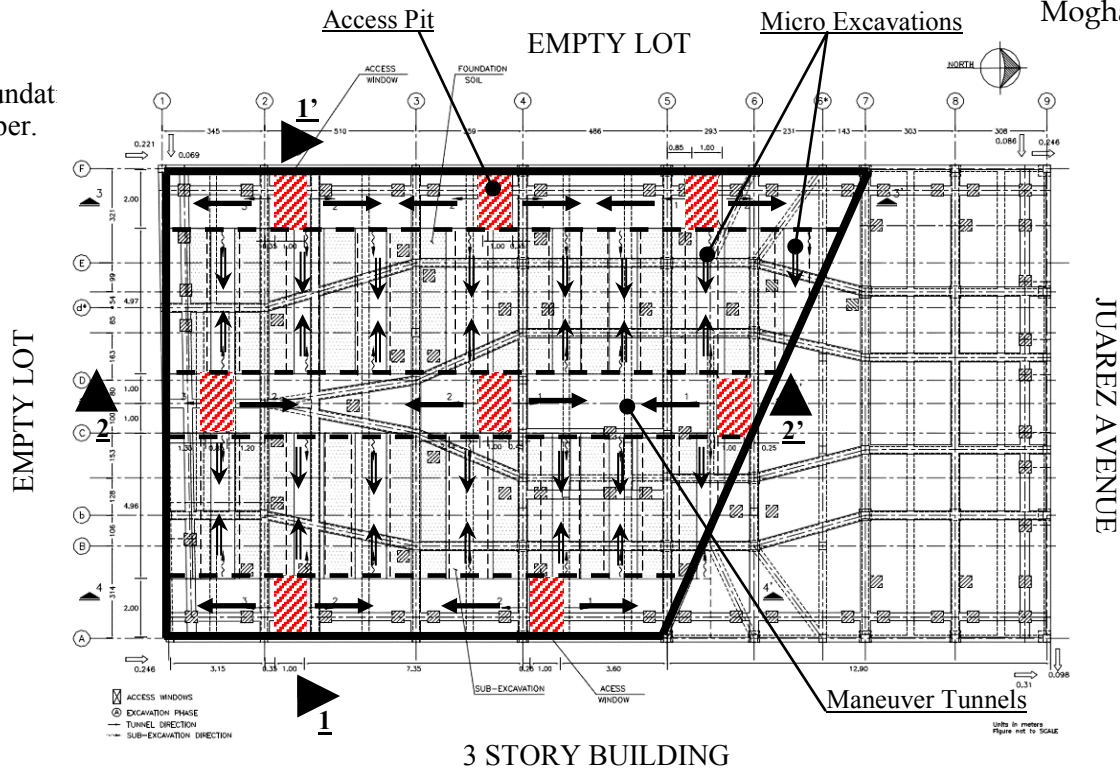
Fig. 1 Access Pits, Maneuver tunnels, and Micro-Excavations

Considering the inclination of the building towards north and east, it was determined that the sub-excavation will be conducted within a trapezoidal area representing approximately 2/3 of the total footprint area of the building (See Figure 1). To achieve this, eight 1.0m (3.3ft) x 2.0m (6.6ft) access pits were opened to a depth of 2.0m (6.6ft), through the foundation slab. Then maneuver tunnels were advanced using multiple excavation fronts starting from different access points and continuing until convergence was achieved. Advance cycle for the tunnels was estimated as 1.5m (5ft) and during each cycle peripheral walls were protected with shotcrete layers and bracing system. The shotcrete consisted of a 70mm (2.75in) thick mortar shotcrete placed in two layers with a 6x6-6/6 wire mesh in between. The bracing system consisted of 100mmx300mm (4inx12in) wood beams placed vertically (similar to soldier piles) and braced with 100mm (4in) diameter struts in two levels (See Fig. 2). Once all three maneuver tunnels were completed and protected, eight 120mm (4.75in) micro-excavations (sub-excavation windows) were excavated between the tunnels, as shown in Fig. 1 and 2. These windows were gradually widened until the designed deformations were achieved. During and after the completion of the sub-excavation process, the movements associated with the structure were monitored and recorded. The results from the monitoring process and the deflections achieved from the sub-excavation process are discussed in the following section.

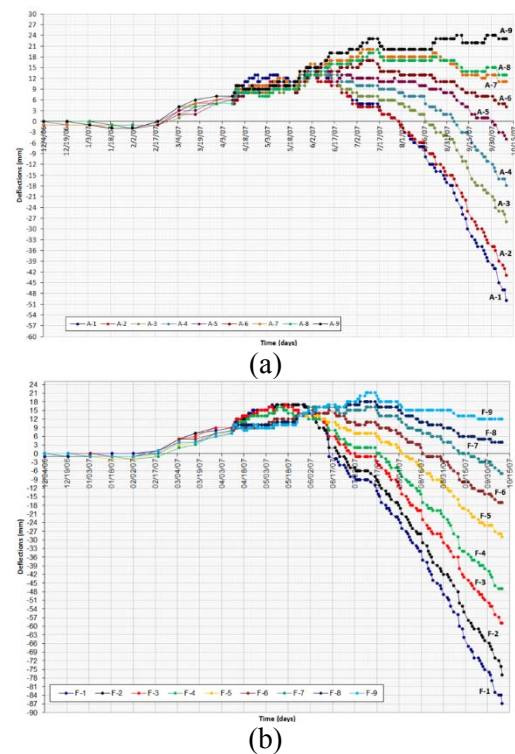
Fig 3. Monitoring plots corresponding to (a) Axis A and (b) axis F

upward movement due to the soil’s elastic response (See Fig. 3). For a period of three months the building presented an average upward movement of 12mm (0.5in), mainly in the south end. This upward movement gradually turned to a settlement once all the micro-excavations were completed.

Based on the surveying data, the results of the sub-excavation process became evident almost immediately. Survey data revealed vertical downward movements towards the south and west of the building. Maximum deflections recorded during the sub-excavation process are shown in Table 1, and the monitoring plot corresponding to the two axes with major deflections are shown in Fig. 3.

By the end of the sub-excavation process, 87.0mm (3.5 in) settlement for the point F-1 located at the southwest corner of the structure and 27.0mm (1.10in) upward movement for the point A-9 located at the northeast corner of the structure, were recorded. As it is noted in Table 1, all movements indicate a deflection pattern starting with major settlements in the south side of the structure (Figure 1-Points A-1 to F-1), and ending with slight upward movements in the north side (Fig. 1-Points A-9 to F-9).
