The Instability of Natural Slopes and the Reconstruction of Sabrosa Quay, in Douro River

A. Santos-Ferreira
DGRM, Lisboa, Portugal

ABSTRACT: Douro River is one of the Iberian Peninsula's largest rivers, crossing east to west Portugal's northern territory, being of the utmost importance for this region's socio-economic development. For thirty years the navigation in the Portuguese territory has been established with the construction of several dams, and fluvial quays have been built, as Sabrosa's fluvial quay, located in the right bank of Douro River. Sabrosa quay consisted of a 100 m quay wall, flanked with a gabion wall. Recently, deformations were detected at the quay's foundation ground, as well as heavy gabion corrosion. A geotechnical study of the area's natural slopes identified instability issues in some areas. This information was included in the rehabilitation design. The solution consisted, taking in account the instability mechanisms identified for the involving slopes, in the design of a new quay wall consisting in a tied-back sheet pile wall with a total quay length of 410 m, 119 ground anchors in a single row, horizontally spaced by 3 meters, was used. This solution

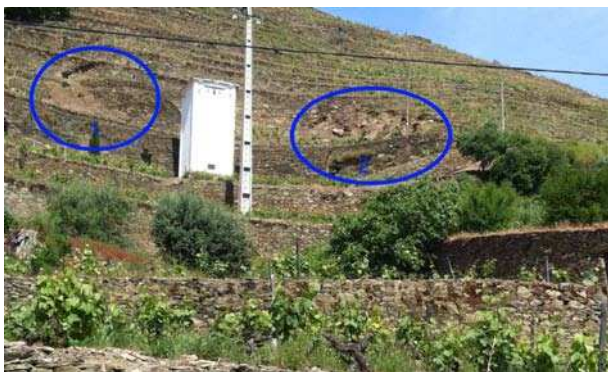
Concerning local tectonics onsite, a complex system of tectonic faults (NW-SE), which affects the formations of Bateiras and Ervedosa, is observed. Those thrust faults intersect the harbour in its downstream area. Besides, there are some slope slides of small dimension (Fig. 2).

In Fig. 2 it is showed the presence of two landslides overtopping the quay, which is an issue of major concern.

Fig. 2 Slides overtopping the harbour area (Orive Vega 2013).

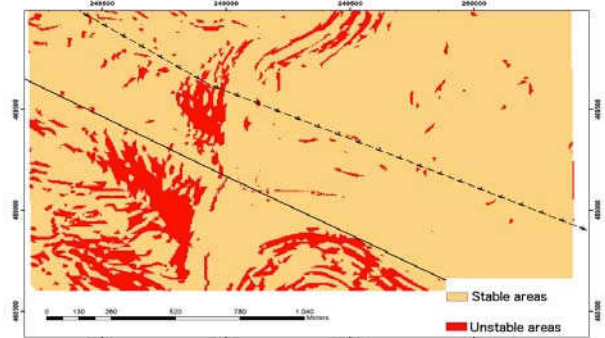
The landslide susceptibility map showed that Sabrosa's quay area is potentially unstable regarding the landslide hazard, in a calculated area of 400 m². Although this area is small, it was necessary to take it into account, due to the high declivity of the slope and due to the fact that part of it overtopped the quay area.

Fig. 3 Landslide susceptibility map. In red, potentially unstable areas (Orive Vega, 2013)

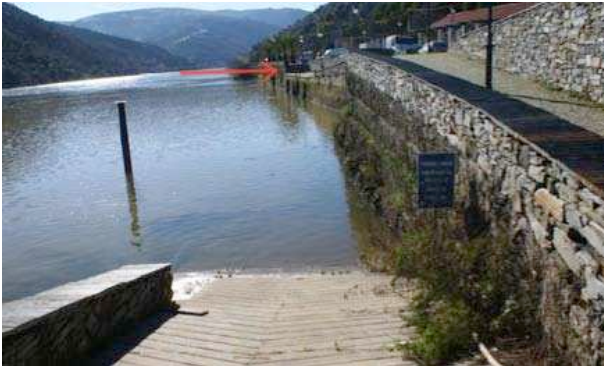
Fig. 4 Sabrosa's actual harbor, with the docking quay (red arrow).

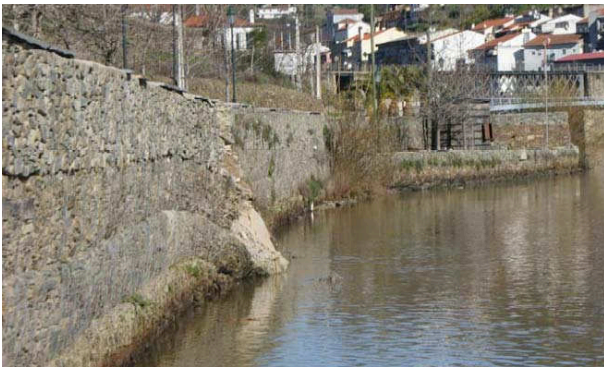
As mentioned, one of the Sabrosa quay structures are gabion retaining walls. Despite the used gabion retaining walls steel grids are protected with a 4-5 μ m PVC coat, it wasn't enough to protect them against corrosion, as floating debris can harm the coating, and the level fluctuation of the river increases corrosion, by frequent wetting and drying cycles.

Due to the corrosion problems, significant displacements and structural deformation were observed in the retaining wall, as well as the collapse of a portion of it, as showed in Fig. 5. It is probable that these consequences were increased by the fault and instability problems of the slope.

Fig. 5 Collapsed gabion wall

The adopted methodology allowed the comprehension of local geology and the tectonic phenomena that affects it. It also allowed accessing the gabion wall rupture cause. The geological and geotechnical conditions were excluded and, instead, the corrosion phenomenon was pointed out as the main cause for the described situation. This relates to dry and wet periods, due to variations of water level in Régua’s reservoir, which directly affects Sabrosa’s quay.

As solution to the gabion collapse, the construction of a new sheet pile quay tied back wall is proposed. In a technical point of view, this solution will allow surpassing the local constrains that promote some instabilization situations as metallic elements corrosion. Moreover, the planned structure will improve touristic and docking conditions for the design ships (hotel boats).

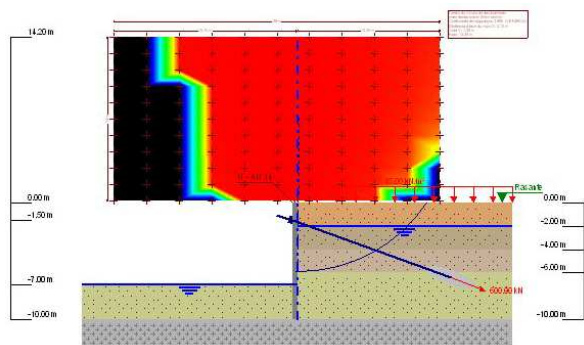
Fig. 8 Resulting limit equilibrium analysis, in the most unfavourable situation

As showed in Fig. 8, the bond length is out of the most probable slide surface, as defined in FHWA-IF-99-015 (1999). Additionally, according to Eurocode 7 (1997), the minimum SF required is 1.5 and, as the obtained SF in the design was, in the most unfavourable situation, 3.37, the all structure is within the required SF range. It must be noted that this high SF is necessary, although the bond length must be in the stable formations and not in the potentially unstable upper layers materials, as it can suffer corrosion despite the considered protection (Ribeiro, 2012).
