# Back Analysis and Rectification of a Failed Cut Slope in the Southern Expressway

U. K. N. P. Dharmasena, K. N. Bandara and W A Karunawardena  
*National Building Research Organisation, Sri Lanka*

**ABSTRACT:** A failure occurred in a cut slope of the southern expressway where all the surface drainage measures had been implemented. The failure surface was shallow but it has disrupted three levels of berms. The debris of failure were quite dry. A close examination indicated that a cascade drain has cracked and water is leaking to the slope. There were five systems of joints in the rock and adversely oriented relict joints were identified during rectification work. The failure could have been triggered by infiltration of rainwater through relict joints, reduction of matric suction and development of pore pressure. Rectification process involved installation of soil nailing and cable anchoring together with long sub horizontal drains.

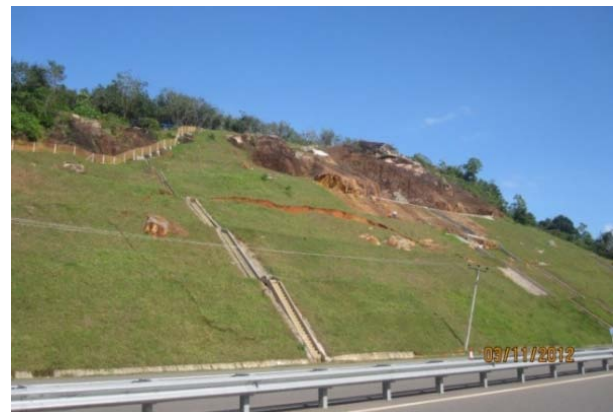
A failure occurred in a cut slope at chain edge 42+340 to 42+400 in the southern expressway after few days of rain. As illustrated in Fig. 1 tension cracks were noted in the slope around 9 AM and the traffic on that side was diverted. Complete failure occurred by 5 PM on the same day (Fig. 2). The failure surface was quite shallow (Fig. 3) but it destroyed the system of berm drains and cascade drains over three levels of berms. The debris of the failure were quite dry. The ground water table is quite low. Close examination indicated that one cascade drain had cracked sometime prior to failure and water had been leaking into the slope. Whitish clay of low shear strength was seen at some locations in the failure surface. (Fig. 3). The slope is formed of residual soils where the parent rock is metamorphic. Due to weathering under high ambient temperature and high rainfall conditions and the differences in the lithology of the parent rock the weathered product is highly variable. Rocks with no or slight weathering were embedded in a matrix of soil (boudinage structures). Five different joint systems were identified in the rocks in the area (Fig. 4) and adversely oriented relict joints filled with water were identified during the rectification process. Kulathilaka and Sujeevan (2011) illustrated the infiltration of rainwater and associated reductions of matric suction and pore pressure development due to a rainfall. Kulathilaka and Kumara (2011) illustrated how the changes in the pore pressure regime are minimized by surface drainage and

Fig. 1 Tension cracks on the verge of failure

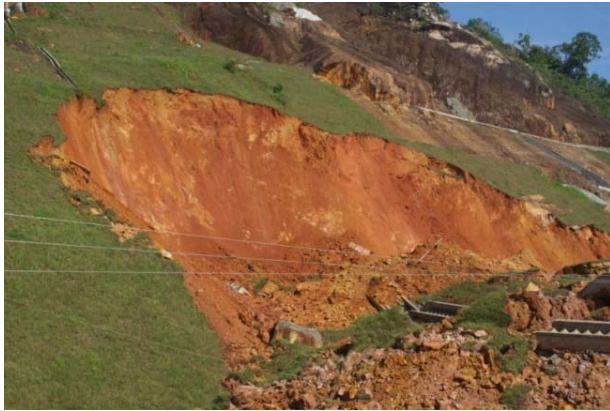
Fig. 2 After the catastrophic failure

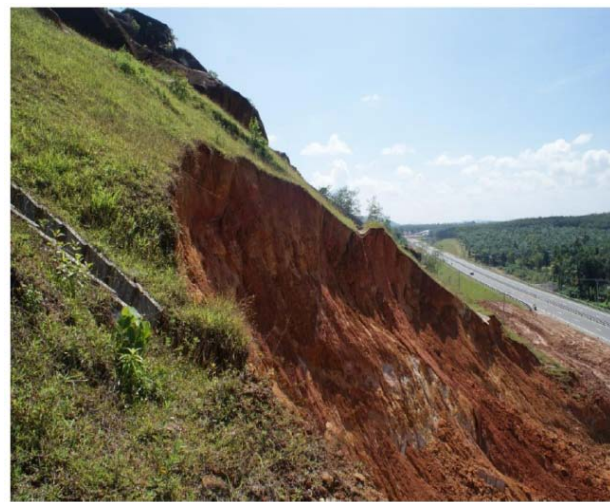
Fig. 3 Failure surface is shallow. Whitish clayey is seen at some locations

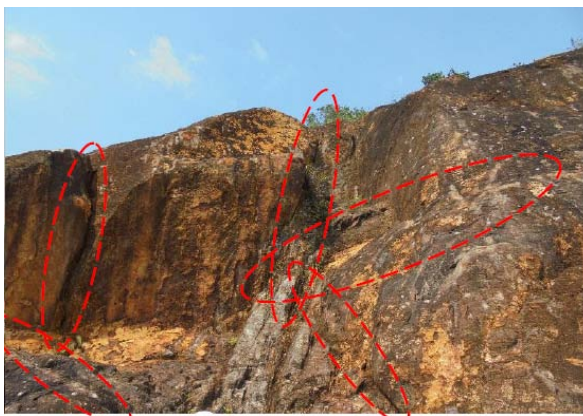
Fig. 4 Joint sets in the bedrock exposed at the top of the slope

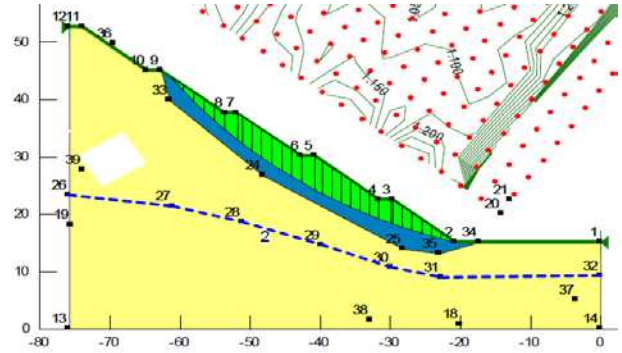
surface protecting vegetation. Analyses were done with GEOSLOPE (2007) software. In the case of this slope all such measures were implemented. It appears that the loss of matric suction had been facilitated by the presence of adversely oriented relict joints and leaking drains. When the back analyses were performed with different values of apparent cohesion the critical failure surface given in Fig. 5 was obtained for a value of 7 kN/m<sup>2</sup>. A detailed study modeling the infiltration with relict joints is currently in progress.

Fig. 5 Simulated failure surface

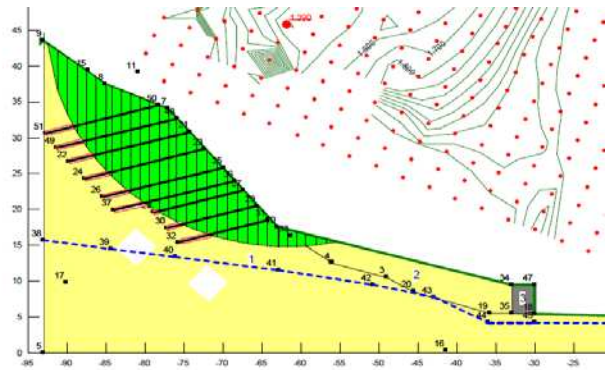
Fig. 6 Proposed stabilization with soil nailing subsurface drainage and toe wall

proposal involved; strengthening the existing scar of failure by soil nailing after removal of the

debris, reconstruction of surface drainage and use of a series of long sub horizontal drains. In addition, a gabion retaining structure is to be constructed at the toe (Fig. 6). Soil nailing design involved nails of 16m length at the highest location. Later it was decided to use cable anchors in place of those long nails. The other nails were of length 12m. During the drilling (Fig. 7) boudinage structures and water filled relict joints were encountered in some drill holes. Water was gushing out at high pressure in those drill holes covering the workers in mud (Fig. 8). During the grouting of boreholes after placement of nails, the grout was coming out from non grouted holes. The volume of grout used was also much greater than the volume of holes which indicates that the systems of joints are interconnected.

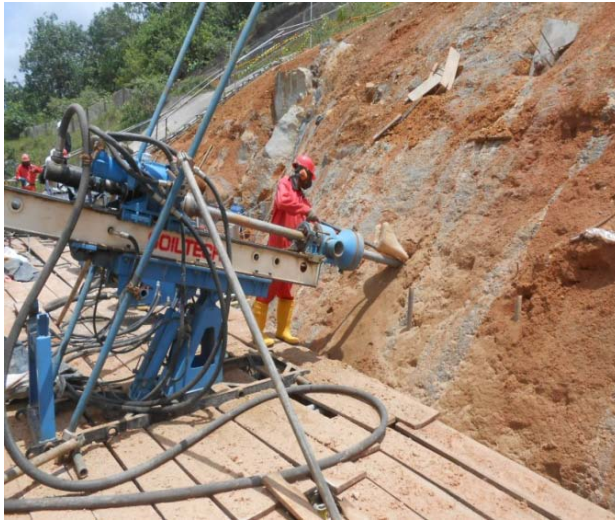
Fig. 7 Drilling for soil nailing /cable anchoring

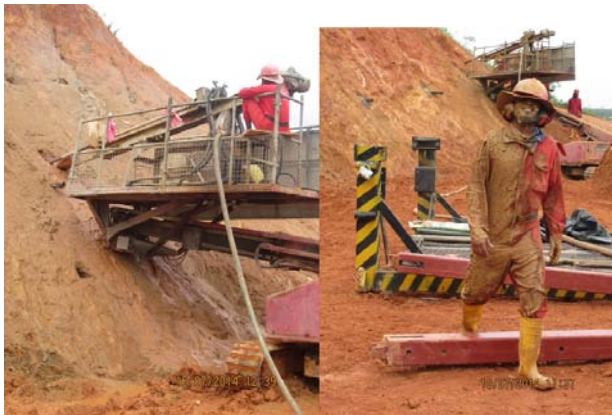
Fig. 8 Water oozing out of relict joints during drilling

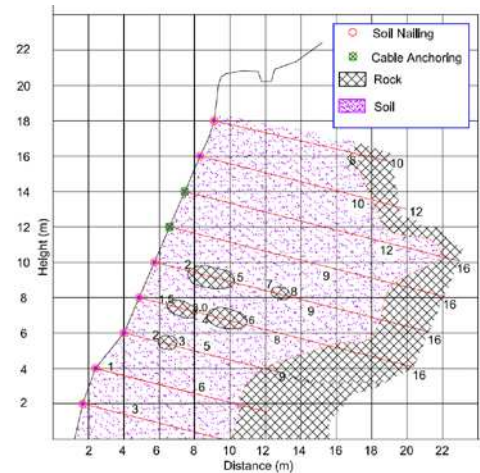
Fig. 10 Typical drilling records indicating boudinage structures

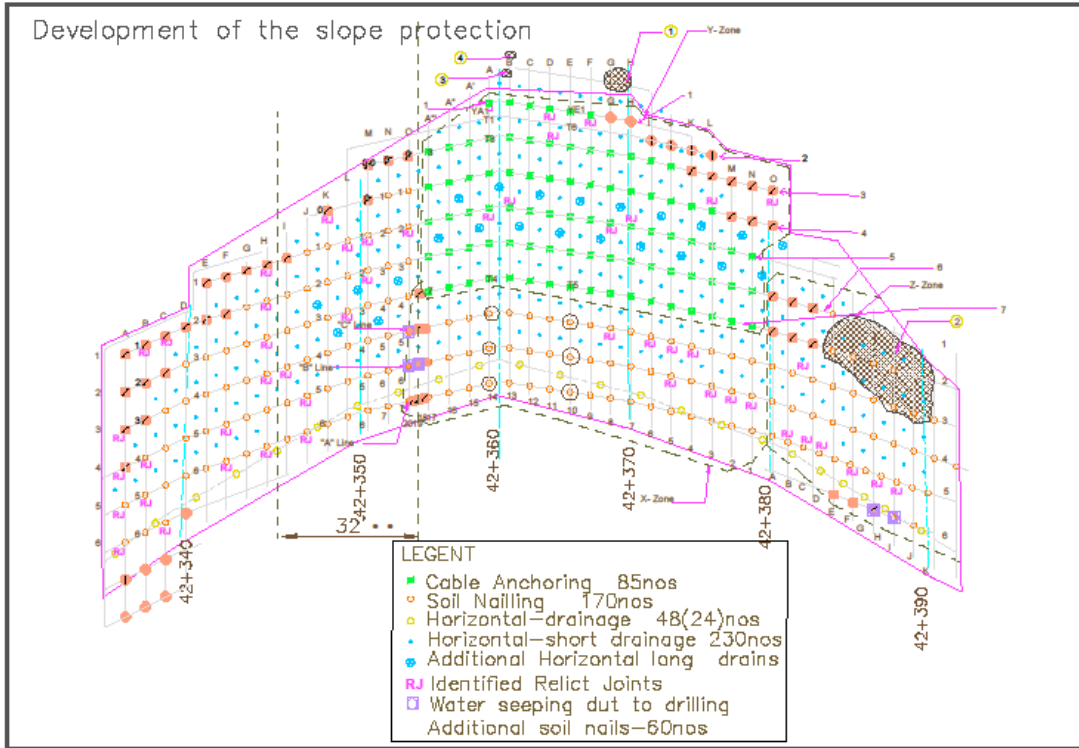
Fig. 11 A front elevation with locations of soil nailing, cable anchoring and sub surface drains.

A typical system of joints as identified by the evidence surfaced during drilling for rectification work is presented in Fig. 9. This evidence supported the earlier hypothesis that the failure was facilitated by the water entering the slope through relict joints. Water pressure will also built up in relict joints. As such, number of long horizontal drains were done at identified locations of water filled relict joints to facilitate rapid release of water. A typical condition with boudinage structures encountered during drilling is presented in Fig. 10. The location of soil nails, cable anchors and long horizontal drains are presented in the elevation diagram in Fig. 11.

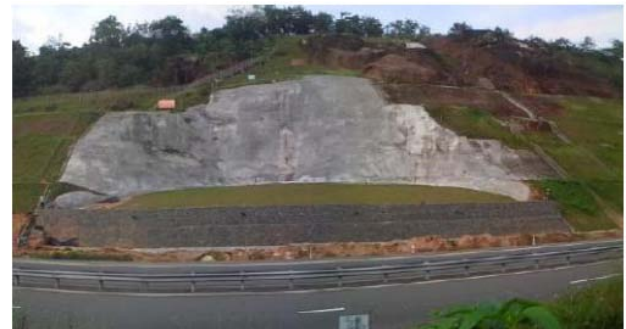
Fig. 12 Slope after completion of rectification

Cable anchors used were pre-tensioned to 180 kN. Thereafter all the nail heads and cable anchoring heads were connected by a system of beams and the complete surface was shotcreted (Fig. 12).
