Investigation on Slope Failures Caused by the 2018 Northern Kyushu Torrential Rainfall, Japan

Takashi Fujishiro

Hemanta Hazarika

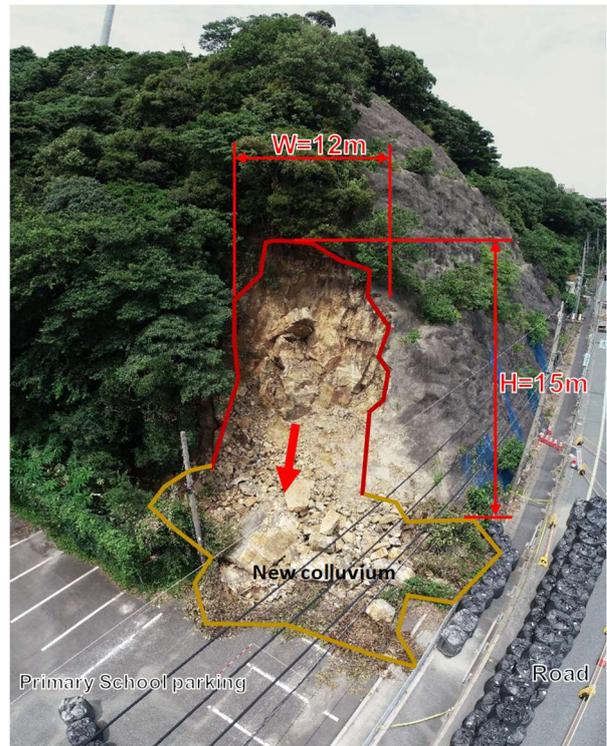
Figure 6. Bird's eye view of the collapsed slope

The slope failure occurred around 20:00 on July 5. The slope failure scale is 15m in height, 12m in width, 2m in average slope failure depth, 360m³ in slope failed soil volume (all approximate) (Fig. 6).

The slope failure partly reached the road, but because it was mainly directed to the adjacent primary school parking lot side, it did not cause major damage.

The geology of the slope is equivalent to the Orio sandstone of the Paleogene Ashiya Group, and is composed of massive sandstone with cracks. Although the weathering of the rock is weak, the cracks are square and open. No spring water was seen from the slope failure surface. An unstable rock mass remains on the slope failure surface, and an overhanging rock mass is seen at the slope failure head. Even after several hours of slope failure, small rockfalls (about the size of a human head) have occurred, and there is a possibility of expansion. On the slope of the road side, there was no expansion of deformation that was a sign of slope failure.

In the Mizumaki area, it was necessary to remove the collapsed sediment that had reached the road as soon as possible. The slope was steep and many unstable rock blocks were seen on the failure slope, making it difficult to approach for topographical survey. Topographic plan and cross-sections were created by aerial photogrammetry using UAV, and countermeasures were examined. It was judged that the slope stability countermeasure work requires a structure countermeasure because it is difficult to secure a stable slope by cutting (re-cutting is difficult) due to site restrictions.

In addition, as a result of UAV images and telescopic observation, it was confirmed that an unstable soil mass (failure residue) remained above the failure site. Therefore, a reinforcing bar insertion work was adopted as a measure for stabilizing the remaining block. In addition, the wire net work will be installed for the purpose of integration by connecting the heads of the reinforcing bar inserts to ensure stability and to prevent the falling of small pieces of unstable soil blocks.

On the other hand, since many cracks develop in the lower part of the collapsed part, it was decided to stabilize by grating crib work.

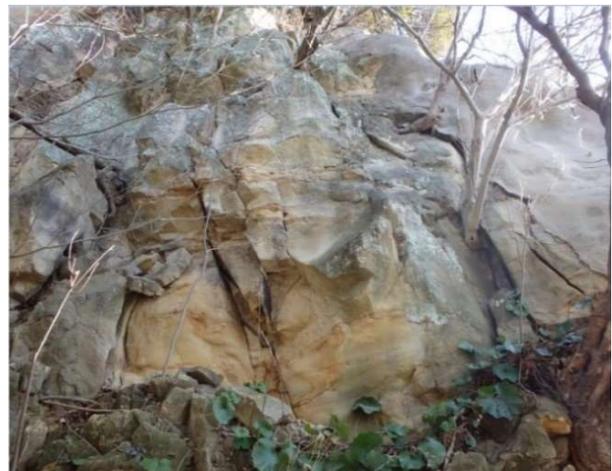
Figure 7. The outcrop of the slope before the collapse

The slope failure part is continuous with the cut slope of the main line. Before the slope failure, part of it was protected by a mortar sprayer, forming a steep cliff near the vertical and exposing the rock mass with many cracks (Fig. 7).

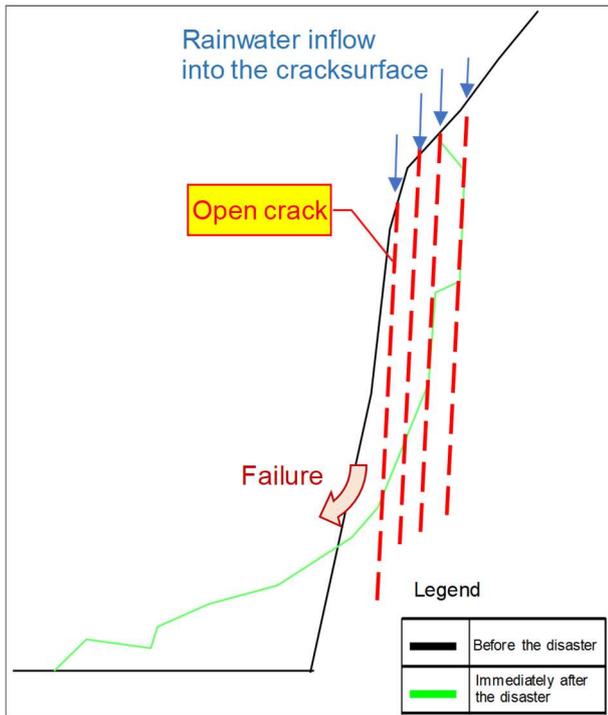
Figure 8. Schematic diagram of slope failure

Based on the topographic and geological conditions of the slope, the failure mechanism is assumed as follows: (Fig. 8).

1. Longitudinal cracks have developed in the natural grounds, and tree roots have invaded some of them.
2. A lot of water flows into the crack surface due to heavy rain
3. Water pressure is generated in the crack, and the adhesion of the crack surface decreases, so stability is lost and slope failure occurs.

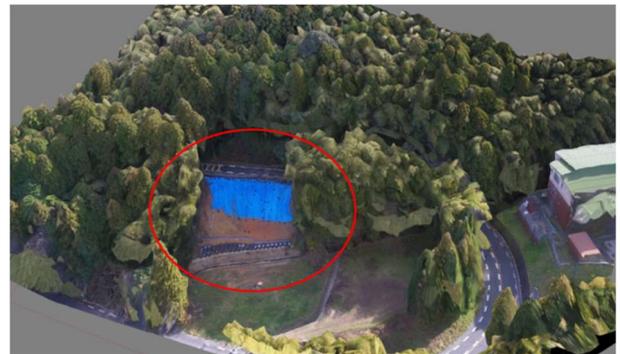
Figure 9. Bird's eye view of the failure slope

The slope failure occurred early morning on July 6. The scale of slope failure is 10m in height and 20m in width, from the embankment slope to the natural slope below the road (Fig. 9). Fig. 10 shows the topographic map around the target site, and Fig. 11 shows a photograph and sketch of the slope failure slope.

Slope failure has occurred in embankments and cliff deposits. On the left side of the landslide slope, erosion marks due to water leakage from the broken road gutter are seen.

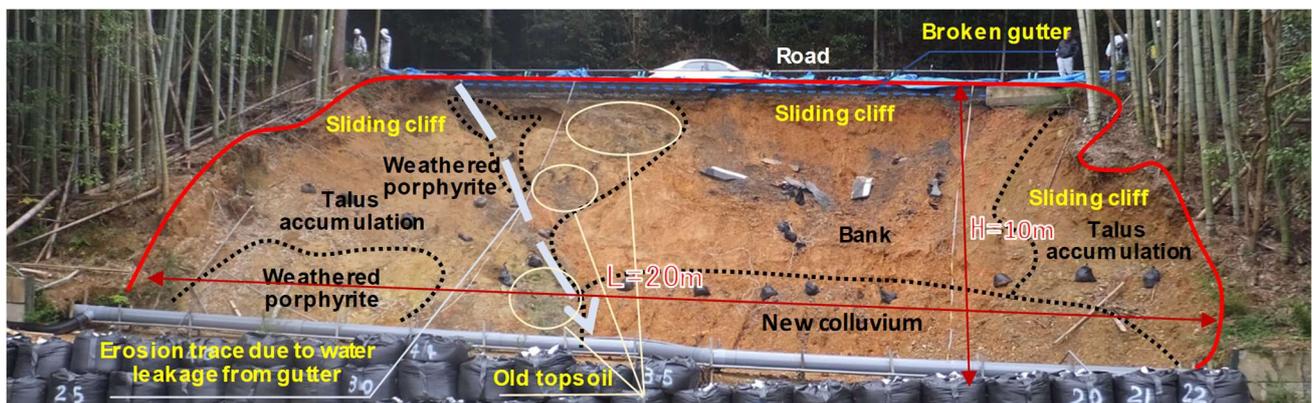
Figure 11. Photograph and sketch of the failure slope [7]

On the failure slope, weathered porphyrite, talus accumulation and embankments corresponding to the Lower Cretaceous Kanmon Group and Shimonoseki Group are confirmed. The natural ground at the slope failure site is composed of porphyrite that has been earthen by strong weathering. Although it is weathered to sandy soil, the original rock texture is clear and no slope failure has occurred.

It can be seen in the lower part of the talus accumulation on the left side of the slope. Talus accumulation can be seen on the right side and on the left side of the slope. It contains a large amount of breccia with a maximum gravel diameter of about 20cm and has a light reddish brown color. The humus soil, which is

supposed to be part of the old topsoil, is thinly distributed on the surface of the cliff-cone deposit, and a blue glue deposit is characteristically seen. The embankment is found in the middle of the landslide slope. It is reddish brown, contains a lot of soft gravel, and is a loose clay soil. It is distributed so as to cover the cliff cone deposit. The origin of the talus accumulation and embankment is thought to be the same weathered porphyrite, but the embankment is soft with gravel and loose matrix, the cliff-cone deposit contains a lot of rubble, and some of the surface has old topsoil. Characterized by remaining.

The topography of the slope failed land is a parallel slope on the side of the ridge topography and does not show a typical water collection topography. The slope on the mountain side of the road is an untreated cut slope, and a part of the slope failed horseshoe-shaped depression (valley-like landform) is seen.

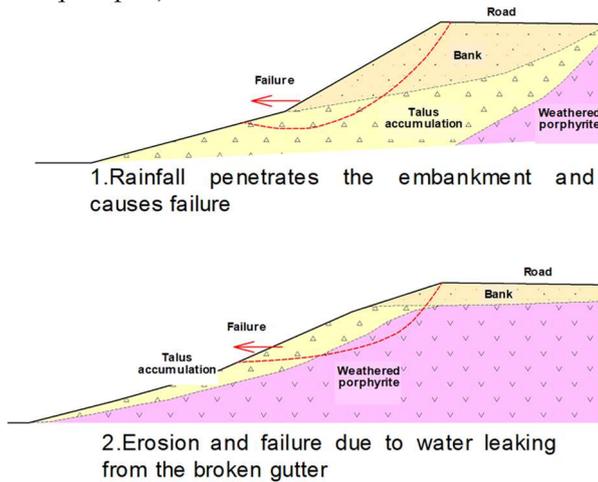
Figure 12. Failure form and assumed geological section

Based on the topographic and geological conditions of the slope, the failure mechanism is assumed as follows (Fig. 12).

1. Rain infiltration concentrated on the embankment filled with a small catchment topography, and when it saturated, the surrounding talus accumulation also involved and collapsed (collapse on the right side from the center of the collapse).

2. At that time, water leakage occurred due to the rupture of the shoulder-side gutter, and talus accumulation on the left side of the collapse, surface layer collapse of weathered porphyrite, and erosion occurred (collapse and erosion on the left side of the collapsed part).

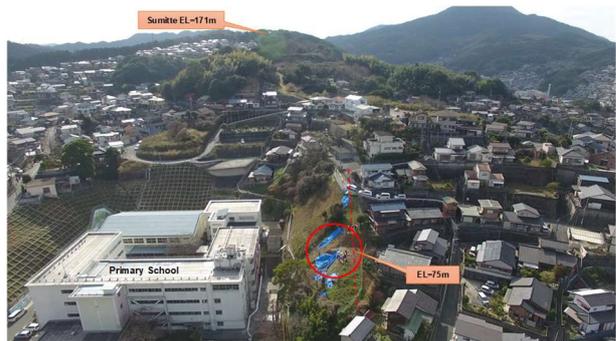
Figure 14. Bird's eye view of the failure slope

The slope failure occurred early morning on July 6. The scale of the failure is a cut slope with a height of 10m, a width of 20m, and a valley formed by the creation of the primary school.

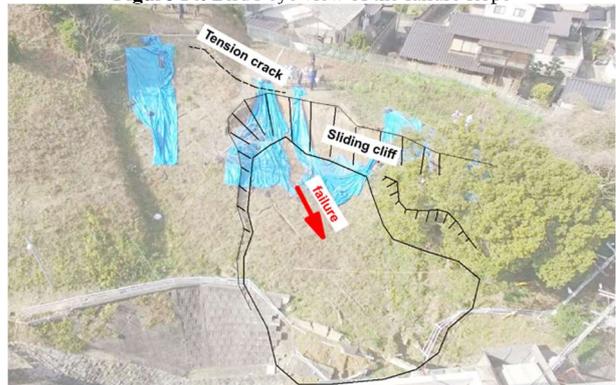
Figure 15. Photograph and sketch of the failure slope

Fig. 13 shows the topographic map around the target site, Fig. 14 shows the aerial photograph, and Fig. 15 shows the photograph and sketch of the failure slope. The failure slope is located in a low mountainous area with small undulations where residential land development has progressed, and on a straight ridge topography. In the borehole survey, fresh rock mass has not been confirmed, and there is no outcrop nearby, so the relationship between geological structure and topography and failure is unknown. Since it is located on the east side of the ridge topography and surface water is not easily collected, it is thought that the influence of surface water on the collapse is small.

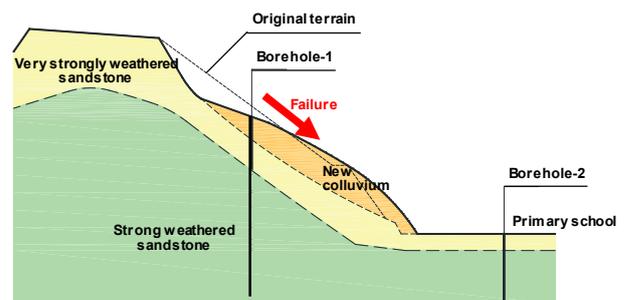
Figure 16. Failure form and assumed geological section

The geology of the failure slope is composed of strongly weathered sandstone corresponding to the Lower Cretaceous Kanmon Group and the Shimonoseki Group, and exhibits a reddish brown to yellow-gray sandy cohesive soil. As a result of the survey, weathering progressed at a thickness of 10 m or more (Fig. 16).

The failure mechanism is assumed as follows based on the geological condition of the slope (Fig. 16).

1. Saturation of the surface sediment increases due to heavy rain.

2. The weight of the surface soil increases, the strength constant decreases, and failure occurs.
