# Application of CPT to investigation of abandoned shallow coal workings, and their remediation by grouting

S. Fityus<sup>1</sup> L. Bates<sup>2</sup>

**ABSTRACT:** CPT testing was carried out before and after the grouting of abandoned shallow coal mine workings to understand the conditions of the workings and to infer the extent of underground voids that were filled with grout during their remediation. The site, with 2-3m of coal extracted by bord and pillar workings from between 10 and 13m depth, has a recorded history of widespread surface subsidence and ongoing potholing over the more than 100 year period since mining ceased. Prior to grouting, from 3 CPTs and three drilled boreholes, there was no evidence of open voids, indicating that collapse of the workings was extensive. The CPT was found to be a poor differentiator of subsurface conditions in this instance, failing to clearly differentiate intact roof from subsided roof, or between subsided roof and goaf. Despite the phreatic surface lying only 4-6m below the surface, pore water pressure data was inconsistent, fluctuating unpredictably between positive and negative values. Generally, negative pore pressures were recorde

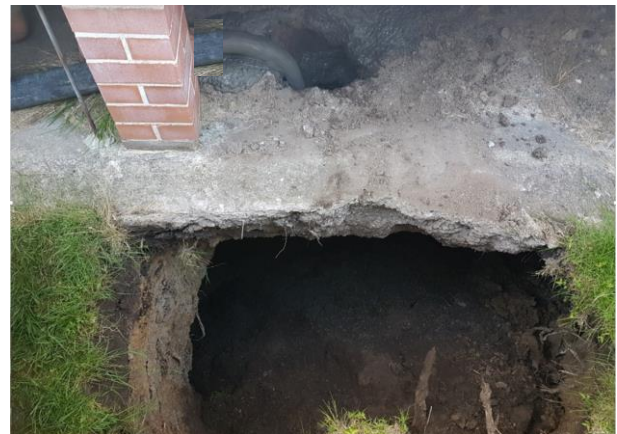
**Figure 2.** Typical surface expression of pothole subsidence of shallow mine workings, and filling with concrete.

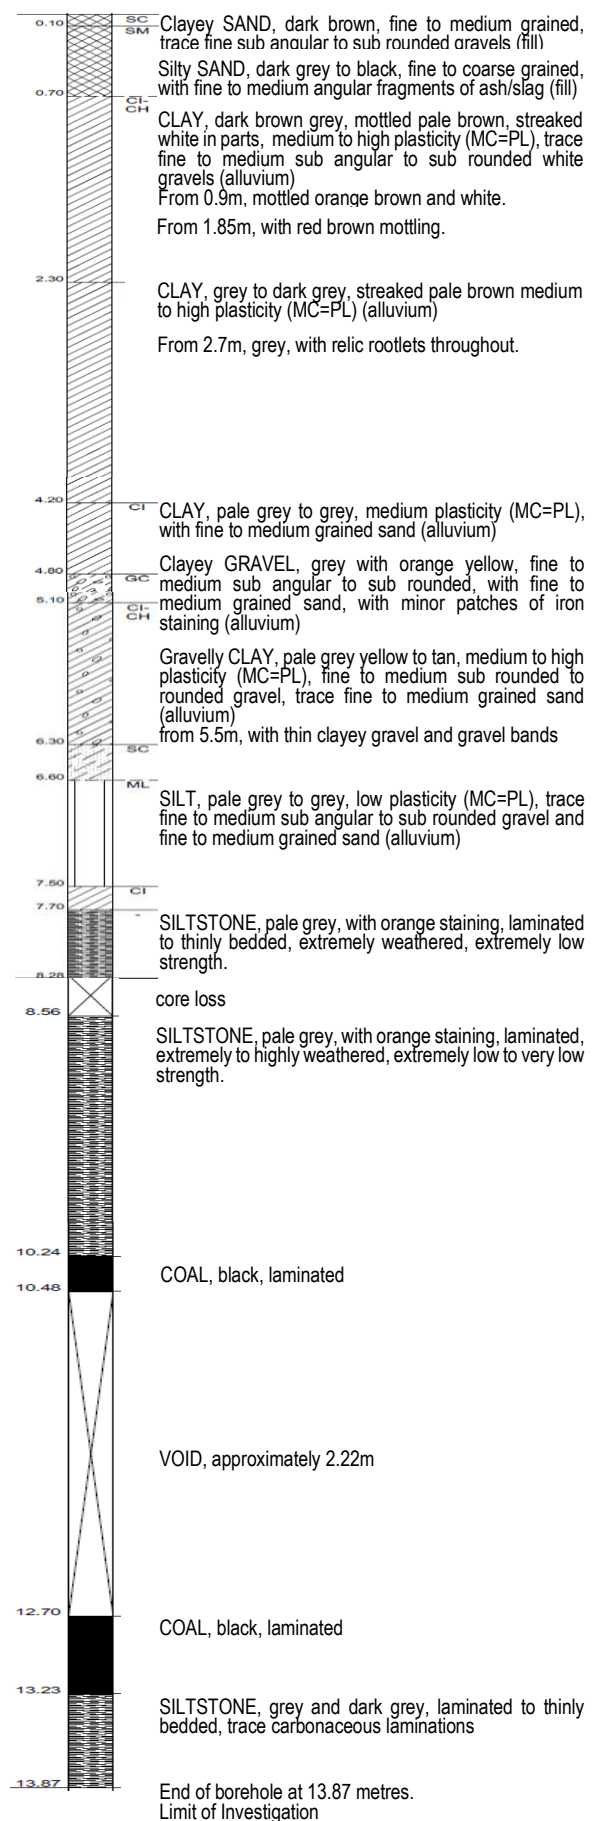
The immediate roof of the mine is made up of extremely weathered siltstone and claystone rock types of the Tighes Hill Formation (Hawley and Brunton, 1995), although at this site, only 3-4m of very low strength rock is present, and the upper 6-8m of the profile comprises stiff alluvial clays. The immediate floor of the Borehole Seam is the stronger Waratah Sandstone, however mines in the area typically left a small thickness (~300mm) of intact coal (referred to as “bottoms”) on the floor. The ground profile for the site, as recorded in a logged borehole, is shown in Figure 4.

**Figure 4.** Typical ground profile (BH1) from the site, which recorded standing workings (free-standing void) in the seam. (after GHD, 2017)

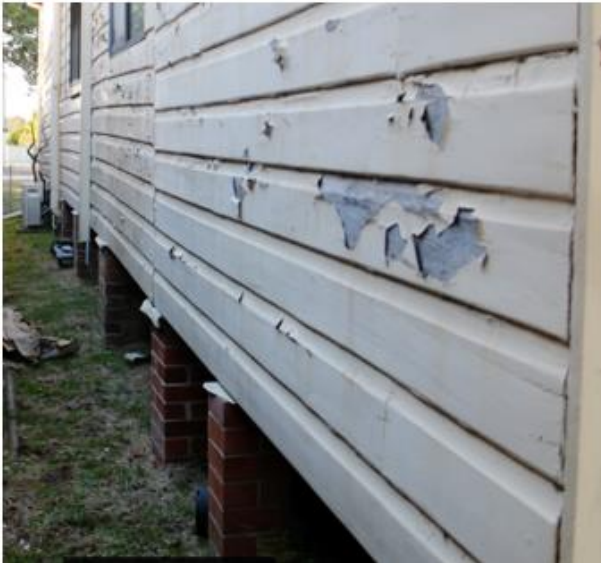
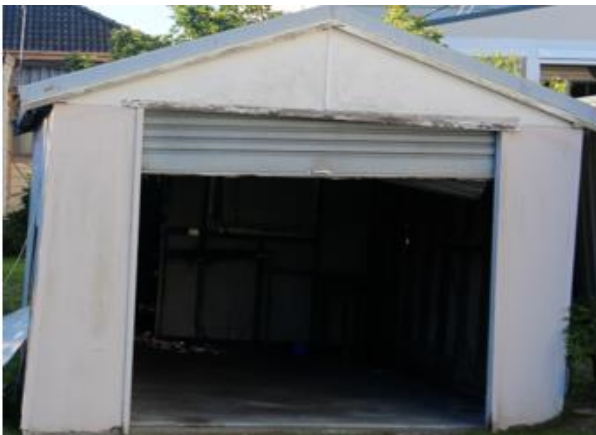
Sometime after mining occurred, a single-storey timber-framed weatherboard cottage was constructed on the site, founded on shallow isolated piers, spaced at between 1.5 and 2m. Accessible records of the site are available from 1961 onwards, and these document a number of subsidence events from 1963 to 1980 that severely impacted the property. Subsequent events from 1980, to 2018 resulted in further damage. Figure 5 (top) shows the curvature evident when sighting along the western wall of the house (the centre is higher than the ends by more than 200mm). Figure 5 (bottom) shows the tilt in the garage (which was tilted by 150mm from side to side).

**Figure 5.** Damage to structures on the site due to ground movements caused by subsidence.

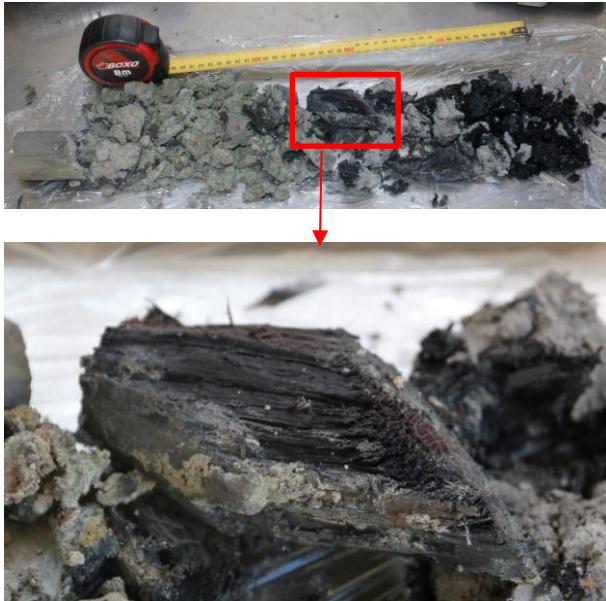
In addition to the 14 CPTu tests and the 3 cored boreholes, a sample was taken with a 0.5m long push sampling tube via the CPT rod string in CPT2a. motivated by the ambiguous results from CPT2. The sampling tube recovered what is interpreted to be a sample of extremely weathered siltstone roof material together with a section

of hardwood timber pit prop and weathered coal fragments shown in Figure 6. Due to the highly variable nature and poor spanning characteristics of the immediate overburden of the Borehole Coal Seam, mines in this area were known to heavily “timber” the roof, using hardwood props to provide standing support for the bords being mined. Commonly, this timbering was removed (if safe to do so) post mining, however in areas where secondary extraction (i.e. pillar removal) occurred, much of the timber used to support the roof had to be left in place.

**Figure 6.** CPT sample pushed at the level of the mine roof at CPT2a: 500mm of recovered material with EW siltstone to the left and coal fragments to the right (top); enlargement of hardwood timber fragment push-cored by the sampling tube (bottom).

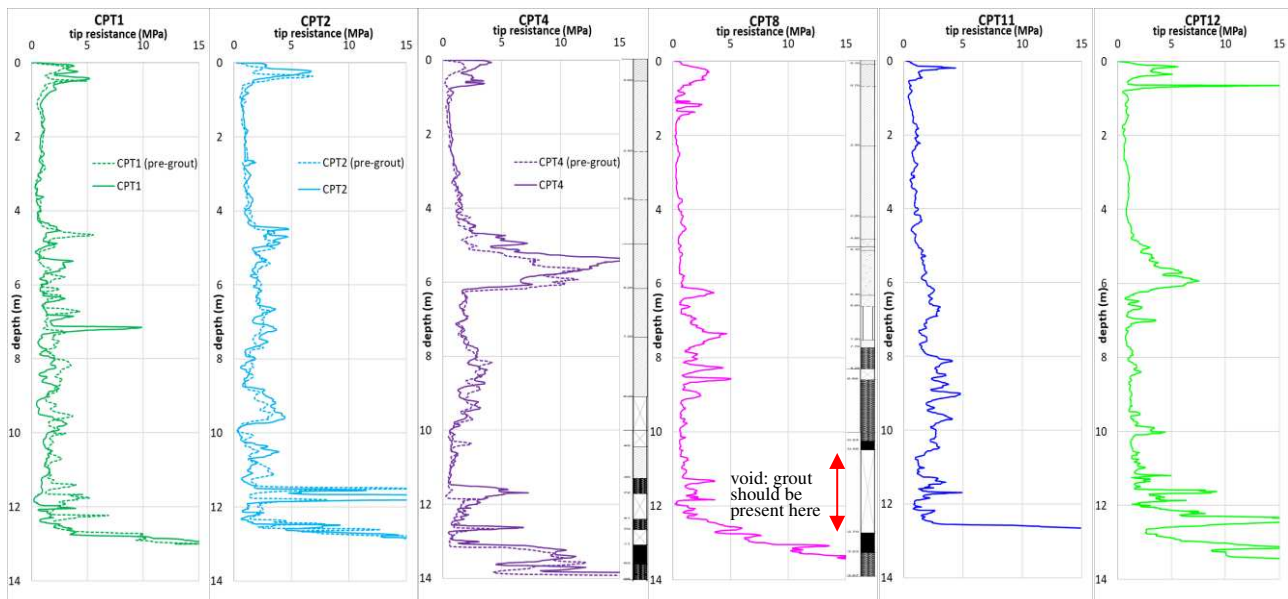
Figure 8. Individual tip resistance plots for selected CPT test locations.

A selection of tip resistance plots is presented in Figure 8. Tip resistance was only moderately useful to differentiated units in the subsurface profile. The fill layer at the surface was generally evident as a stiffer material with values between 4 and 7 MPa, reflecting some degree of surface compaction by site activity.

Below this, the alluvial clays generally displayed a consistent increase in stiffness with depth with few stiffer peaks. The gravel layer was only strongly evident in about half of the CPTs, and its tip resistance signature varied greatly both in terms of magnitude and position.

The interval between the gravel layer (~6.6m) and the top of seam (~10m) resembled the stiff clay above, except it was slightly stiffer, more erratic and did not exhibit the same consistent increase in strength with depth. For example, in CPT11, where the gravel layer was not present, the demarcation between the alluvial clay and underlying EW siltstone (~6m) is not at all distinct. Also as an example, in CPT8, despite a weakly developed gravel layer, the alluvial clay and underlying EW siltstone have essentially the same tip resistance signature.

The interval corresponding to the seam/workings is perhaps the most erratic, becoming more so approaching the base of seam/floor. This will be discussed further below.

Additionally, the CPT was found to be a poor instrument in determining grouting effectiveness at this site. The only profile highly likely to contain grout was CPT8 (shown in Figure 8), and the expected grouted interval was found to have a similar profile to the alluvial clay unit encountered nearer to the surface, over most of its thickness. The difficulty in confidently distinguishing grout on the post-grouting CPTu profiles was not helped by the low grout volumes that were recorded as being pumped underground at the site: in most locations, less than a cubic metre of grout could be injected, so widespread lenses/bodies of grout cannot be expected. This is a further indicator of likely significant convergence of the mine roof and mine floor over the majority of the site.

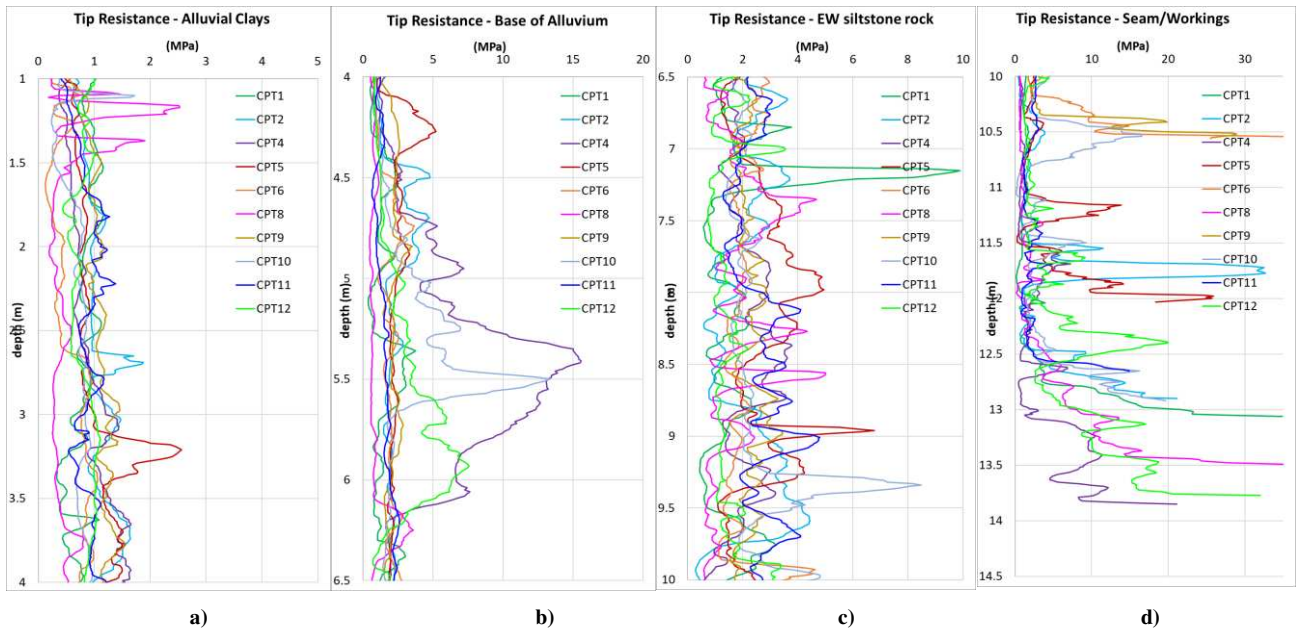
Figure 9. Tip resistance plots for identified subsurface units.

Figure 9 shows the specific intervals corresponding to the units identified in the borehole log of Figure 4. Figure 9a) compares the tip resistance profiles of the alluvial clays, which actually vary in average strength from around 300kPa (CPT8) to about 1MPa (CPTs 2 and 11), or, from soft to stiff. CPTs 2 and 5 seem to contain thin, stiffer lenses between 2.5 and 3.5m.

Figure 9b) compares the tip resistance profiles between 4m and 6.5m, which captures the gravel unit, where present. It is most well developed in CPT4 where it reaches a tip resistance of 15MPa, and less evident in CPTs 10 and 12.

Figure 9c) compares the interval from the base of the gravel to the top of the seam, and which contains the extremely weathered siltstone roof. The trends are variable, indicating that the roof material varies from a stiff to a hard clay. The only anomaly is the significant spike in CPT1 which possibly corresponds to an ironstone nodule, which are often found in the local siltstones of the area.

Figure 9d) is perhaps the most interesting interval as it corresponds to the interval that would contain the seam, or voids, or goaf (collapsed material). Overall, the interval is characterized by significant peaks at various levels throughout the extracted height of the mine, dropping back to values of greatly lower, and highly variable strength. Significantly, despite several profiles showing

very low strength soils in this unit, no intervals with zero tip resistance were encountered at any of the locations tested. Whilst this may be expected in profiles post grouting, if all voids were filled with grout, it also applies to the three pre-grouting CPT profiles in Figure 8 (CPTs 1, 2 and 4). The effectiveness of the CPT tests to identify the presence of grout is considered further later in the paper.

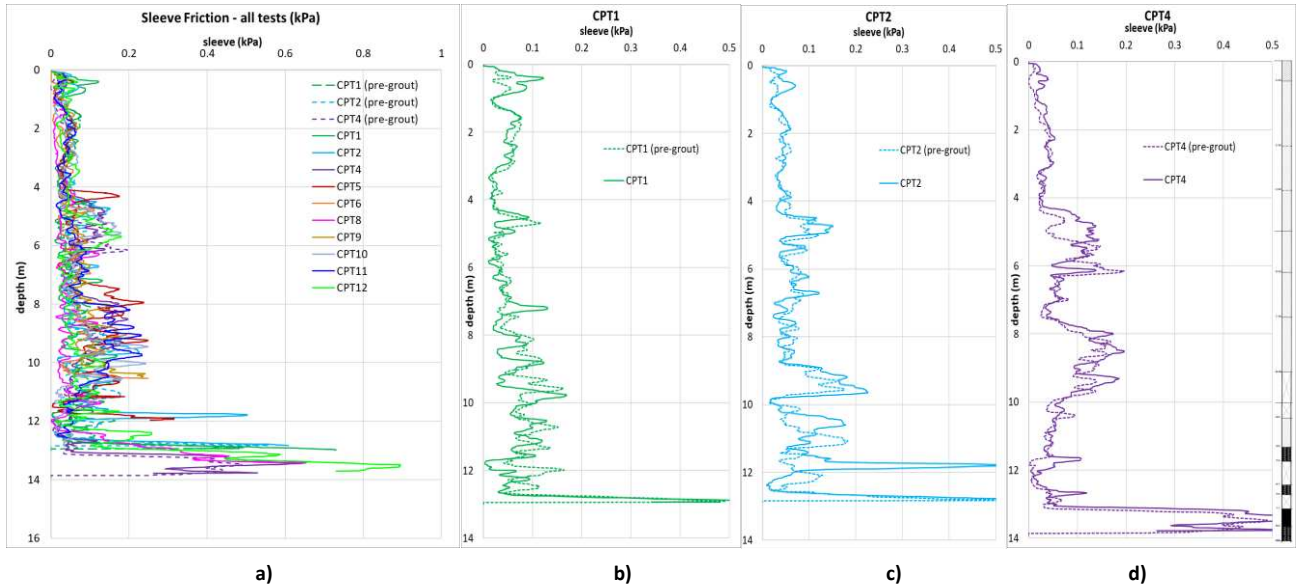
Sleeve resistance profiles are shown in Figure 10. Figure 10a) compares the sleeve resistance for all CPT tests. The sleeve signatures of each unit have similarly limited value as the tip resistance signatures previously discussed. Perhaps the only significant difference lies in the signature of the EW siltstone interval, which for the tip resistances more resembled that of the alluvial clay interval, but for the sleeve resistances more resembles that of the gravel.

Figures 10b)-10d) compare the CPTs for the site in its pre grouted and grouted condition. As for the tip resistance data, there were no discernable differences in the sleeve resistance due to grouting.

Figure 10. Sleeve friction plots for : a) all tests and, b) – d) paired pre and post grouting tests.

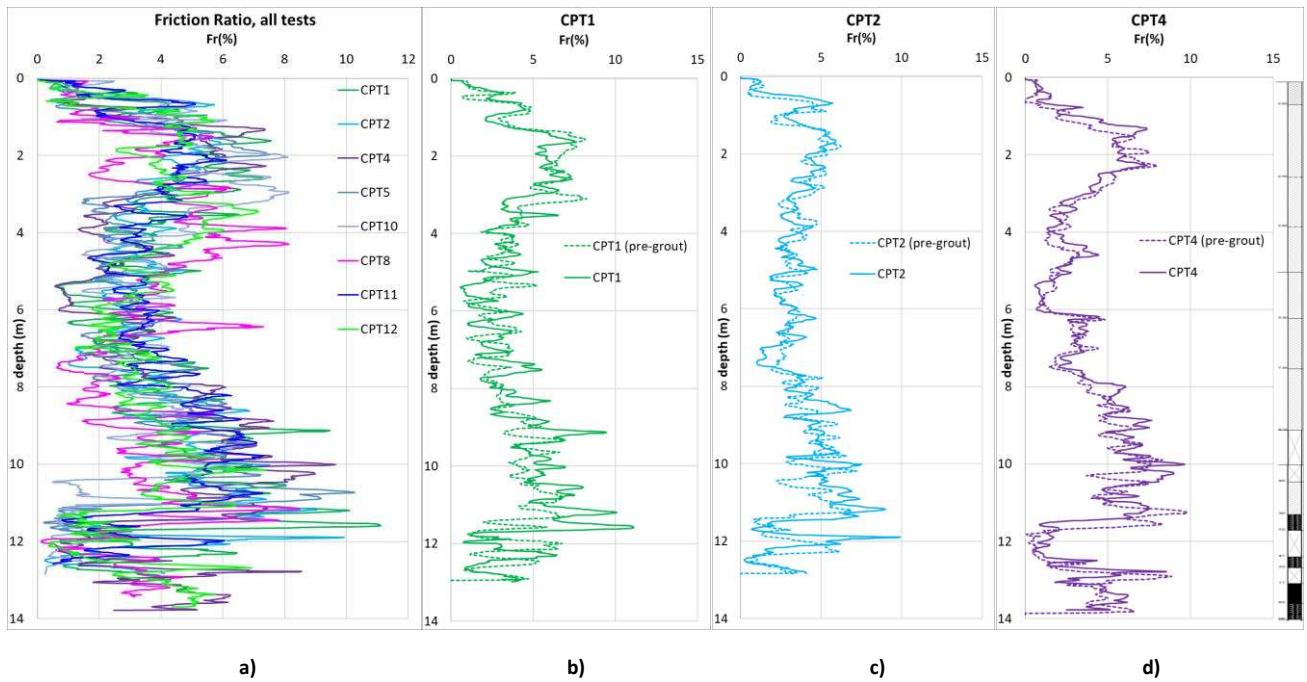
Friction ratio profiles are shown in Figure 11. Figure 11a) compares the friction ratios for all CPT tests completed across the site. As can be seen from Figure 11a), the 4 identified units can be generally consistently inferred, however as with tip resistance and sleeve friction, there was significant variation in individual profiles.

Figures 10b)-10d) compare the CPTs for the site in its pre grouted and grouted conditions. As for the tip resistance and sleeve friction data, there were no discernable differences in the friction ratio due to grouting, with relatively even amounts of positive and negative variations throughout each profile.

**Figure 11.** Friction ratio plots for : a) all tests and, b) – d) paired pre and post grouting tests.

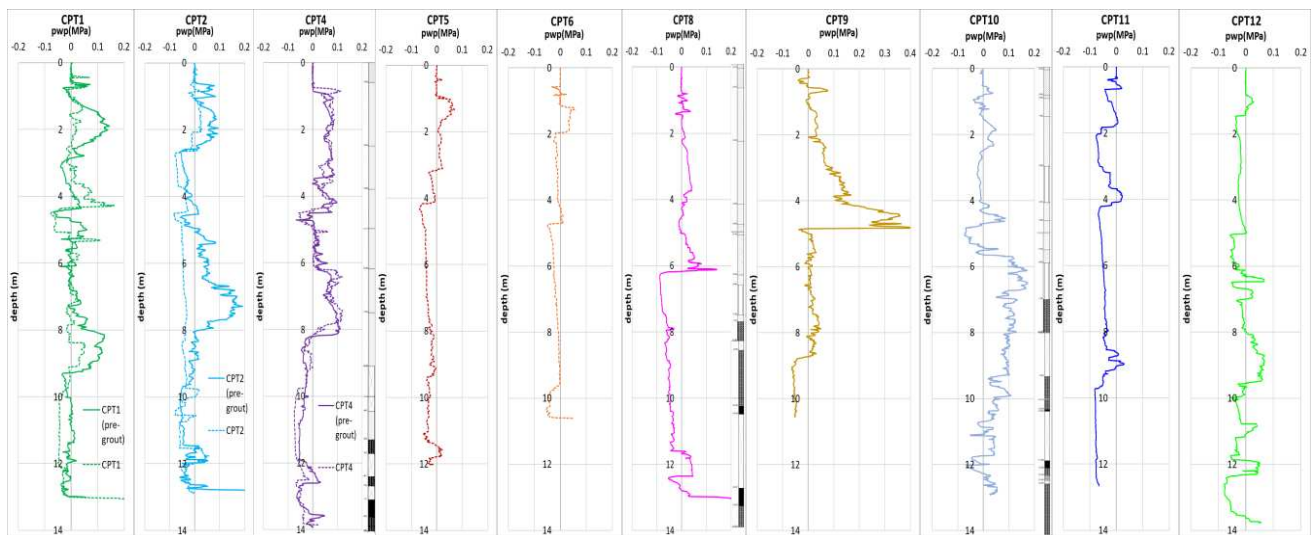
The pore water pressure (PWP) results for each CPTu are displayed in Figure 12, together with paired tests or the profiles from closely located boreholes (if applicable). From Figure 12, it can be seen that the profiles of each CPTu test location vary significantly across the site, with inconsistent results, both pre and post grouting. Similar reoccurring features such as sudden drops in PWP and consistently negative pore water pressures are evident in all profiles, but at inconsistent locations. These anomalous drops in PWP and zones of negative PWP occur throughout the entire profile and are not limited to a single unit. CPT 11 recorded negative PWP values over almost its entire depth, whereas CPT 9 is predominantly

**Figure 12.** Pore water pressure results for paired CPTu tests, individual tests and CPTu/cored borehole paired tests.

positive; CPT4 is predominantly positive in its upper part, and negative below, whereas CPT 9 is inclined to be negative in its upper parts and positive below.

There are no obvious reasons for the sudden changes and localized anomalies, but it is suspected that it may be indicative of a highly disturbed groundwater profile at the site. The boreholes on this site recorded standing water at relatively consistent depths of 7-7.5m, however on an adjacent site, water levels between 5.5 and 9m have been noted. Further evidence of a highly disturbed groundwater profile at the site exists from notes on the drilling logs of the grouting contractor noting that in around boreholes across the site anomalously wet clay was identified.
