# Specific slope stability study of Aomar region— characterization and proposal of reinforcement measures

**ABSTRACT:** The 162 km High-Speed Railway project connecting the two Algerian cities Thenia in the north and Bordj-Bou-Arerridj in the east encountered a lot of engineering challenges, among which the 10 km landslides that occur in the region of Aomar, district of Bouira. This paper presents a specific slope stability analysis of one of these landslides. The region is historically well known of being the centre of many landslides (the landslide area of “Djabahia” region located next to Aomar is witnessing many landslides and still presenting a major risk for the East-West Highway). In order to a better understanding of the Aomar’s landslides typology, a slope stability analysis is carried out with an emphasis on geomorphological, geological and hydrogeological conditions in addition to geotechnical data. Slope stability analysis was conducted using correlations between laboratory and/or in-situ tests with soil strength parameters in both drained and undrained conditions. The General Limit Equilibrium method (GLE) was then used to estimate the safety factor of the slip surfac

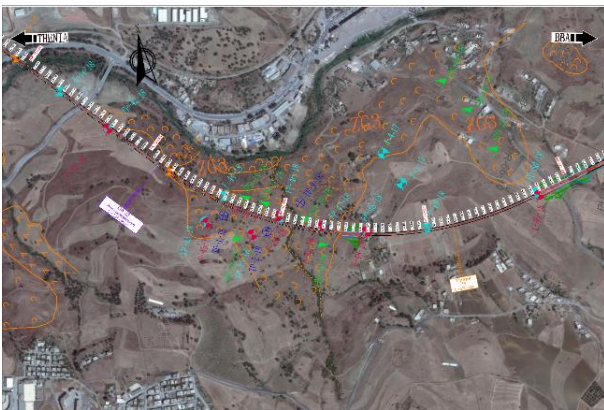
**Figure 2.** Railway line crossing the sliding area between PK36+300 and PK37+900

This clayey marl area has undergone landslides in three different directions, it is characterized by significant slopes exceeding 40%. Several significant landslide areas have been identified.

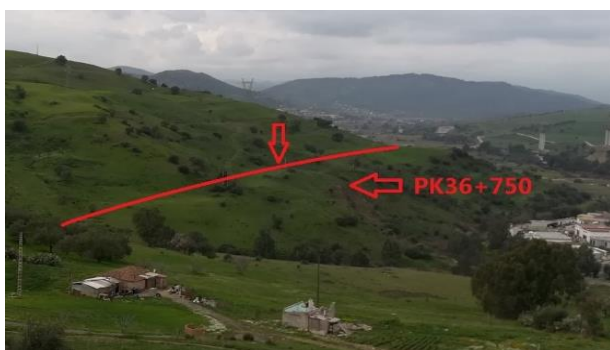
Detailed geological mapping of the sliding area (Fig. 3) has made it possible to identify the area in motion, to properly locate and delimit unstable parts, as well as the geological, hydrogeological and morphological environment in which they have evolved.

**Figure 3.** Topography between PK36+600 and PK37+050: View of the foot of the slope, with the sandstone bench

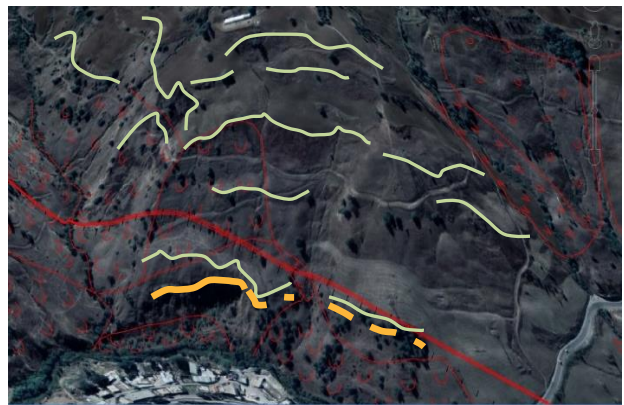
Between PK 36 + 300 and PK 36 + 600 (Fig. 4), the terrain is relatively flat, then the natural slopes of the terrain gradually increase, reaching 20° in some places. The section between PK36 + 700 and PK36 + 800 is characterized by the presence of a cliff of approximately 30 meters high, corresponding to a sandstone bank (continuous orange lines - visible bench, discontinuous line - probable bench).

From a morphological point of view, the existence of this sandstone bench makes it possible to dissociate the upstream and downstream areas. The upstream area affected by the landslides are limited in their lower part by this stable slope. This makes it possible to assess the depths of the fracture surface at about 10 m at the level of the bridge foundation. And also to consider that there cannot be a deeper surface, which would extend from the top of the slope to the bank of the wadi (rejected hypothesis).

**Figure 4.** 3D satellite image from PK 36+300 to PK 37+150

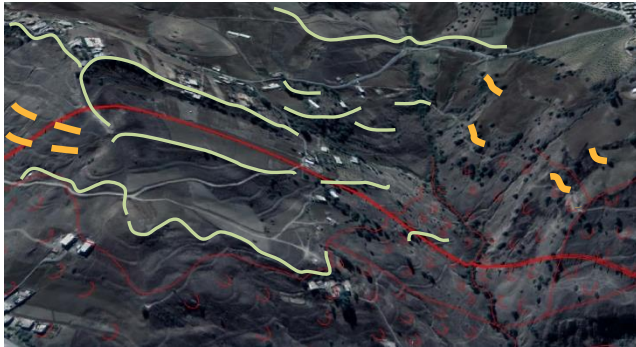
From PK 37+150 (talweg) to PK 37+500 (Fig. 5), the slope is generally regular, with slight humming. To the right of the railway line, begins a very flat and sloping large surface (this point corresponds to the entry of the TU09).

From PK37+500 to PK37+700, there is a large flat surface, surrounded upstream by an old tearing pattern, which would suggest a sliding crown, suggesting that the flat surface would correspond to the upper part of a very large sliding body. However, this morphological interpretation is not compatible with the flatness and inclination of the surface.

Beyond the slope break at PK 37+700, we descend to the road at PK 37+900, exit of the tunnel TU09. This slope is marked by a direct erosion morphology, which indicates the presence of sandstone marl. These benches extend laterally quite far, indicating that they have a regular dip.

This observation leads to the conclusion that the previous large flat surface is in fact a stratigraphic structural surface. The crowning all around would then represent the scar of an old landslide and total flattening of the entire rock cover. Such a slide in sandstone marl,

with clayey marl intercalations, is only possible in an earthquake situation. If this hypothesis is correct, the downstream slope would correspond to the accumulation of residues from this large, abrupt rock slide. It turns out that in this area, there are many sandstone blocks scattered on the slope, which support this hypothesis.

**Figure 5.** 3D Satellite image between PK 37+150 and PK 37+900

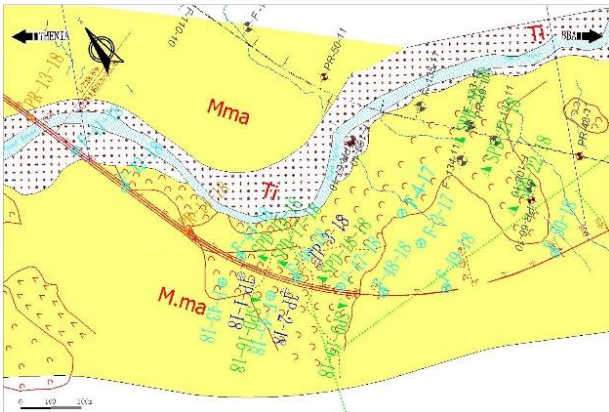
Geological surveys in this section on Aomar region (Fig. 6) have shown that the soils consist of Miocene marl interspersed with friable sandstone benches. Those sandstones are characteristic of the Aomar region.

**Figure 4.** Geological survey between PK 36 and PK 38 (Miocene marl of Aomar region)

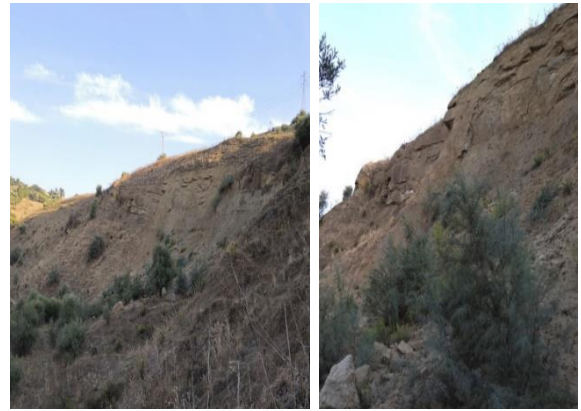
**Figure 5.** Sandstone bench outcrop between PK 36+700 and PK 36+800

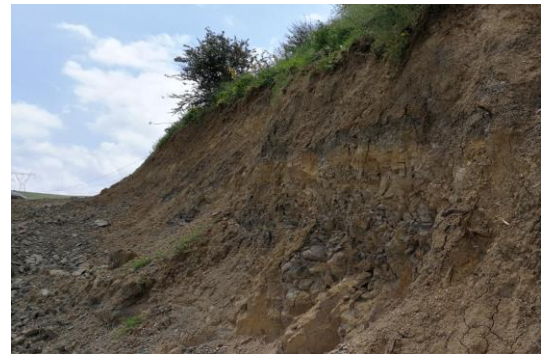
**Figure 6.** Outcrop of weathered clayey marl

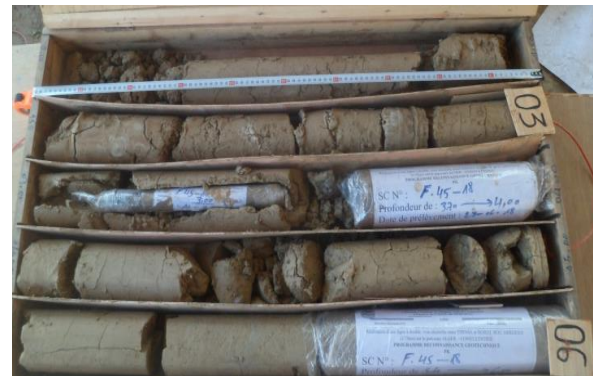
**Figure 9.** Fully weathered clayey marl

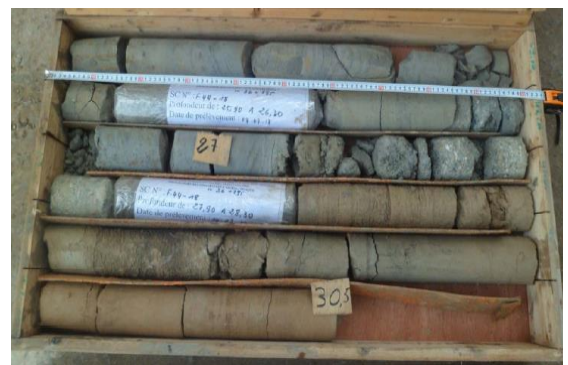
**Figure 10.** Compact marl interspersed with sandstone

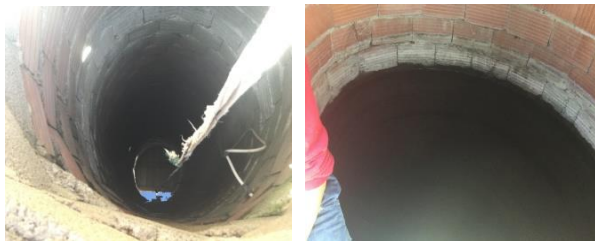
Groundwater is omnipresent in this sliding area (fig. 11). The groundwater level recorded in the piezometers is located in the weathered clayey marl and varies from 1.0 to 9.50 m from ground level.

It is important to note the presence of several wells along this section with a practically water level on the surface. The small dam located upstream (100m in vertical drop upstream) of the line could be part of the source of supply for these wells, especially in dry periods.

**Figure 7.** Several wells located in the sliding zone

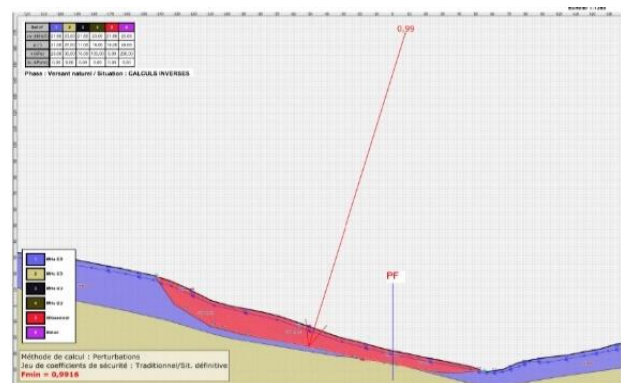
Back analysis is carried out using the french software TALREN by the limit equilibrium calculation method according to the simplified Bishop formulation and/or the method of perturbations, Fig. 12 shows the results obtained from back analysis performed on one of the four selected critical sections.

Figure 12. Back analysis section 2-2' at PK36+800 (Pier 35)

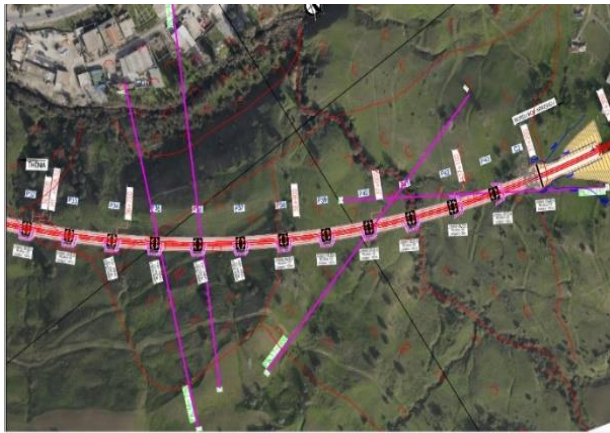
**Figure 13 .** Reinforcement system for the bridge piers P32 to P43

The solution adopted for the stabilization of the landslide affecting the piers P32 to P43 and the abutment of the bridge is the construction of a retaining structure consisting of a pile wall on "U obtuse shape". This reinforcement proposed (Fig. 13) is composed of 1200mm diameter piles, 30m long, with a spacing of 1.5m, stiffened by a reinforced concrete footing on the contour of the foundation and justified with regard to the stability to landslide in provisional and permanent and static and seismic (pseudo-static) situations.
